Appendix J

CARs

CORRECTIVE ACTION REQUEST NO. :CESPK-ED-GG-FY07-0001	
Originator: Lewis Hunter	Date Issued: 27 March 2007
Issued to: Kevin Siemann, Shaw Project: Former Ft Ord, MRS-16 Clean-up CESPK Project Manager: Cynthia Burris CESPK Project Safety Officer: Clinton Huckins Response Due: 3 April 2007	
Description of Condition Found: (As observed or reported)	
<p>QA seed Ord QA29 was detected and recovered on 3/15/07. This seed was planted as a double seed with a second seed buried 6" below. The second seed, Ord QA08 is a 37mm planted horizontally that was buried below QA29. QA08 by itself is undetectable from the surface but should have been detectable with a Schonstedt from the bottom of the hole when QA29 was removed.</p>	
<p>(Appropriate personnel, i.e. contractor PM, Safety Officer, Team Leader, etc., receiving the CAR will provide the following information to the originator by the "Response Due" date above. Please contact the originator if you have any questions)</p>

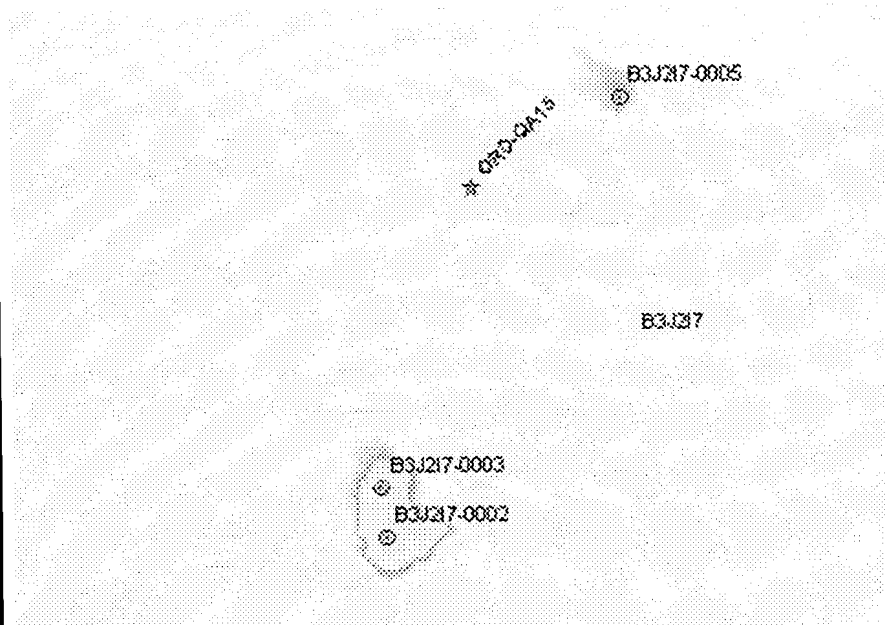
QA seed missed in grid B3J2I7 resulting in failure of grid block in which it was collected.

ORD-QA15 is a 37mm round buried vertically with a depth of 15-in. The nearest pick is B3J2I7-0005 located more than 10-ft to the northeast. Item was not detected by the DGM survey.

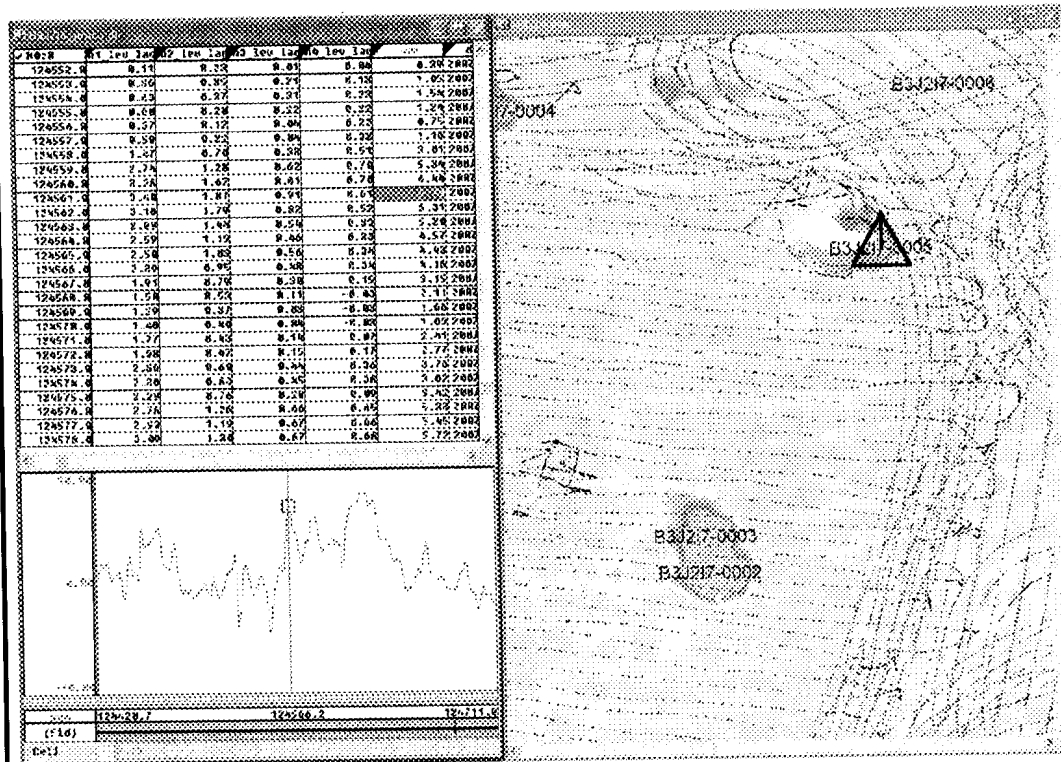
Although CAR 3 does not give coordinates of the QA seed we believe the QA seed is located as shown below in proximity to two other anomalies shown in the CAR 3 map above. The location is shown under the cross-hair point slightly more than 10 feet south west of anomaly B3J2I7-0005 in map below. The EM61Mk2 response is 6.79 mV. This is below the pick threshold. Since we have detected and picked all of the other QA seeds it is unlikely that the equipment couldn't detect this QA seed. Therefore the explanation is complex. Since the data and anomalies throughout the rest of the grid are acceptable and consistent we don't believe there was an equipment malfunction. The tracking data also show good coverage. It may be possible that the QA seed settled or has been shifted by animal activity.

It would be recommended that we bring a single new EM61 Mk2 system to see if the QA seed is detectable at the project threshold. If it is not detectable then the depth of the seed needs to be examined. We also need to confirm the exact location of the QA seed item by getting the coordinates.

Address after additional field investigation. If the item was buried deeper than thought there is no more action required. Order new EM61 Mk2 systems if it is proven to be an equipment malfunction. If not we may increase the number of QC digs below the project threshold.

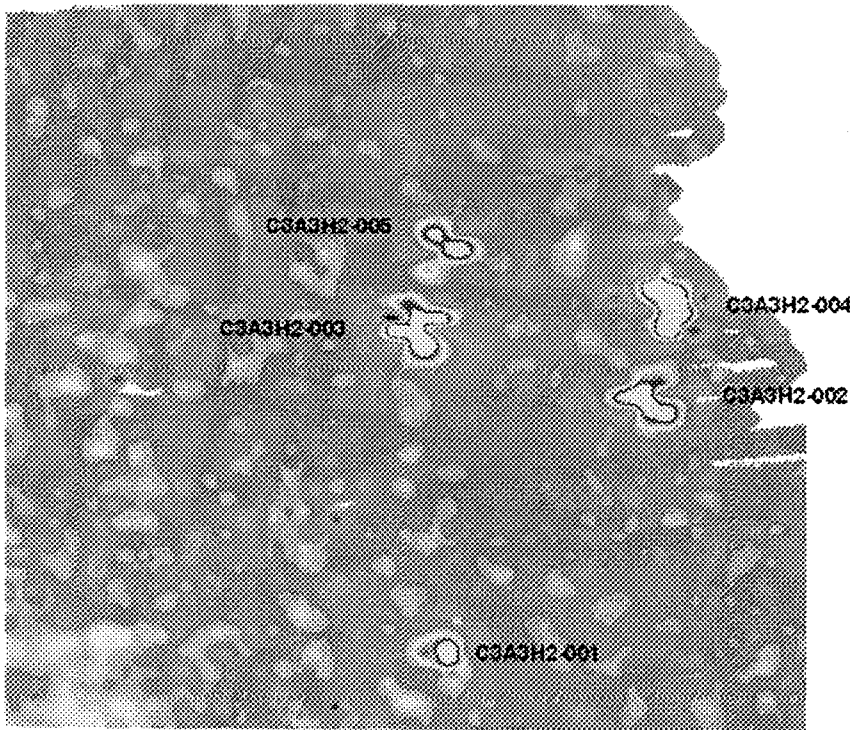
Grid block C3A3H2. 5 anomalies above pick thresholds were identified following QA digital surveys. Dig results found:

ID	mV (Ch3)	Target_ID	X	Y	Comment
C3A3H2-001	17	1	5747728	2122726	rust at 10"
C3A3H2-002	17	2	5747751	2122753	horseshoe at 6"
C3A3H2-003	15	3	5747724	2122763	horseshoe at 8"
C3A3H2-004	34	4	5747753	2122765	2.36 warhead MD at 4"
C3A3H2-005	20	5	5747728	2122773	horseshoe at 8"

Status: QA grid failure

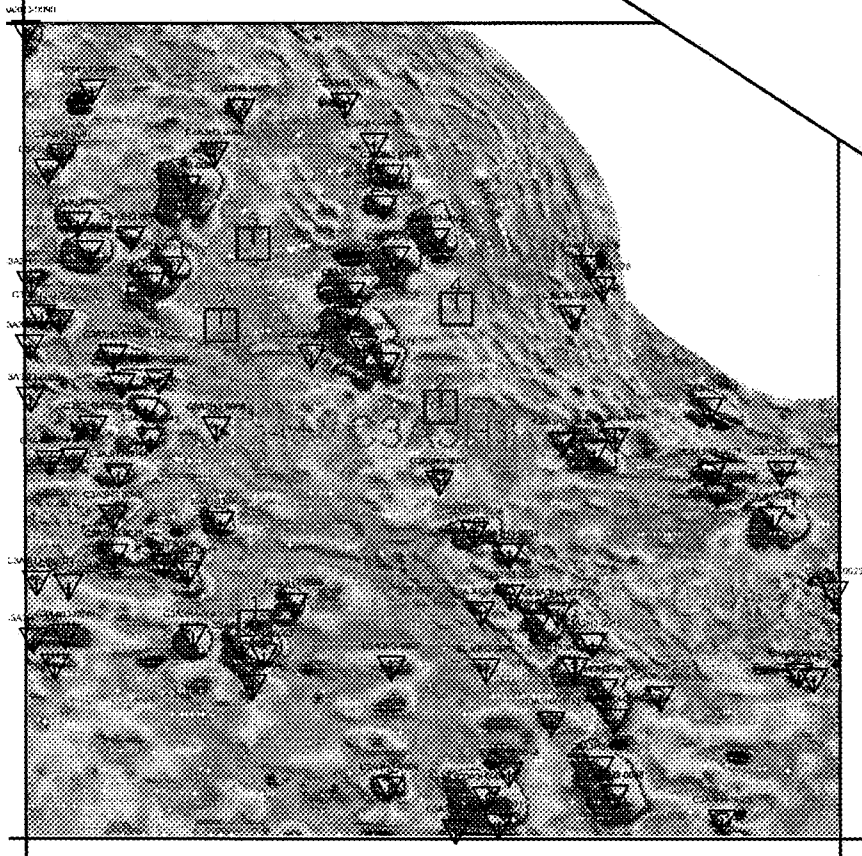
After plotting the locations of the anomalies detected in the QA mapping of grid C3A3H3 Shaw noticed that there were no anomalies for 4 out of the five locations indicated in the QA data (anomalies 2,3,4, and 5 - see above figure). Anomaly 1 is located in a cluster of anomalies and may represent one of the anomalies. We also noticed that all of the anomaly locations, when shifted 10.5 feet to the northwest, fall on top of one of the mapped anomalies. Many times anomaly clusters displaced by the same amount are caused by GPS problems (ergo: one cause can be lack of correction to position from a base station). This caused Shaw to look at the GPS in detail.

The action taken to correct the occurrence is to conduct a re-survey in the areas affected by the loss of lock. This can be done in real-time with the EM-61 Mk2. Most of the other anomalies in Grid C3A3H3 have been excavated in C3A3H3 (excavated from "good lock" data in the rest of the grid). However, the affected "no-lock" area does extend slightly onto the two adjacent grids and covers a very minor part of those grids. Those areas should be surveyed. Anomaly 1 from the QA data in Grid C3A3H3 falls outside of the "no lock" area. The anomaly falls in an area where several anomalies are clustered and is likely the result of inadequate field QC.

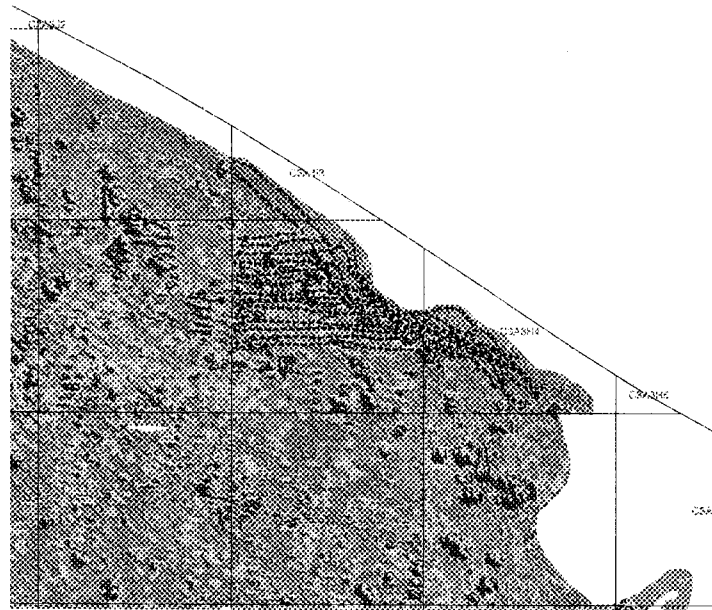
Shaw's next step was to go back and check ALL of the data collected at MRS-16. After checking all of the data from MRS-16 only one other, much smaller area, was affected (in Grid C3A3C5). Both affected areas are shown in the graphic below.

GPS Track-lines showing area where Grid C3A3H3 was affected.

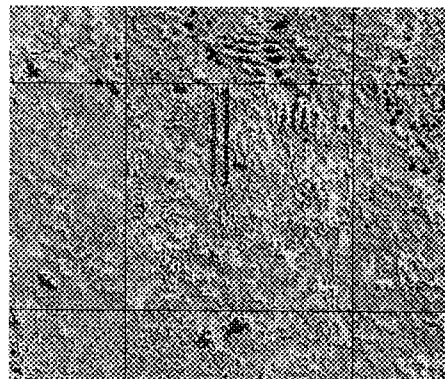
Two GPS Track-lines showing where Grid C3A3C5 was affected.

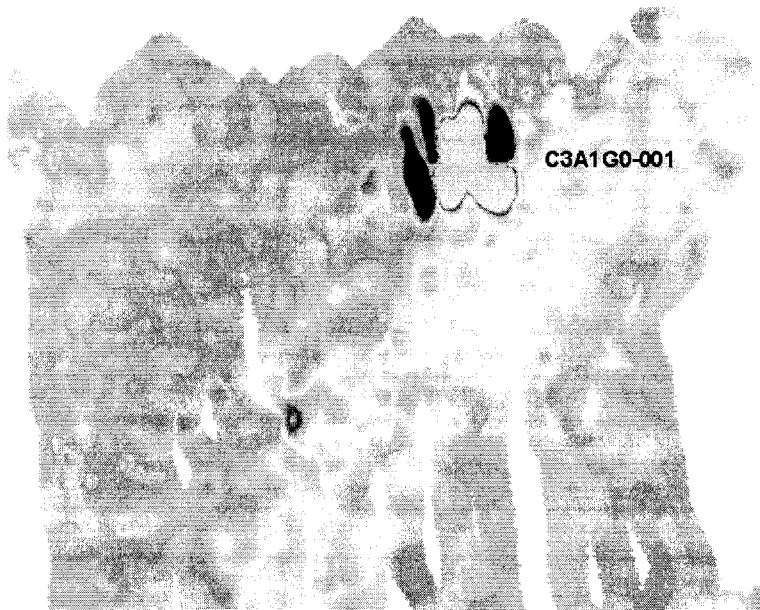
Grid block C3A1E0. 1 anomaly above pick threshold identified following QA digital surveys. Dig results found:

ID	mV (Ch3)	Target_ID	X	Y	Comment
C3A1G0-001	307	6	5746440	2122704	large metal cultural debris item embedded in ground at 6"

Status: QA grid failure

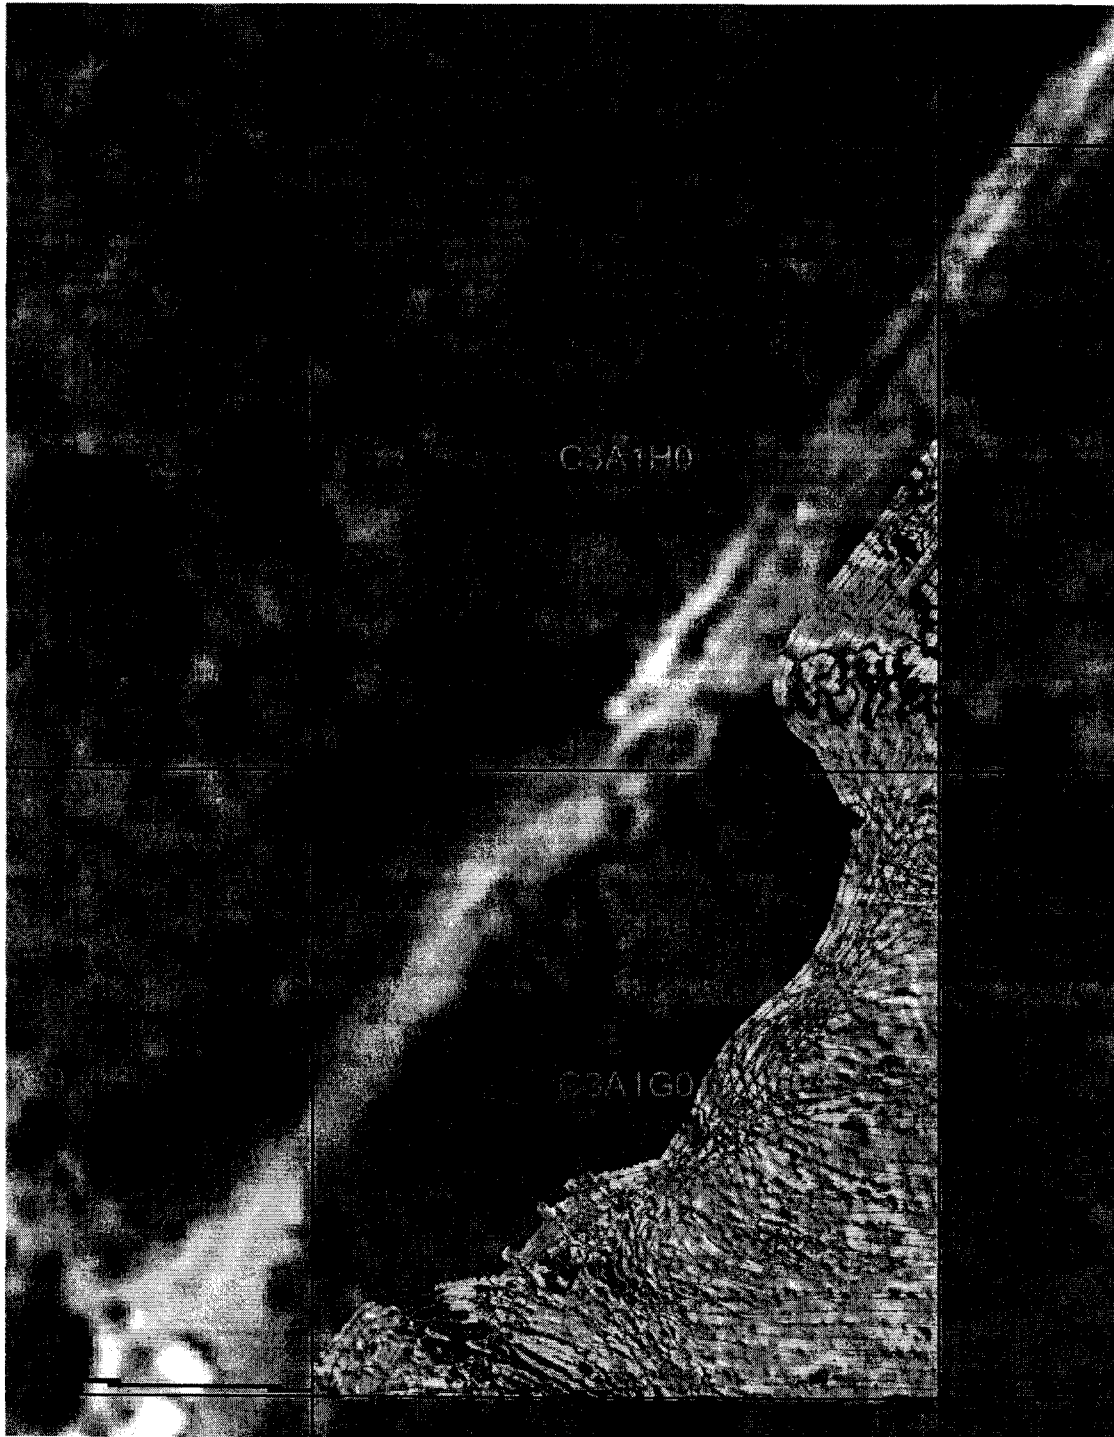
Actual Cause: (Appropriate personnel will investigate and determine cause of condition reported above. Actual cause should be stated as specifically as possible).
Target lies outside of the recently removed fenceline in grid C3A1H0. Real-time EM61 survey was completed along fenceline following fence removal, but did not extend beyond fenceline in accordance with FWV 0024.
