## **2011 ANNUAL BIOLOGICAL MONITORING REPORT FORMER FORT ORD, CALIFORNIA**

USACE Contract # **W91238-08-D-0034**  
Delivery Order 16

August 2011

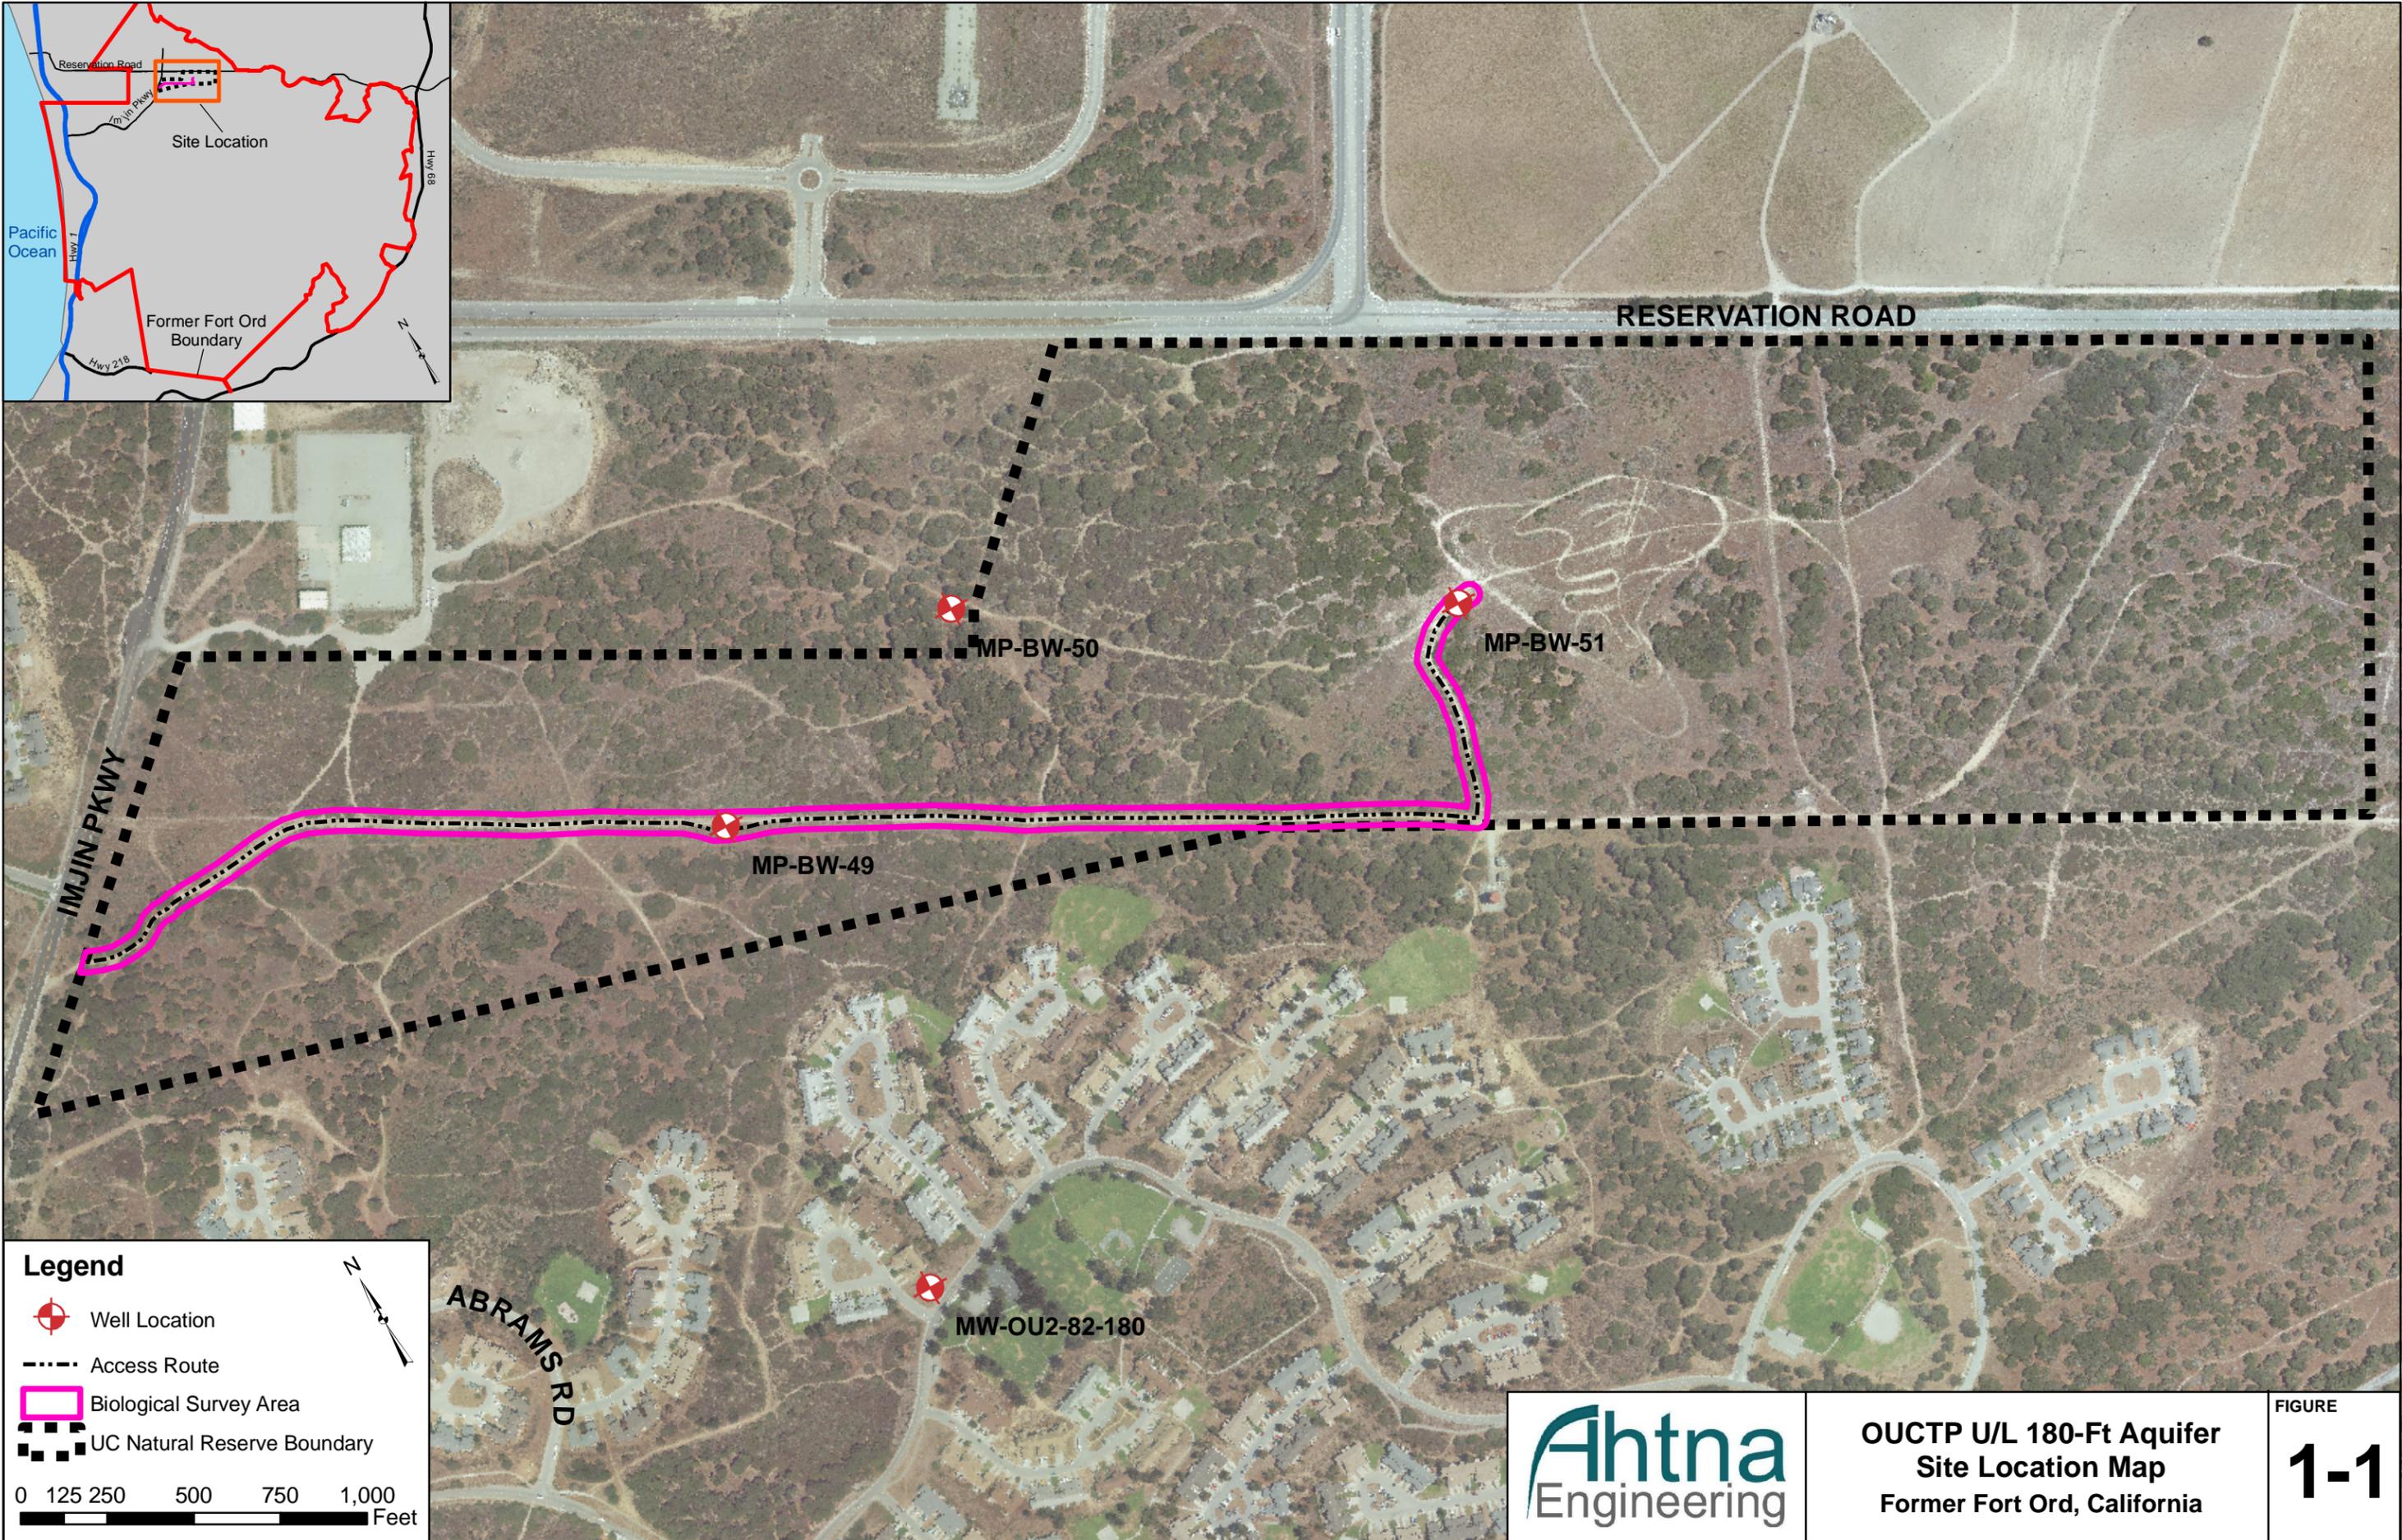
FIGURE  
**1-1**

**OUCTP U/L 180-Ft Aquifer  
Site Location Map  
Former Fort Ord, California**

The location of the wells, access routes and the biological survey area are shown in Figure 2.1.

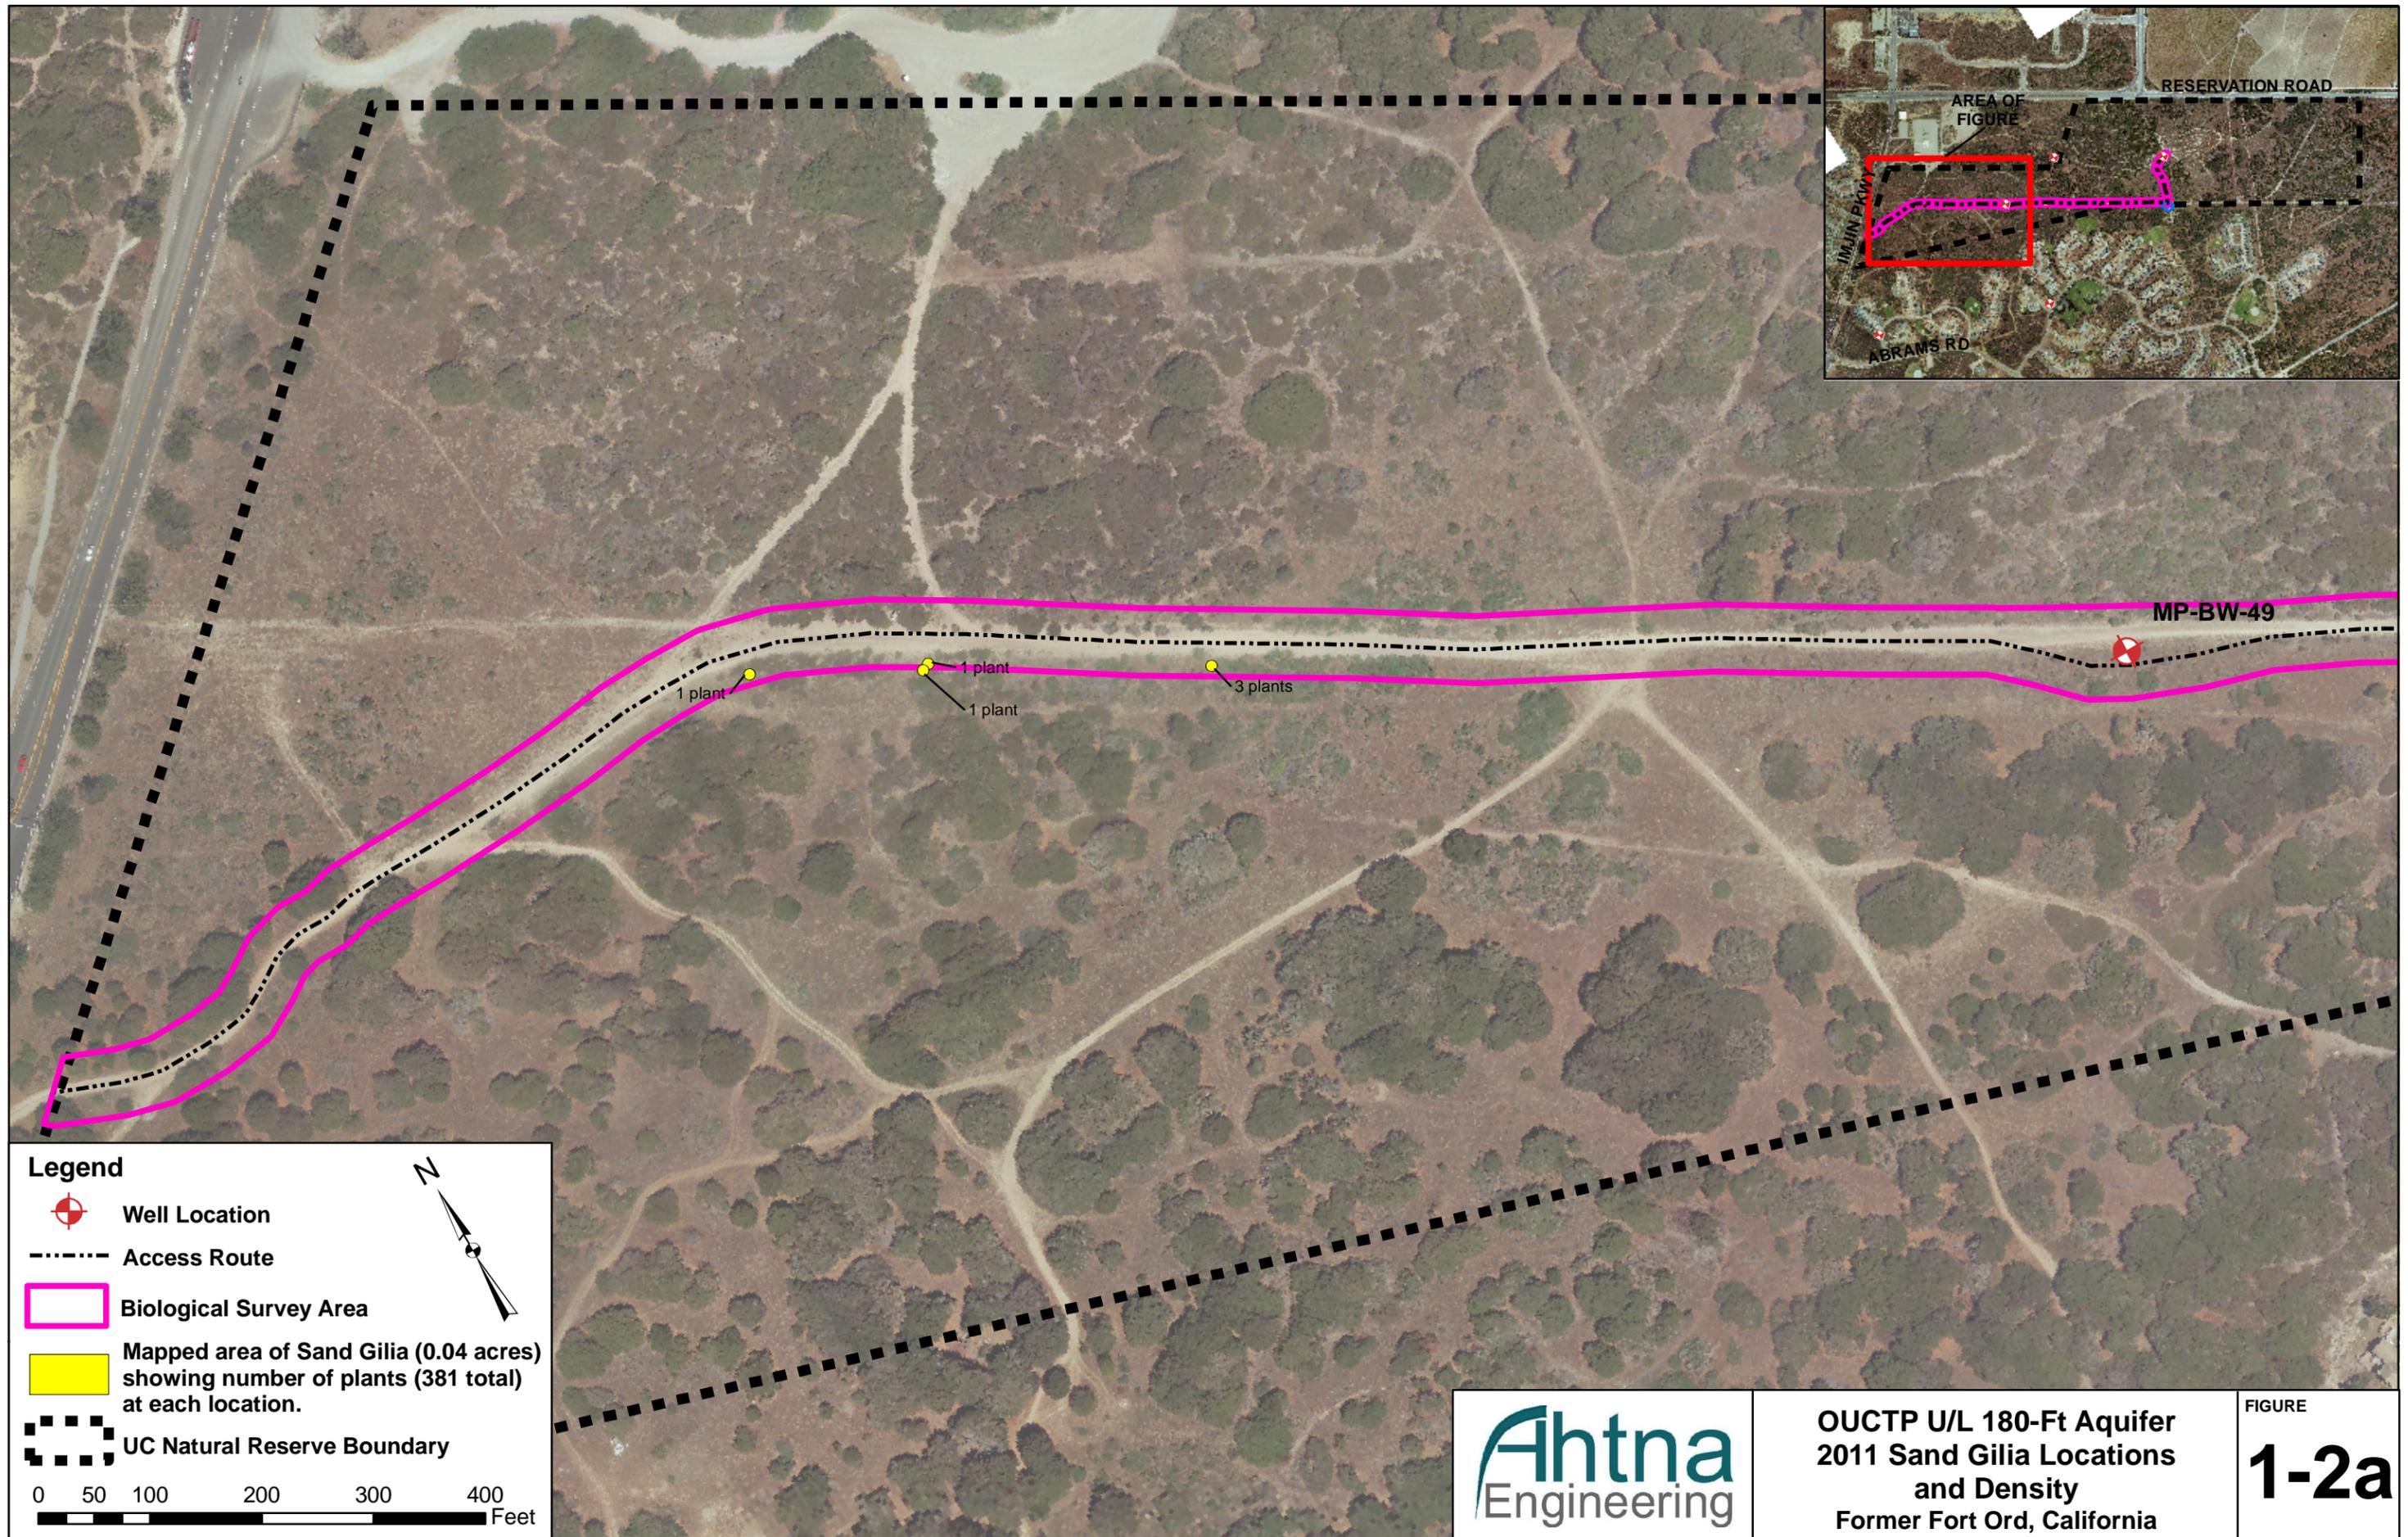
FIGURE  
**1-2a**

- Well Location
- Access Route
- Biological Survey Area
- Mapped area of Sand Gilia (0.04 acres) showing number of plants (381 total) at each location.
- UC Natural Reserve Boundary

OUCTP U/L 180-Ft Aquifer  
 2011 Sand Gilia Locations  
 and Density  
 Former Fort Ord, California

The locations and abundance of sand gilia found in the 2011 survey are shown in Figures 2.2a and 2.2b. Photograph 2.13 shows a typical sand gilia plant on the site.

**Total area of sand gilia in 2011 within biological survey area = 0.04 acres**

**Total number of sand gilia plants in 2011 within biological survey area = 383**

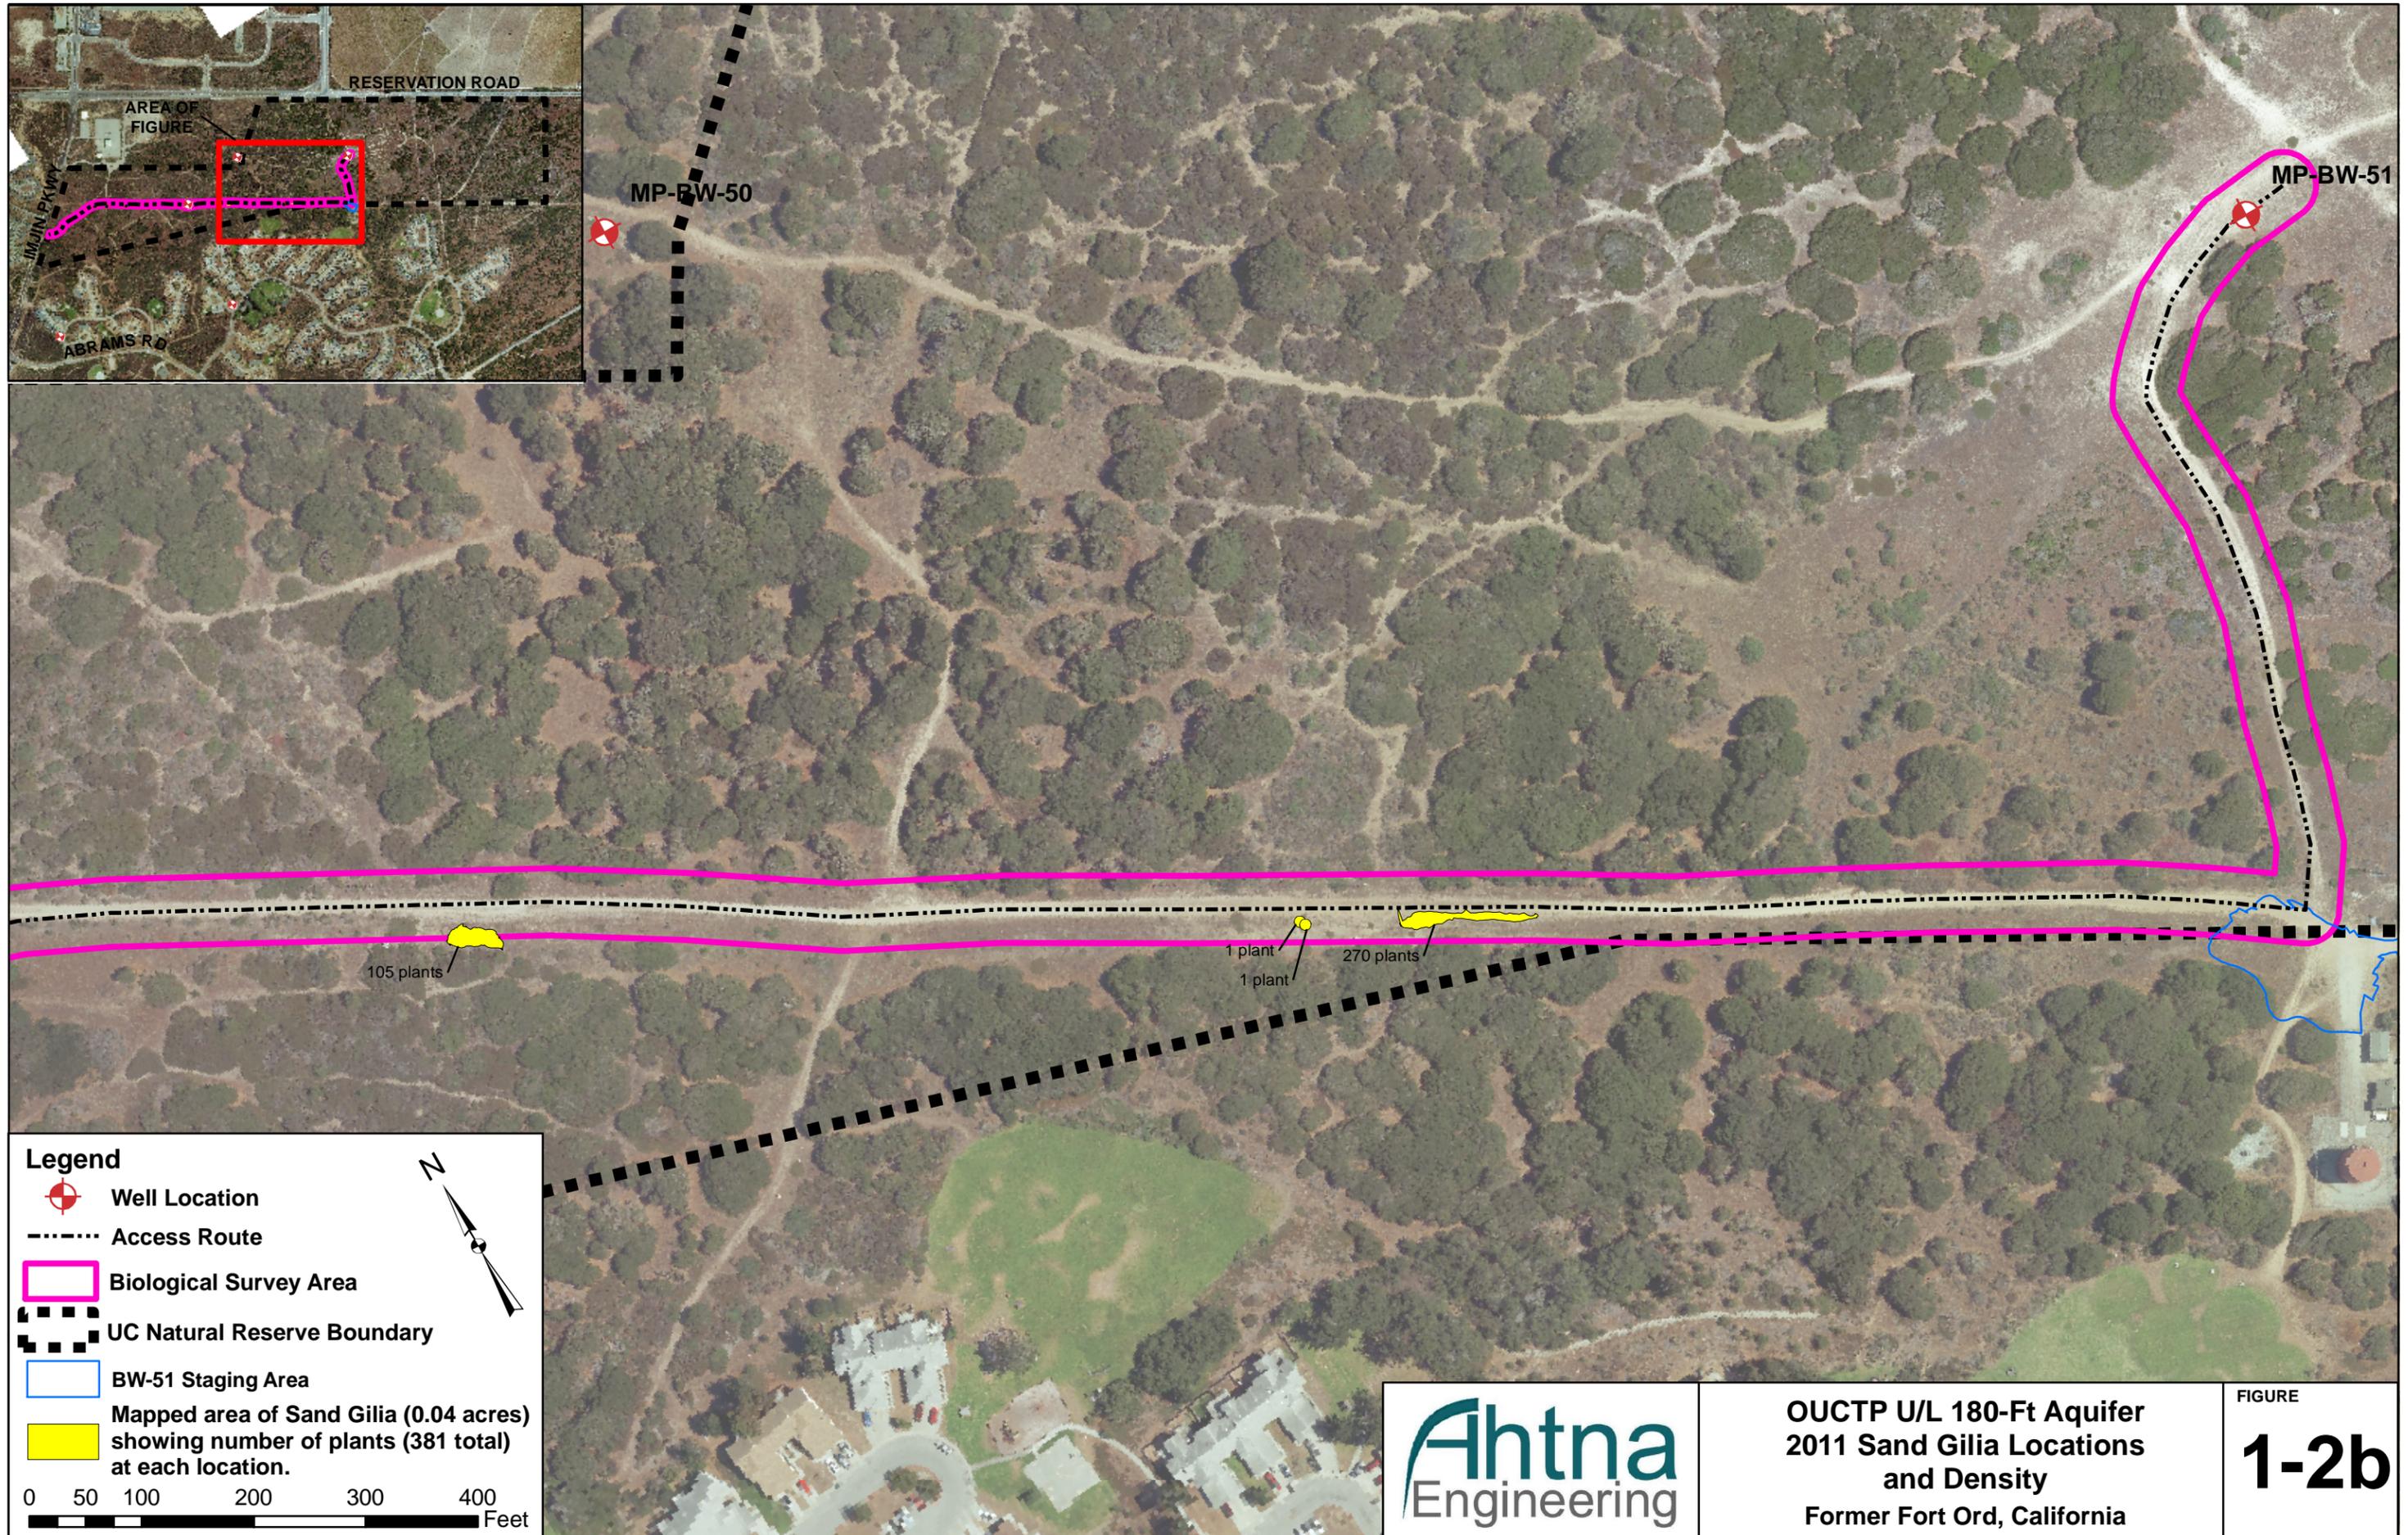
FIGURE  
**1-2b**

- Well Location
- Access Route
- Biological Survey Area
- UC Natural Reserve Boundary
- BW-51 Staging Area
- Mapped area of Sand Gilia (0.04 acres) showing number of plants (381 total) at each location.

OUCTP U/L 180-Ft Aquifer  
 2011 Sand Gilia Locations  
 and Density  
 Former Fort Ord, California

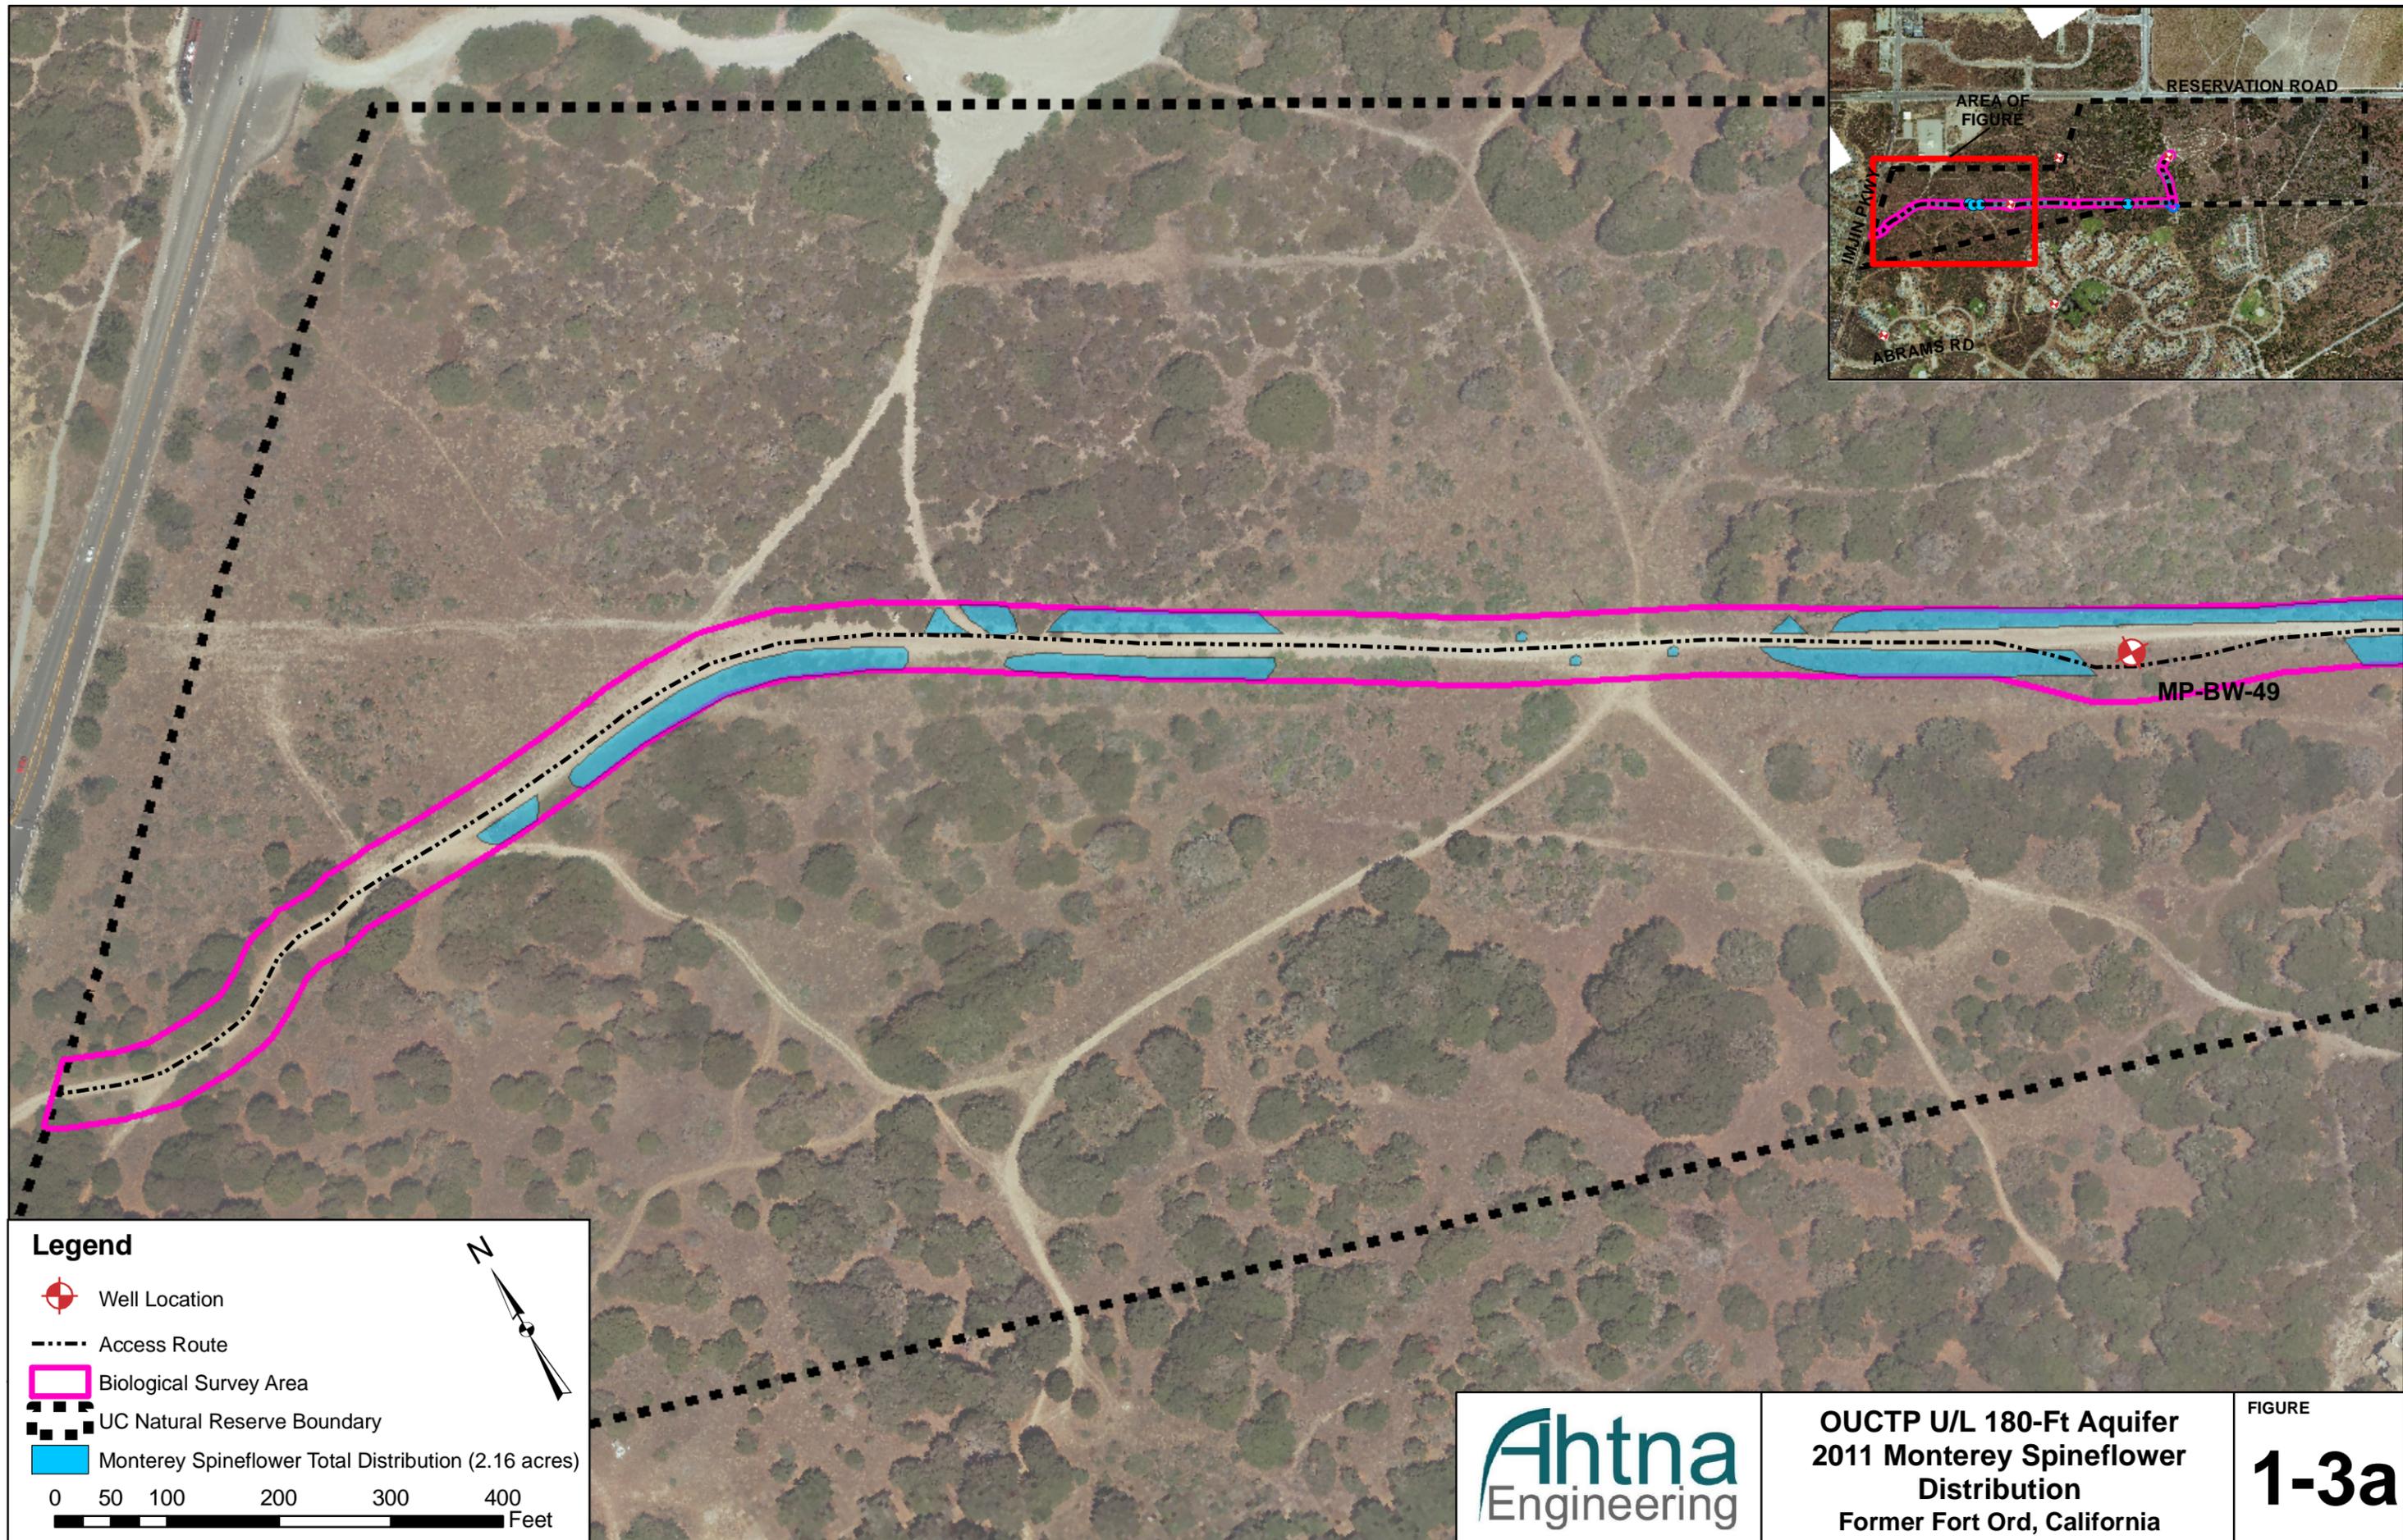
FIGURE  
**1-3a**

OUCTP U/L 180-Ft Aquifer  
 2011 Monterey Spineflower  
 Distribution  
 Former Fort Ord, California

The total distribution of Monterey spineflower within the survey area is shown in Figures 2.3a and 2.3b. The total occupied area at all densities was 2.2 acres.

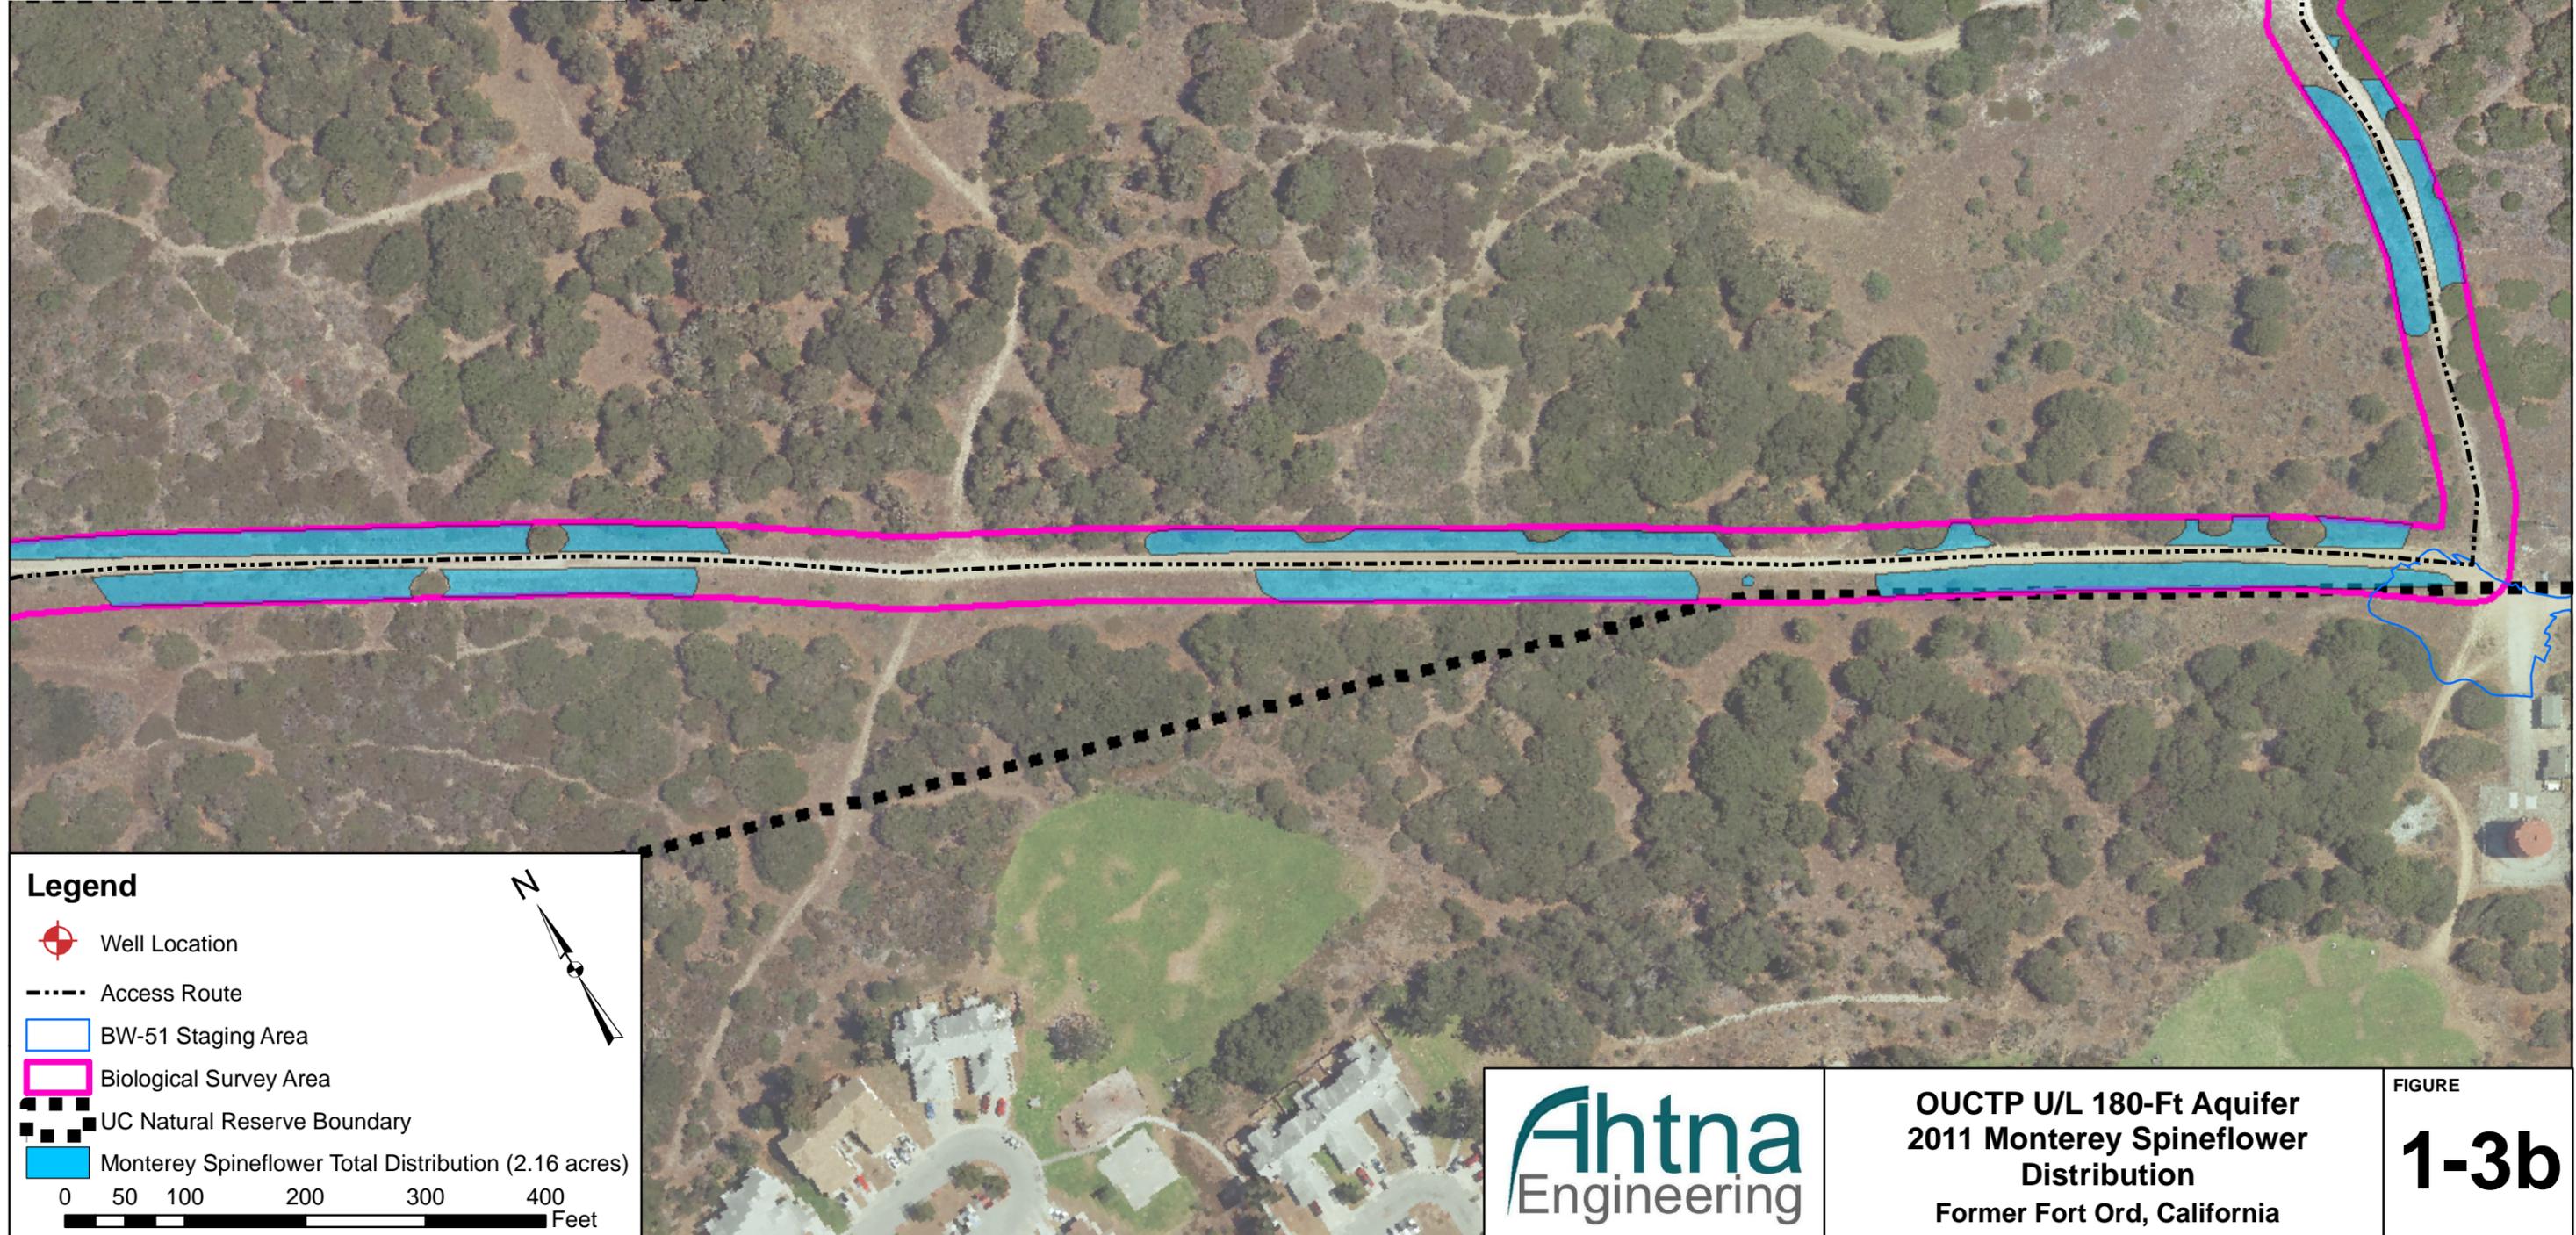
FIGURE  
**1-3b**

OUCTP U/L 180-Ft Aquifer  
 2011 Monterey Spineflower  
 Distribution  
 Former Fort Ord, California

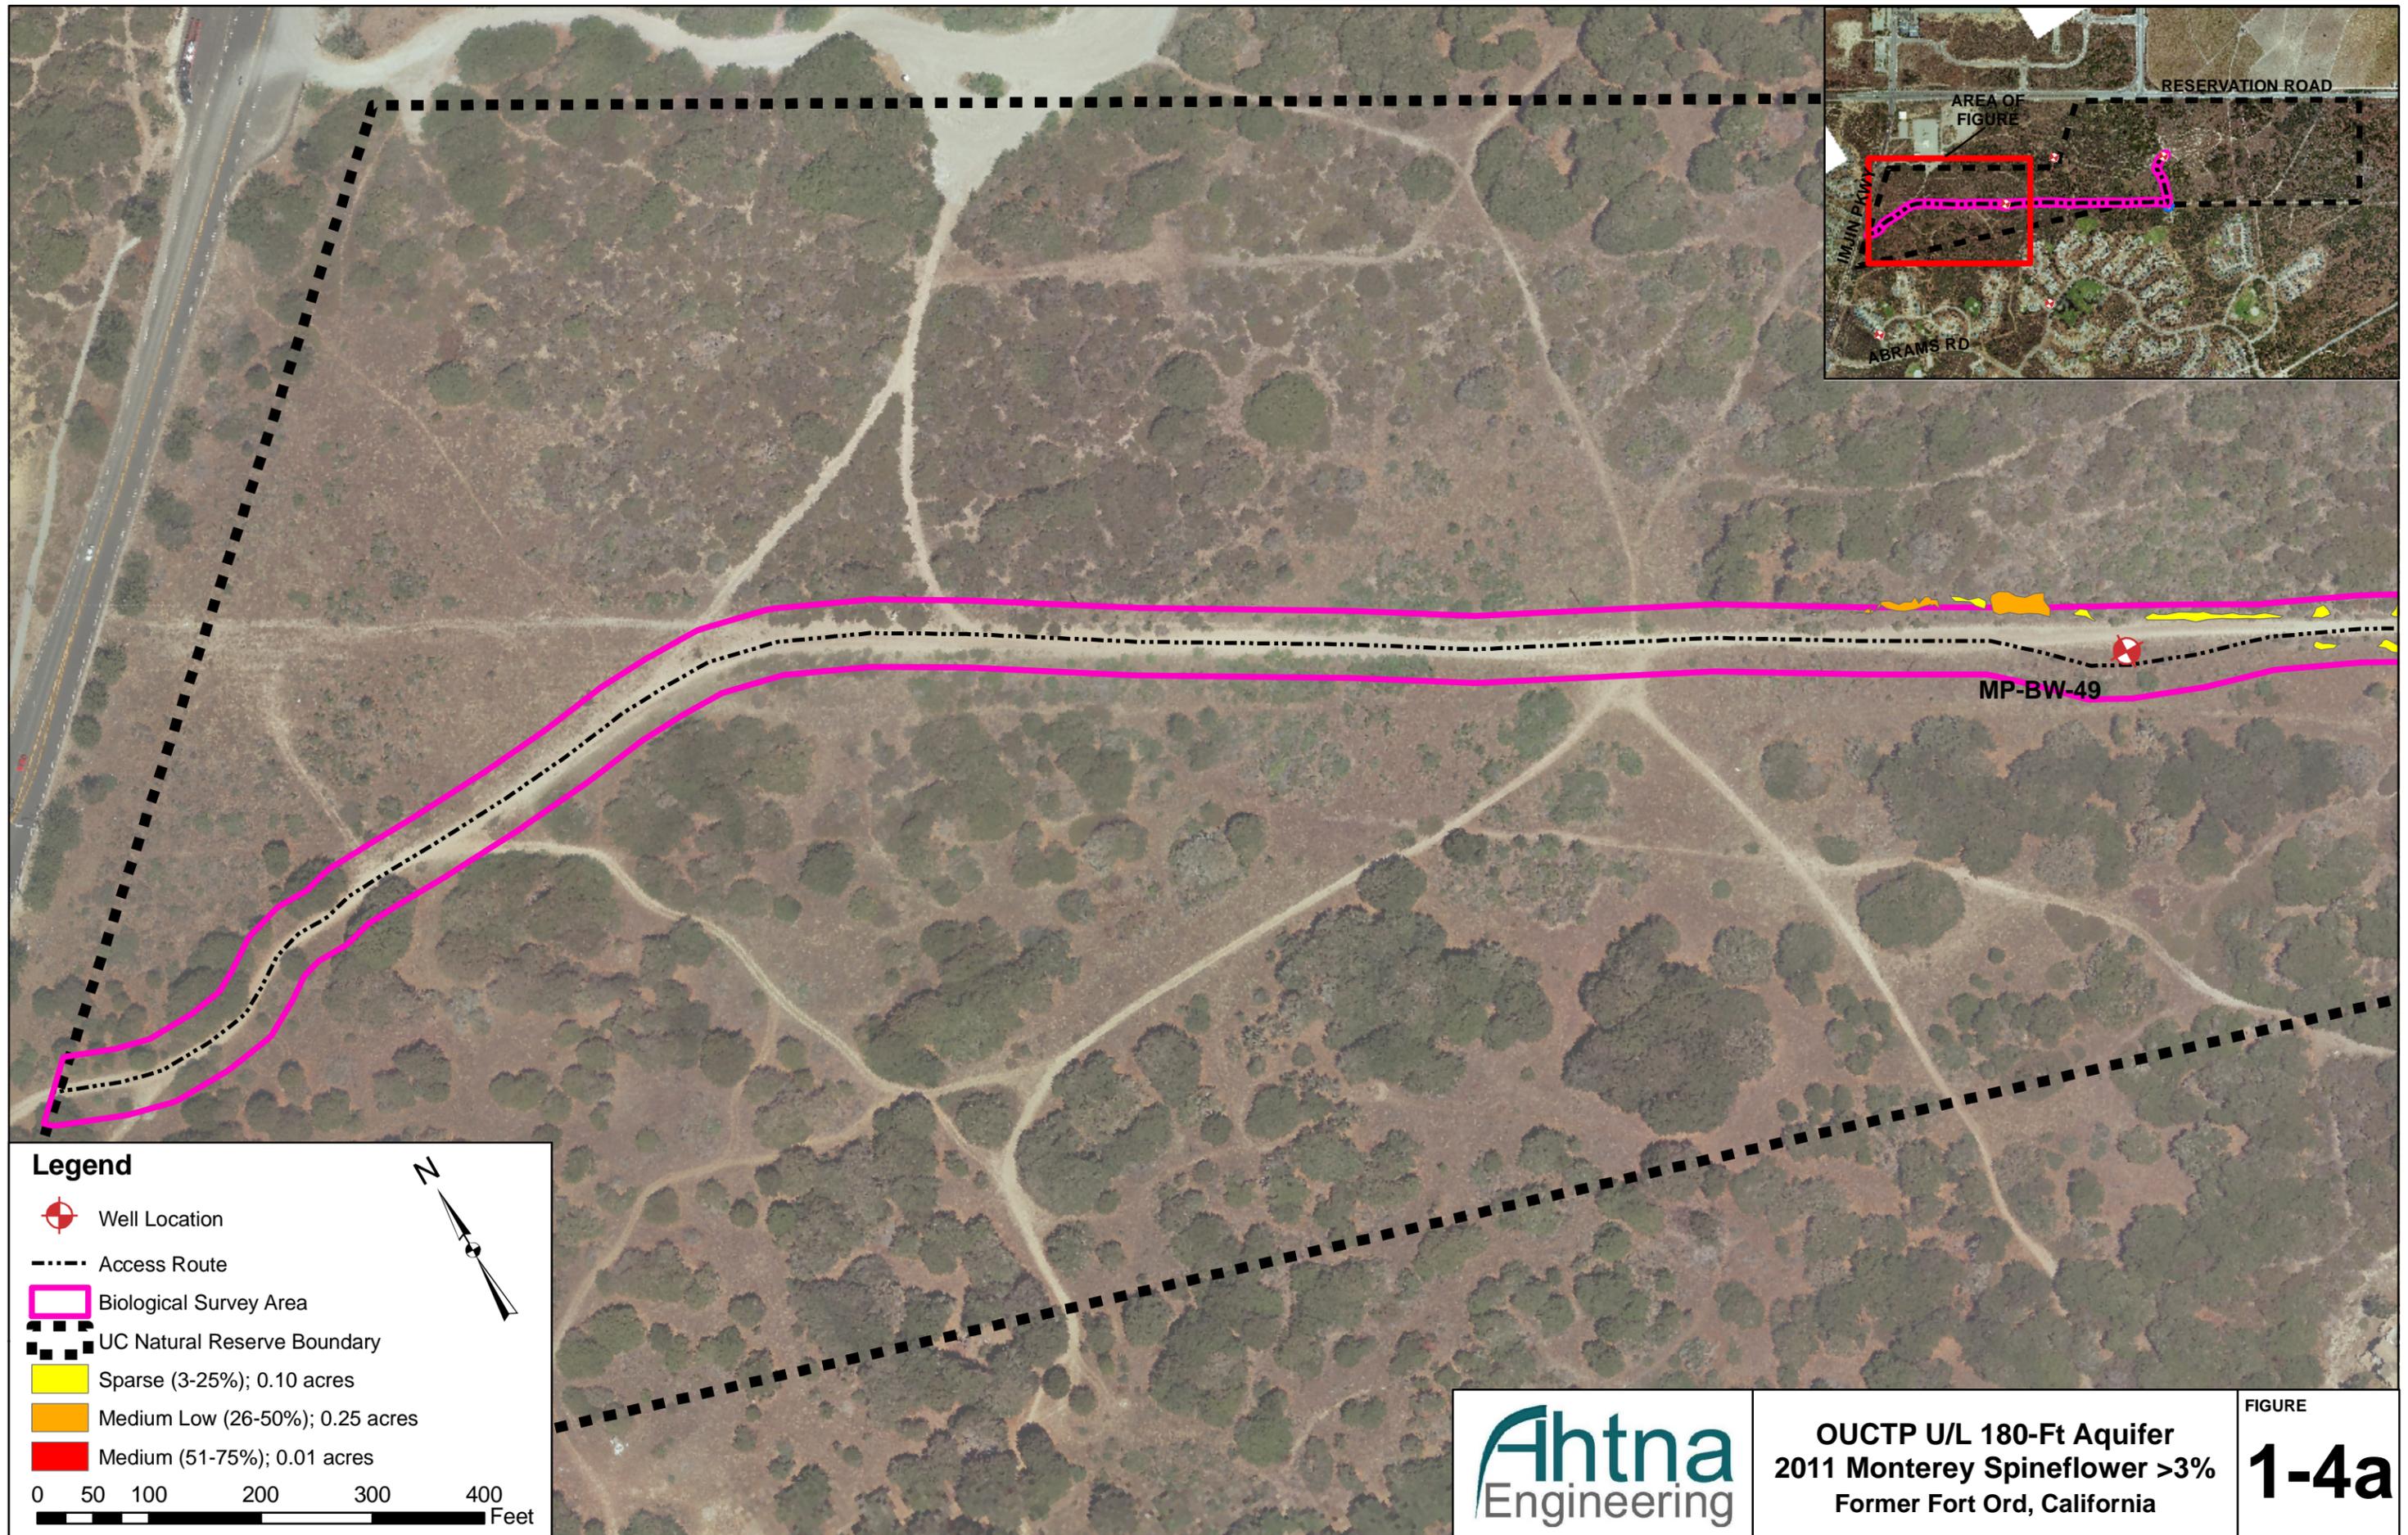
FIGURE  
**1-4a**

- Well Location
- Access Route
- Biological Survey Area
- UC Natural Reserve Boundary
- Sparse (3-25%); 0.10 acres
- Medium Low (26-50%); 0.25 acres
- Medium (51-75%); 0.01 acres

OUCTP U/L 180-Ft Aquifer  
 2011 Monterey Spineflower >3%  
 Former Fort Ord, California

Locations of higher densities of Monterey spineflower (>3% of ground cover) are shown in Figures 2.4a and 2.4b.
