## **2011 ANNUAL BIOLOGICAL MONITORING REPORT FORMER FORT ORD, CALIFORNIA**

USACE Contract # **W91238-08-D-0034**  
Delivery Order 16

August 2011

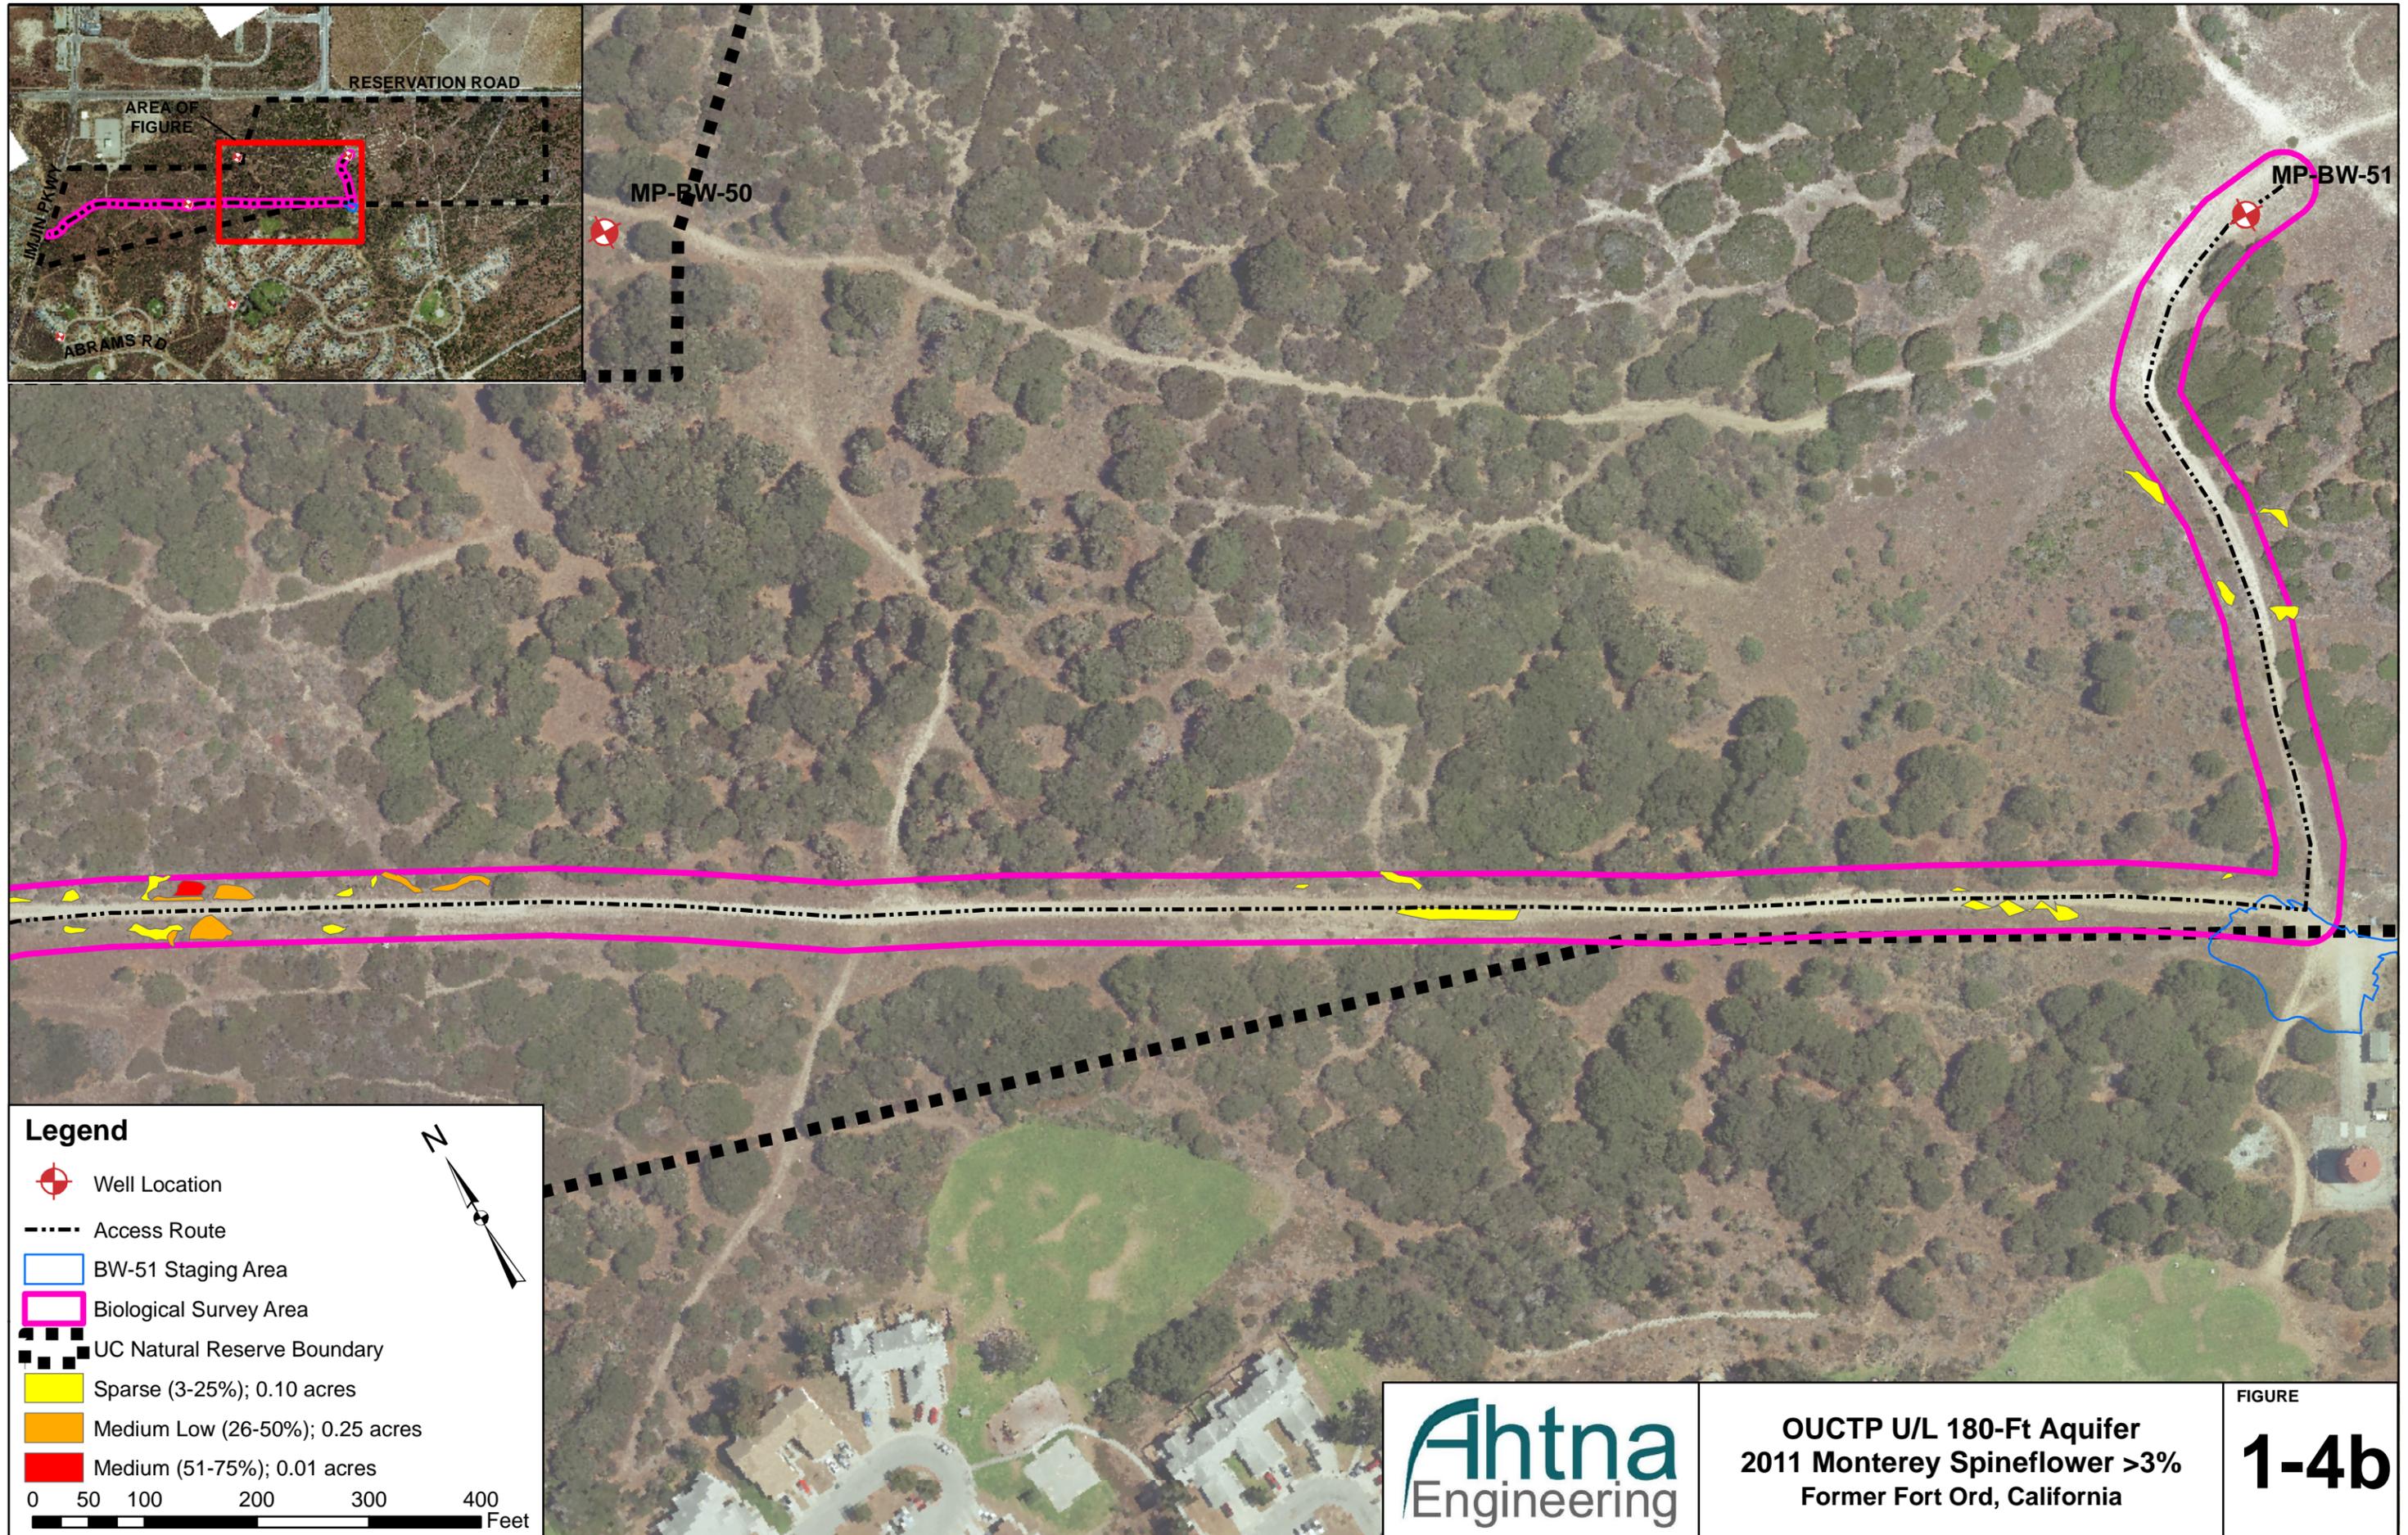
FIGURE  
**1-4b**

- Well Location
- Access Route
- BW-51 Staging Area
- Biological Survey Area
- UC Natural Reserve Boundary
- Sparse (3-25%); 0.10 acres
- Medium Low (26-50%); 0.25 acres
- Medium (51-75%); 0.01 acres

OUCTP U/L 180-Ft Aquifer  
 2011 Monterey Spineflower >3%  
 Former Fort Ord, California

Locations of higher densities of Monterey spineflower (>3% of ground cover) are shown in Figures 2.4a and 2.4b.

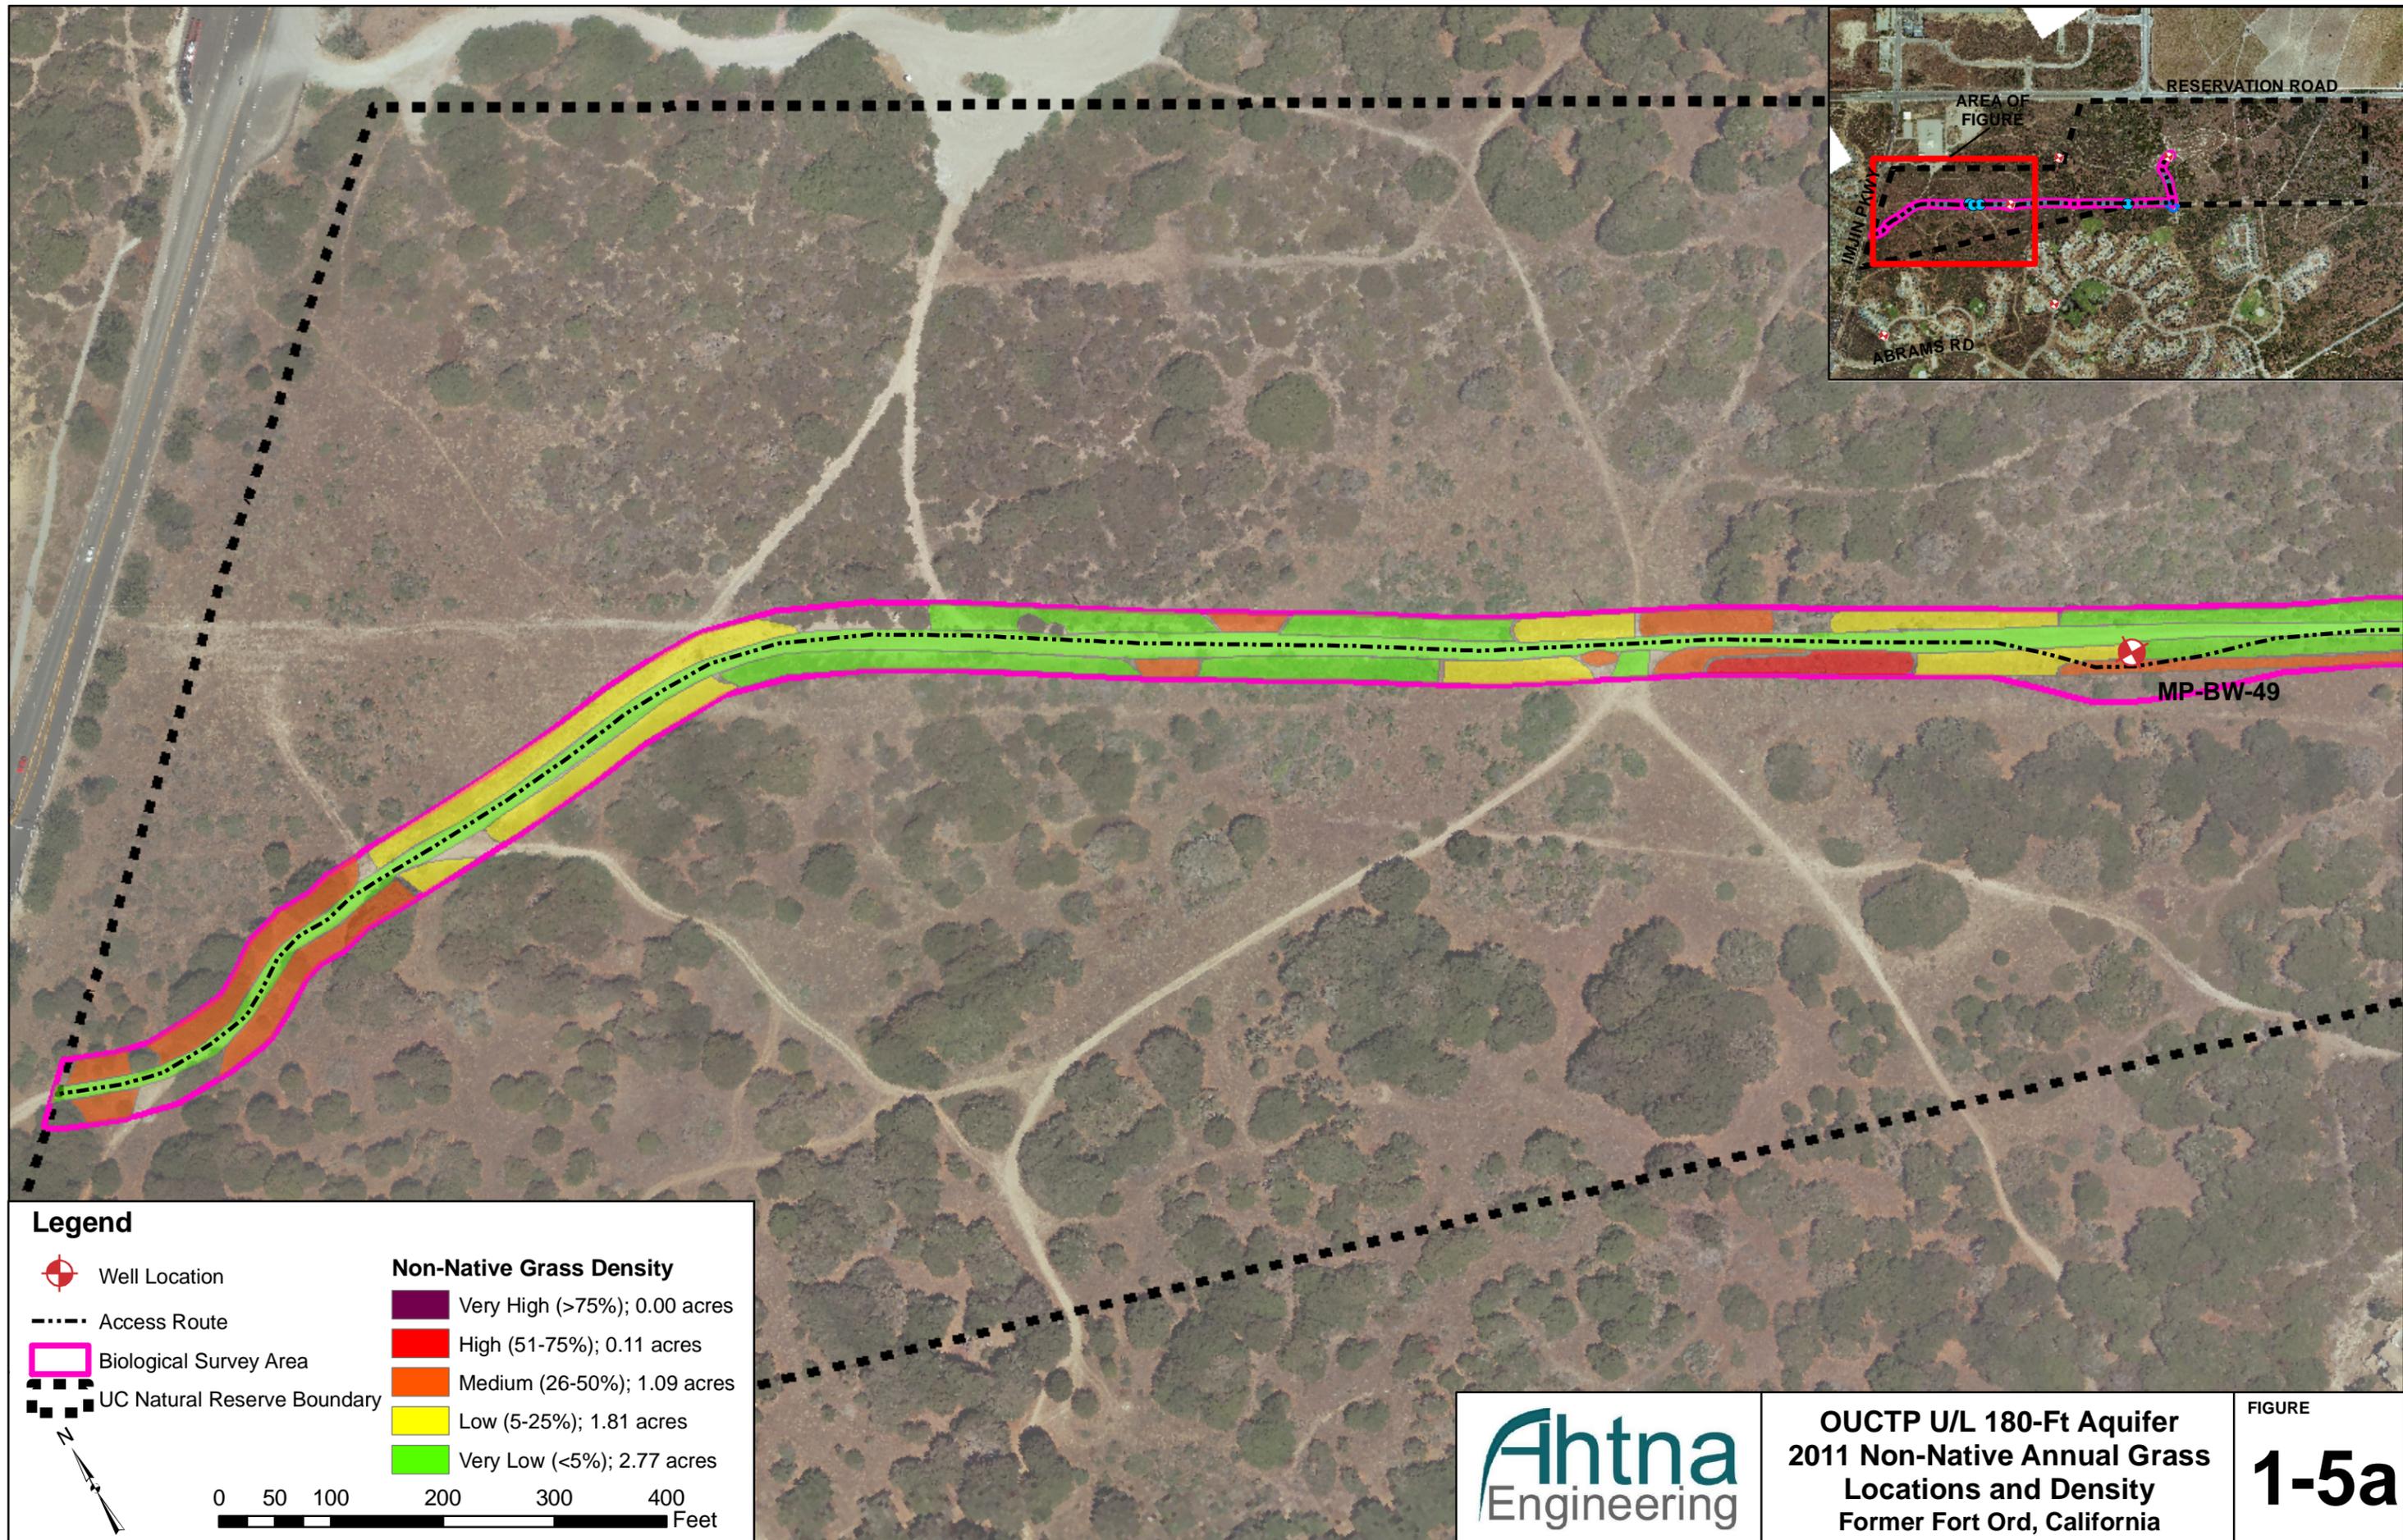
FIGURE  
**1-5a**

OUCTP U/L 180-Ft Aquifer  
 2011 Non-Native Annual Grass  
 Locations and Density  
 Former Fort Ord, California

Non-native annual grass location and densities are shown in Figures 2.5a and 2.5b.

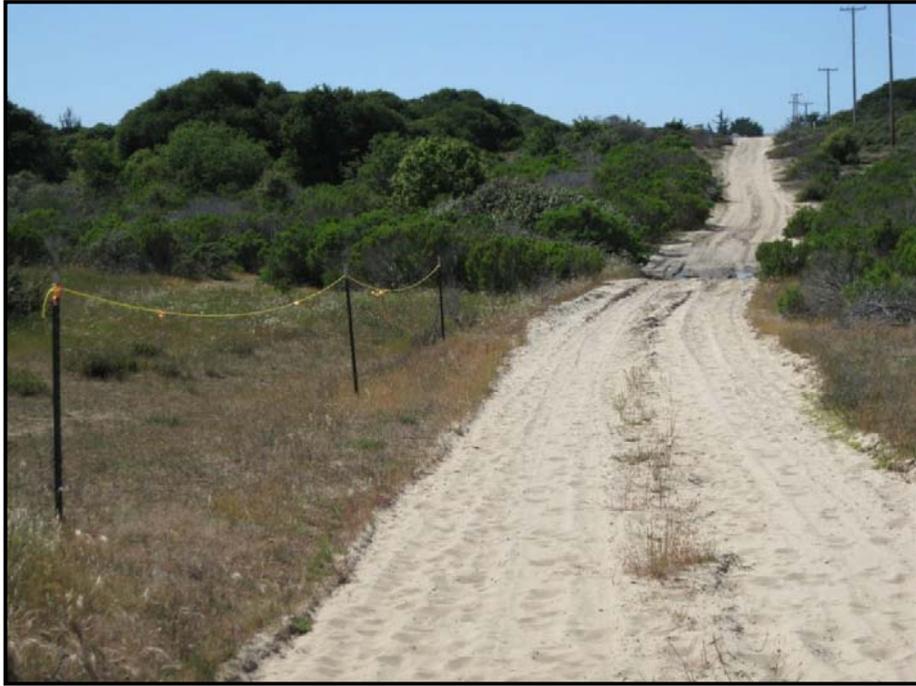
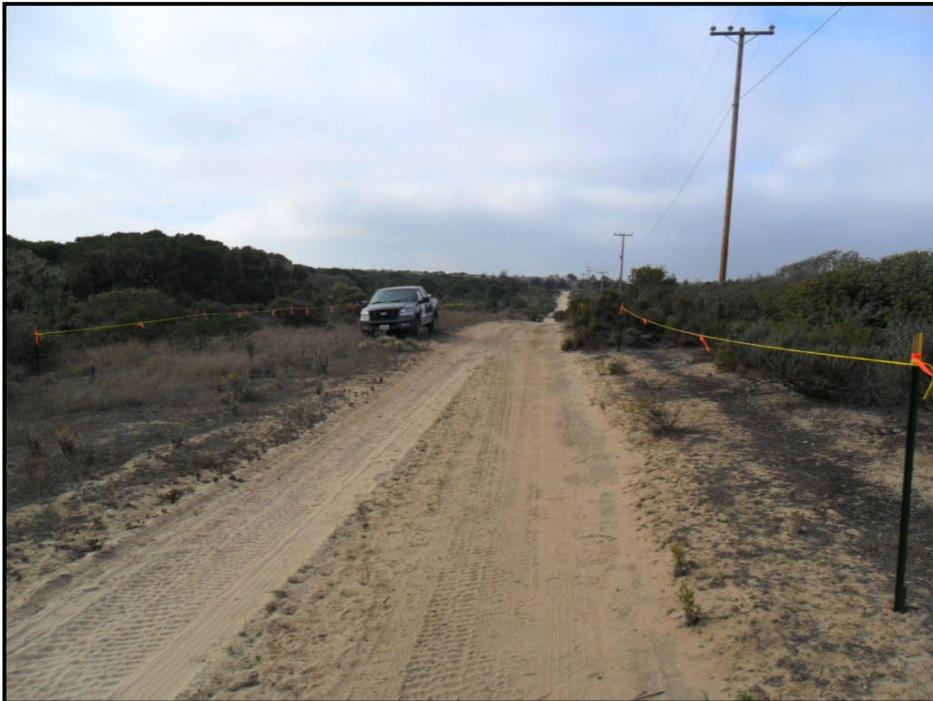
Photograph 2.1a, b – Two views of main access route through the FONR South Reserve (Old County Road). Work vehicles remained on roads at all times except to use designated turnaround and staging areas.

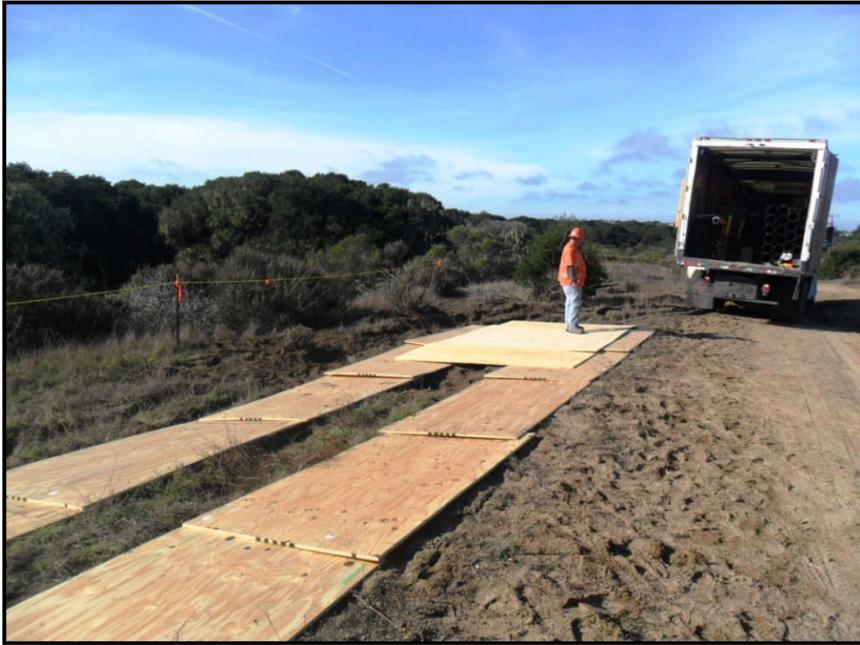
Photograph 2.2 –Plywood boards for staging the drill rig and support truck at well site MP-BW-49.

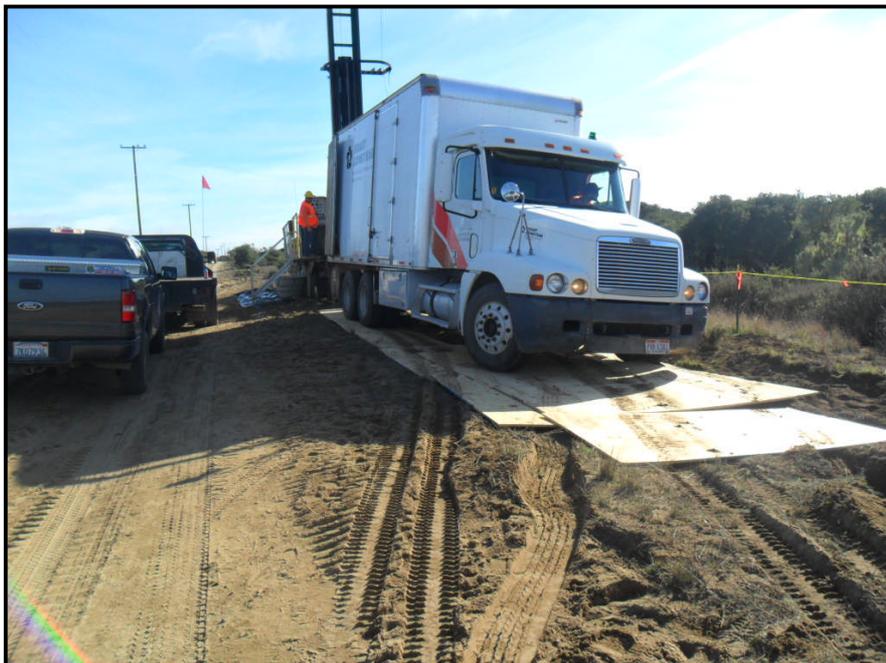
Photograph 2.3 – Drill rig and support truck staged on plywood boards at well site MP-BW-49.

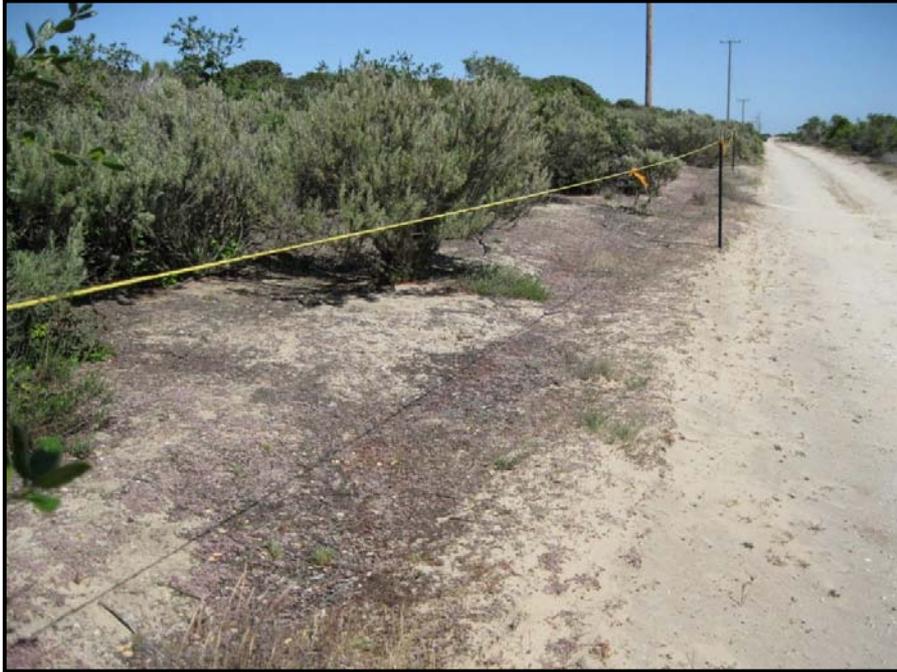
Photograph 2.4 – The road edge opposite the MP-BW-49 site with fencepost and flagging to protect Monterey spineflower habitat close to the work area.

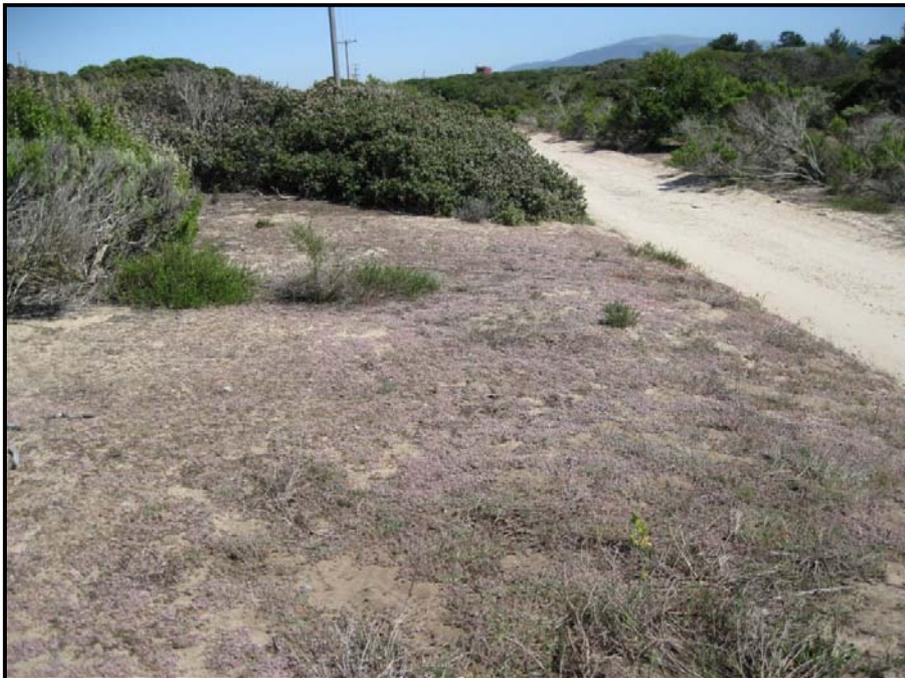
Areas very close to MP-BW-49 and along main access route had relatively high densities of Monterey spineflower (Photograph 2.5). High density areas close to the well work site were marked off with fence posts, rope and flagging to ensure there would be no vehicle intrusion or other disturbances (Photograph 2.4). Except for areas in the vicinity of the two wells, and the staging area for MP-BW-51, there was no off-road use that could cause soil disturbance and effects on the Monterey spineflower populations outside of the roadbeds during the work period.

Photograph 2.5 – Mats of high density Monterey spineflower along the main road edge. Traffic remained inside the roadbed of the main route and did not impact these areas.

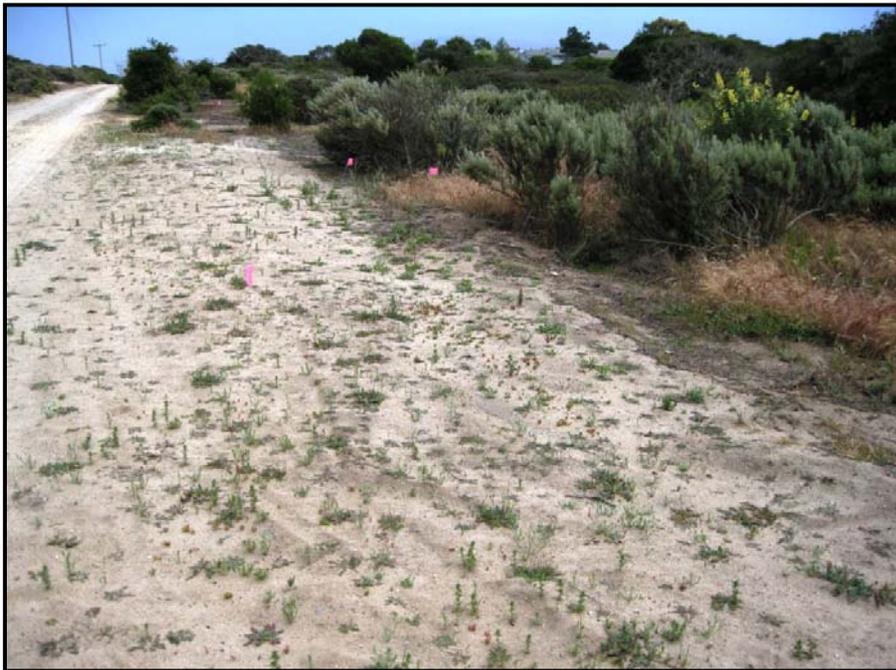
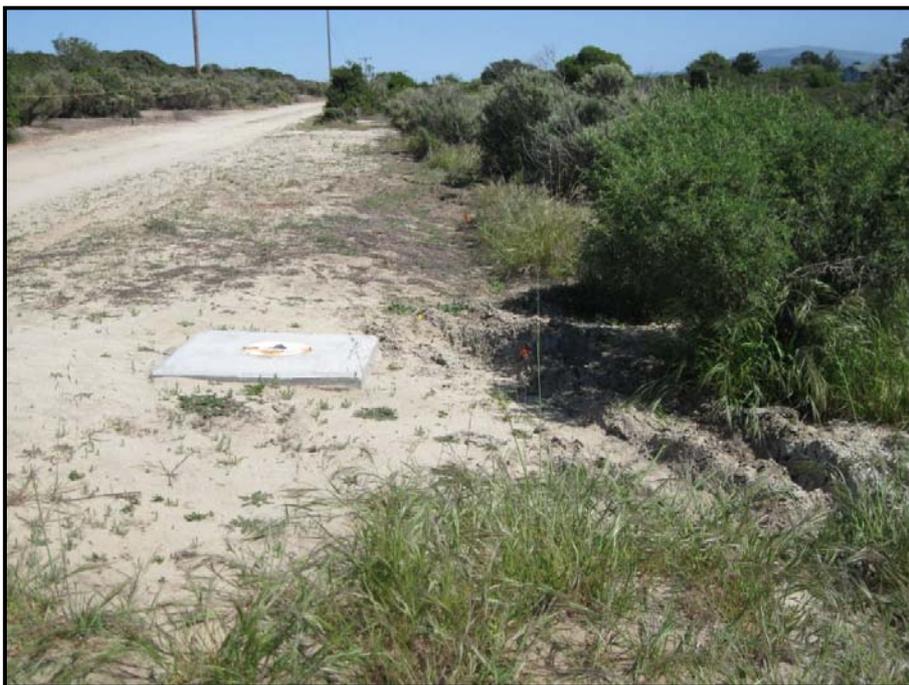
Photograph 2.6a,b – Views of well site MP-BW-49 in June 2011 after work completion. Views show areas of both low vegetation cover in compacted soil areas (top), and patches of annual grasses (bottom).

Both wells, their access routes and staging areas were located in areas of Very Sparse (<3%) cover as mapped in the baseline survey. In 2011, there was a notable absence of Monterey spineflower in the areas impacted by the well installation, and total vegetation cover was also very low in both these areas, as shown in Photographs 2.6 and 2.10. Monitoring in the next two years will determine the recovery of plant species as the soil conditions improve with time.

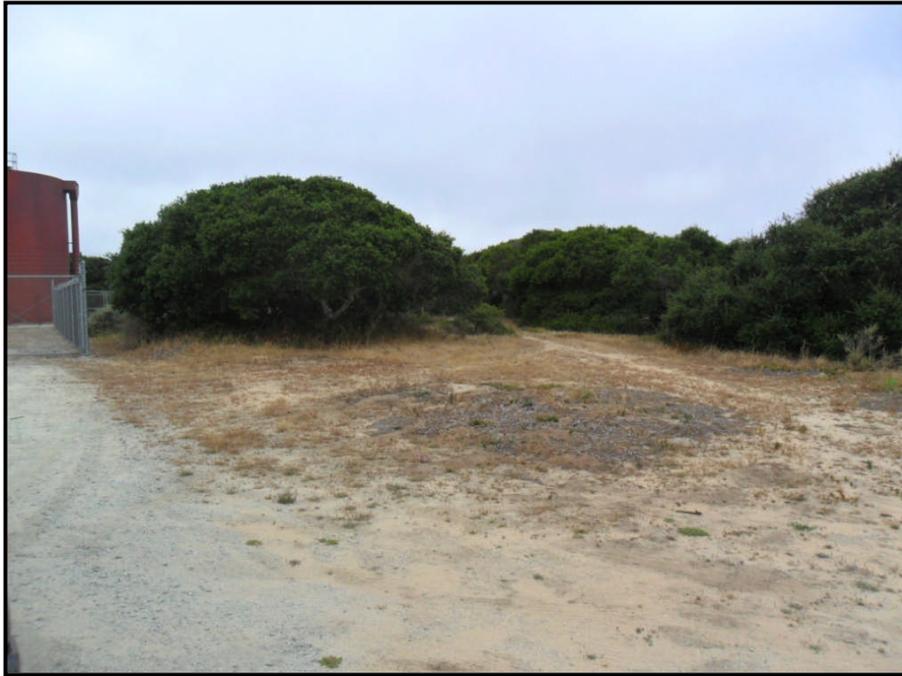
Photograph 2.7 – MP-BW-51 equipment staging area near main road. This area was degraded habitat with iceplant mats (foreground) so there was no impact to rare HMP-listed species.

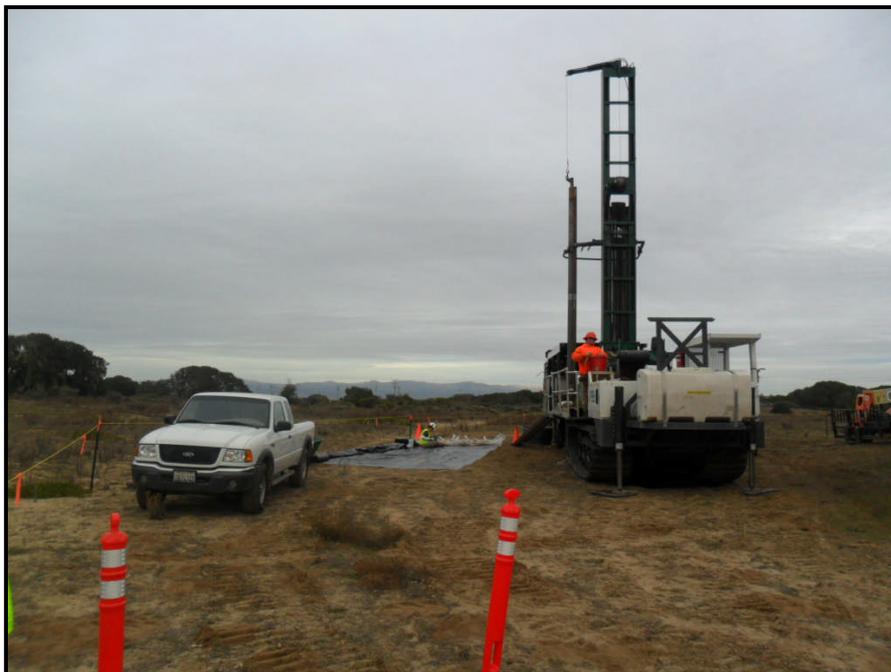
Photograph 2.8 –Drill rig in place at well site MP-BW-51 with soil core lay-down area (plastic tarp).

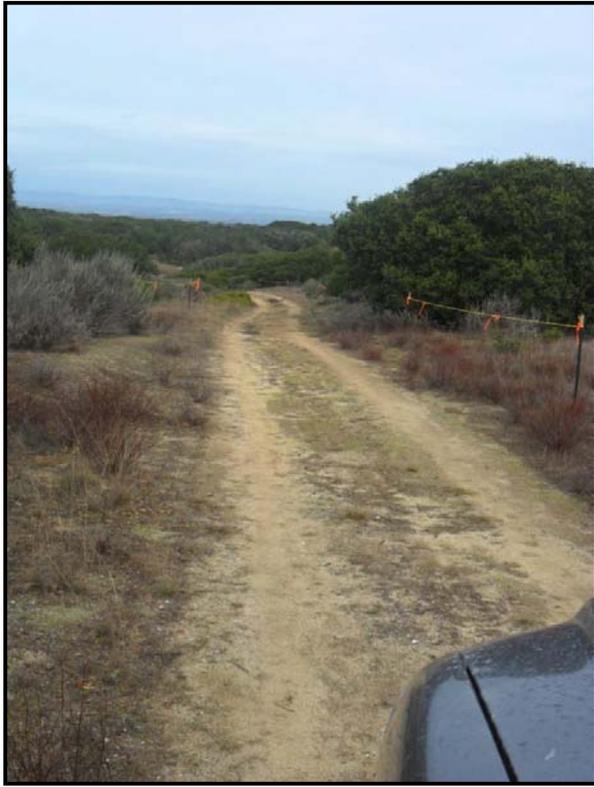
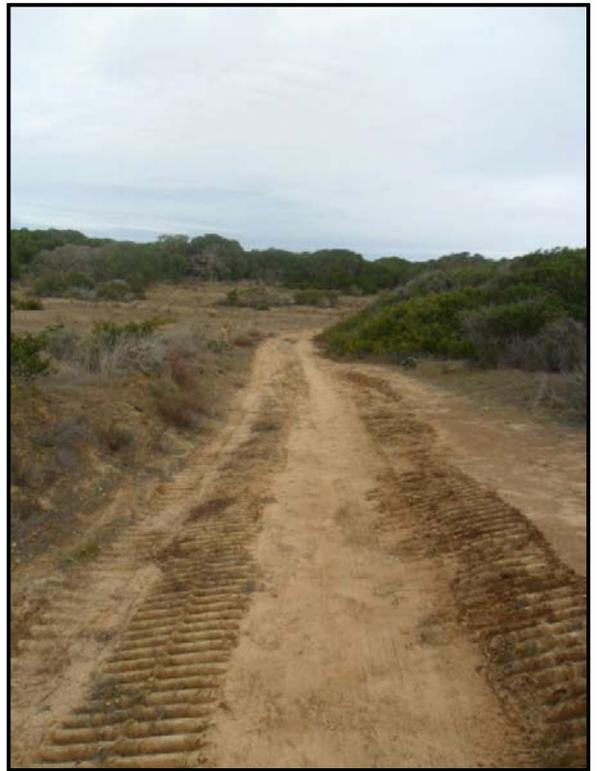
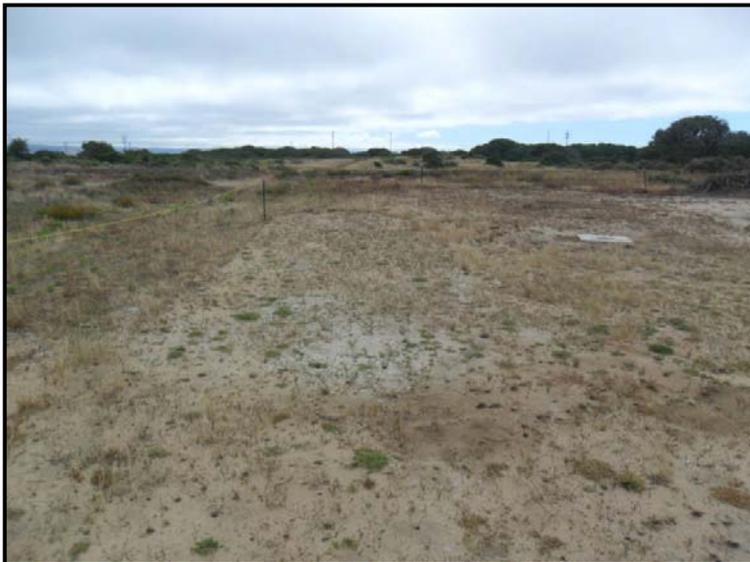
Photograph 2.9a-c –Views of access route from the main road (a,b) to the well site MP-BW-51 (c).

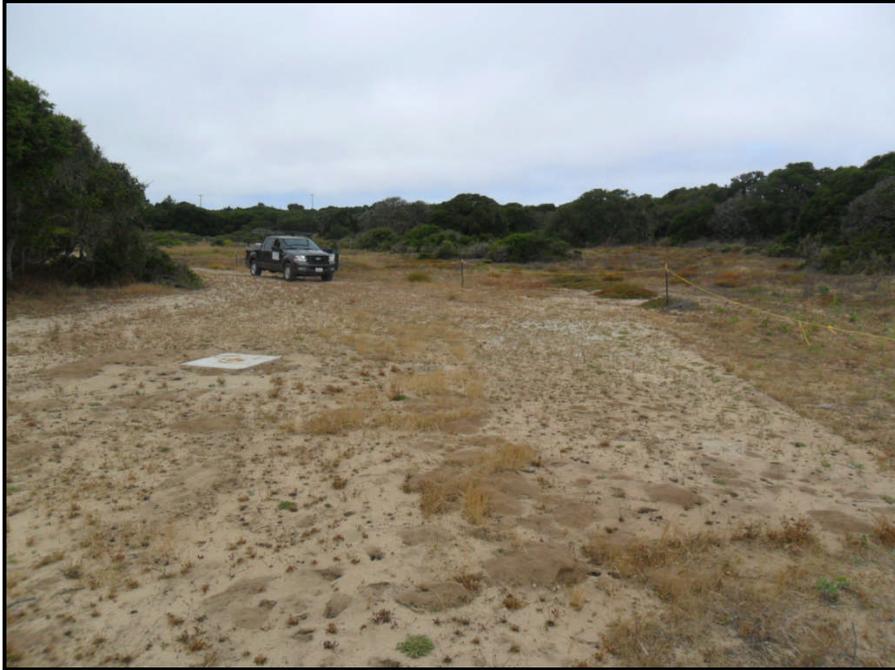
Photographs 2.10 – Well site MP-BW-51 in June 2011 after work completion, showing the sparse vegetation due to soil compaction.

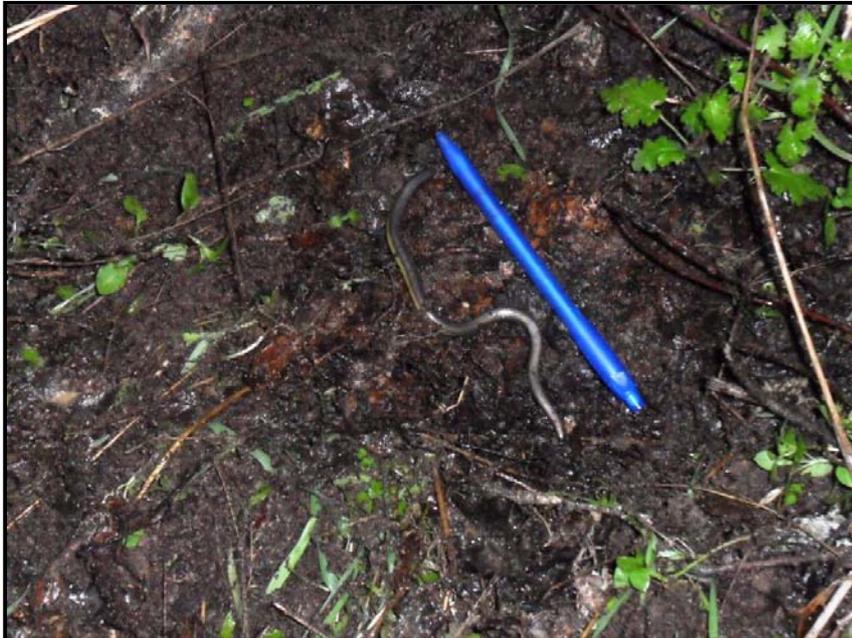
One BLL was encountered during Ahtna work in 2011. A BLL was turned up at the site of MP-BW-51 in January during maneuvering of the drilling rig, which resulted in disturbance of the surface soil. The individual was alive and uninjured, and was relocated to a sandy area outside of the work zone. The Ahtna biologist documented the encounter, oversaw relocation, and submitted a report to the Army. A photo of the BLL and the location and where relocated is shown in Photo 2-11.

Photographs 2.11 – Black legless lizard encountered at well site MP-BW-51 in January 2011 during the drilling operation.

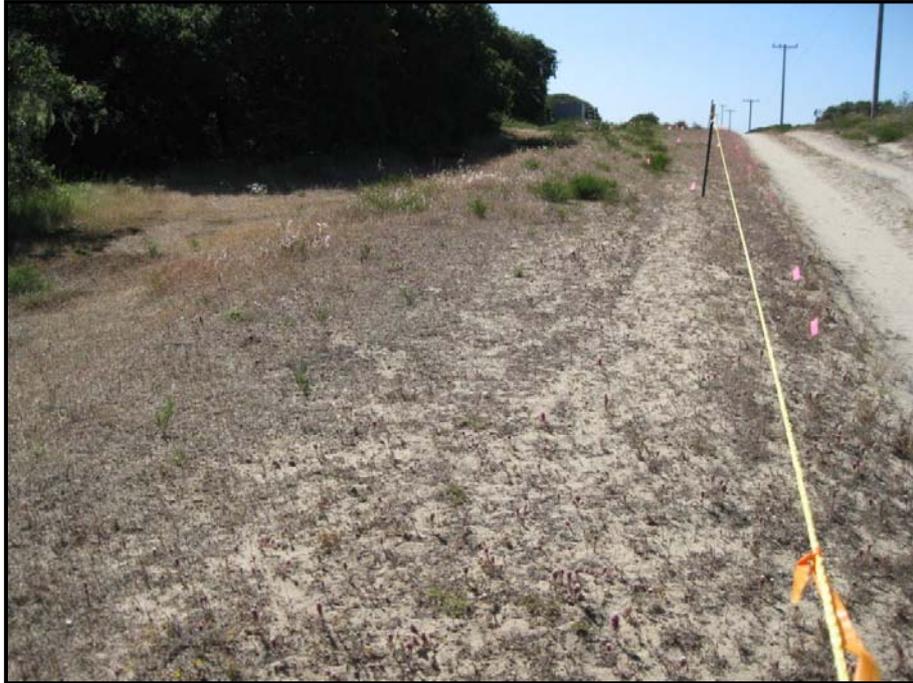
Wells MP-BW-49 and MP-BW-51 were located in areas that in the baseline survey had no sand gilia plants. However, the main access route was close to two sand gilia patches at the edge of the road. To prevent accidental intrusion into sand gilia and other rare plant habitat, these sand gilia were fenced off using metal fence posts and rope (Photograph 2.12).

Photograph 2.12 – A sand gilia area fenced off along main access route.

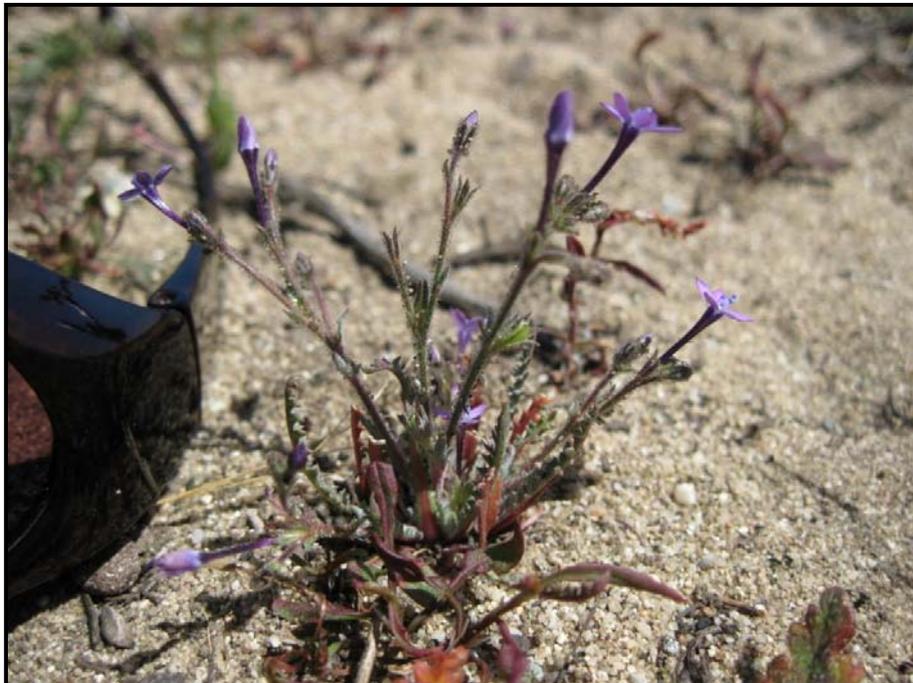
Photograph 2.13 – Typical sand gilia plant in FONR reserve during survey.

The locations and abundance of sand gilia found in the 2011 survey are shown in Figures 2.2a and 2.2b. Photograph 2.13 shows a typical sand gilia plant on the site.
