**BLM Area B Track 2 Ponds
Geophysical Anomaly Investigation
Technical Information Paper
Former Fort Ord, California**

January 2020

**U.S. Army Corps of Engineers
Sacramento District
1325 J Street
Sacramento, California 95814-2922**

**KEMRON Environmental Services, Inc.
1359A Ellsworth Industrial Blvd.
Atlanta, GA 30318
404-636-0928**

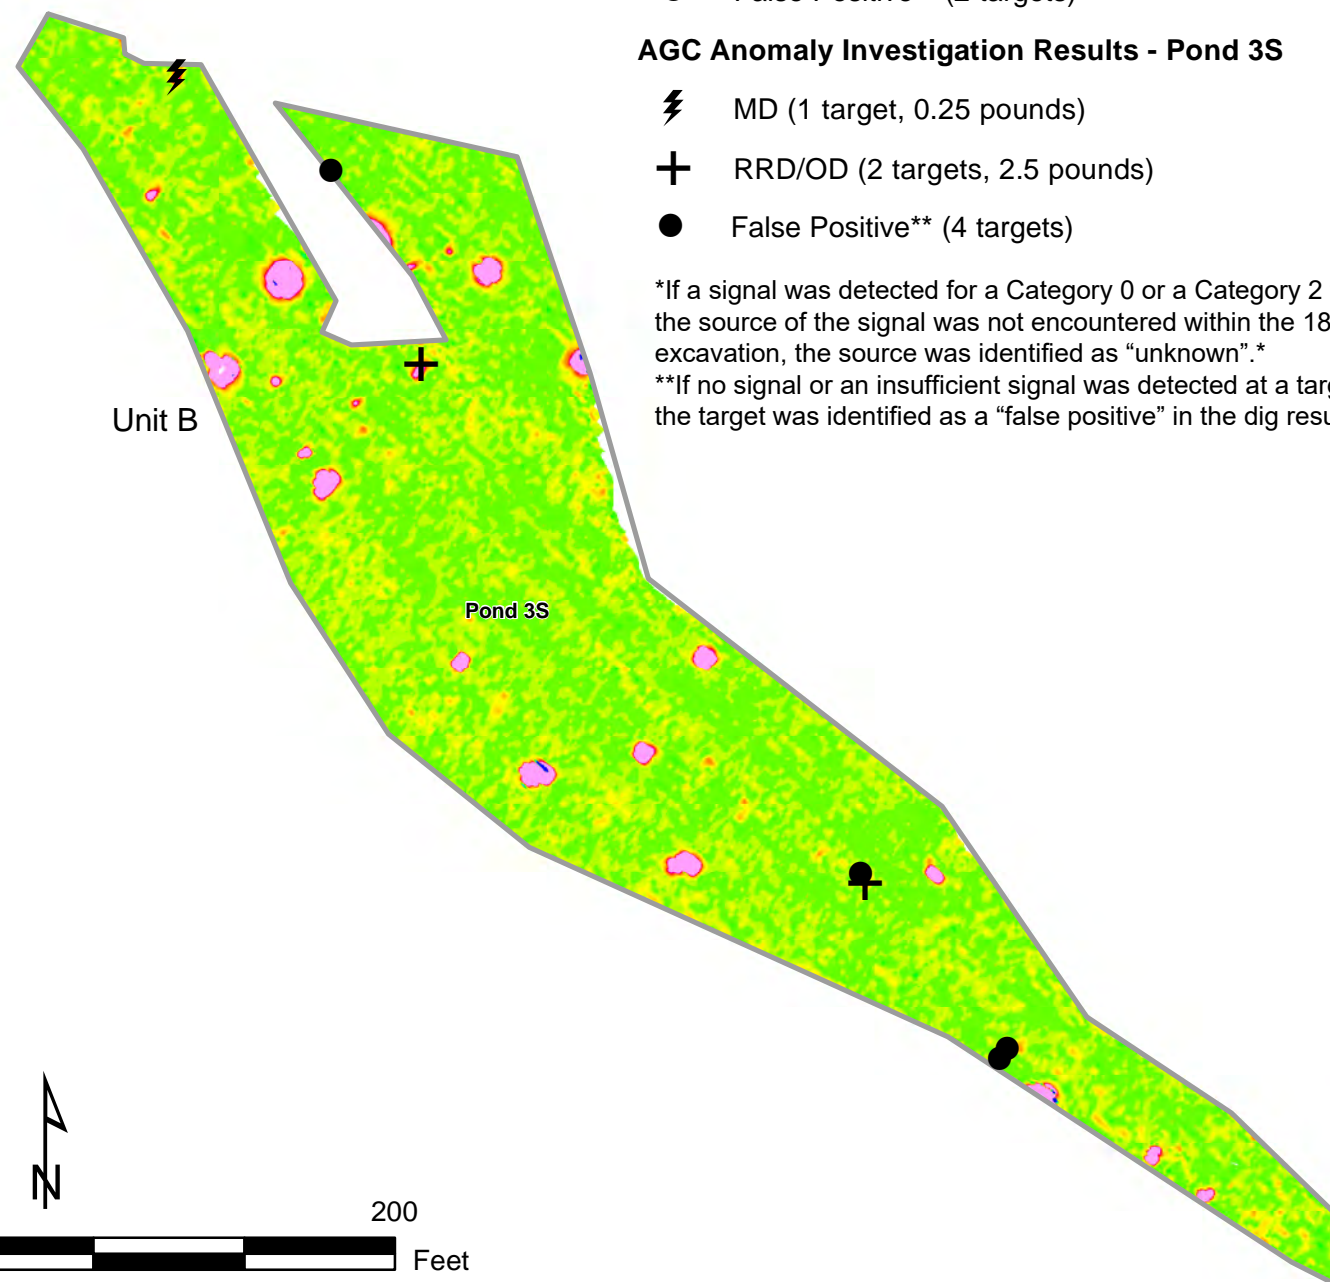
Figure 3A
Ponds 3N & 3S
DGM and Dig Results

Negative values can occur in DGM data as a result of minimum curvature gridding and/or levelling the data.

[Figures 3A – 14B](#) show the pond areas and examples of historic inundation for the selected ponds. Potential risk associated with entering the ponds has been reduced over the extent of the pond areas where anomaly investigations occurred. If biological surveys are planned outside the extent of the DGM pond survey areas during wet conditions, the Ordnance and Explosives Safety Specialist and UXO Safety Officer should be consulted for site specific best practices before undertaking field work.

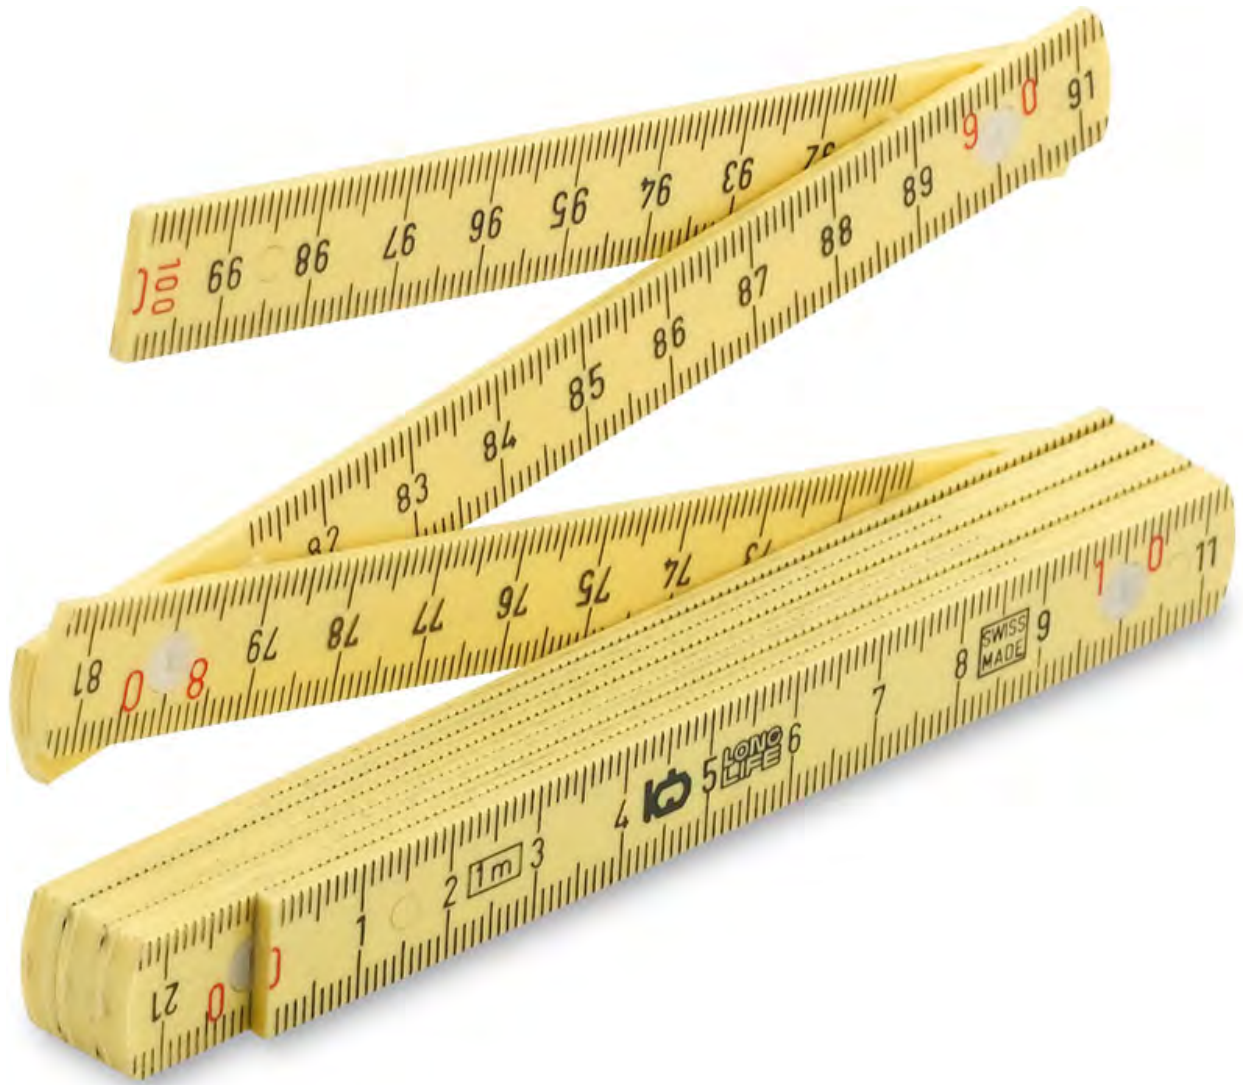
Photograph 1. Suggested example of an engineer's ruler.
