**DRAFT  
CLOSEOUT REPORT  
OPERABLE UNIT 1 GROUNDWATER REMEDIATION  
FRITZSCHE ARMY AIRFIELD FIRE DRILL AREA  
FORMER FORT ORD, CALIFORNIA**

**U.S. Army Corps of Engineers  
Sacramento District  
1325 J Street  
Sacramento, CA 95814-2922**

**HydroGeoLogic, Inc.  
14142 Denver West Parkway  
Suite 225  
Lakewood, CO 80401-3189**

**September 2017**

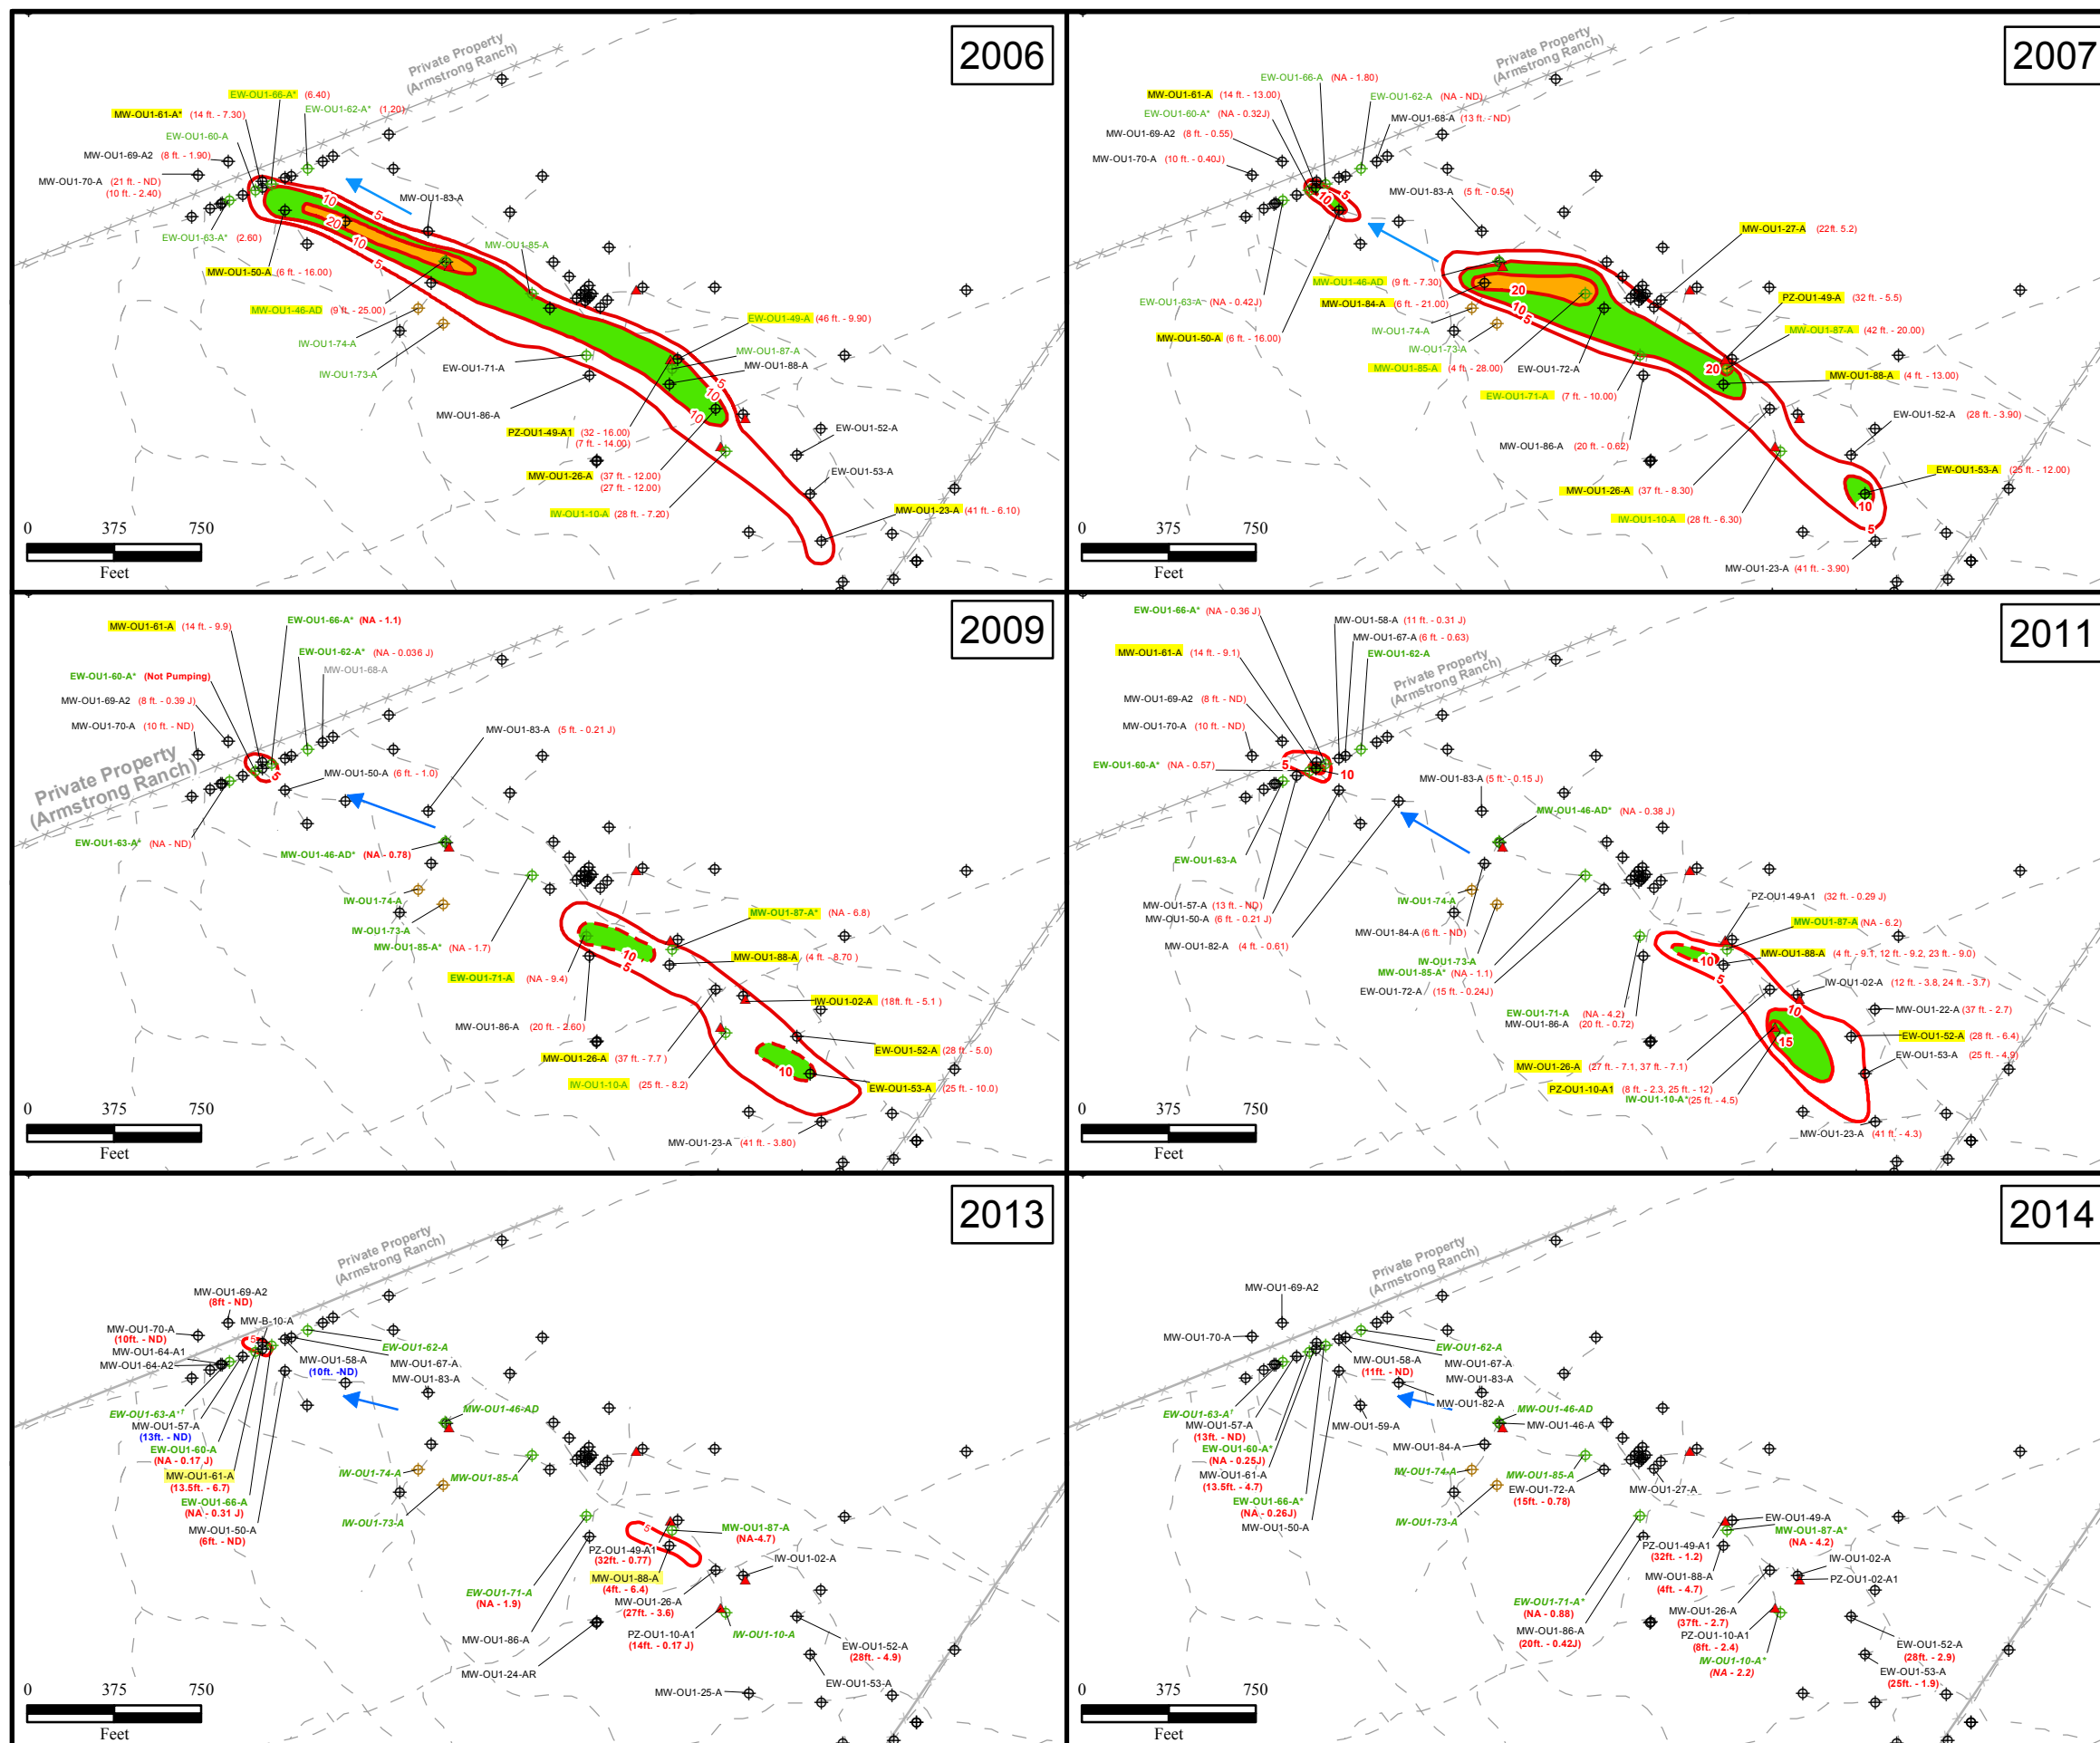
**Figure 3.1  
TCE Concentration in  
September Groundwater Monitoring  
2006-2014**

- ⊕ Monitoring Well
- ⊕ Extraction Well
- ⊕ Injection Well
- ▲ Piezometer
- MW-OU1-88-A Location with TCE Concentration at or Above MCL (5 µg/L)
- 5 — TCE Contour (µg/L) Based on September Data for Given Year (dashed where inferred)
- MW-OU1-88-A — Well ID  
(4 ft. - 6.4) — September TCE Result (µg/L) Sample Elevation (feet above mean sea level)
- 10 µg/L to 20 µg/L TCE
- 20 µg/L or Greater µg/L TCE
- - - Trail/Unimproved Road
- ⊗⊗⊗ Fence
- ← General Direction of Groundwater Flow

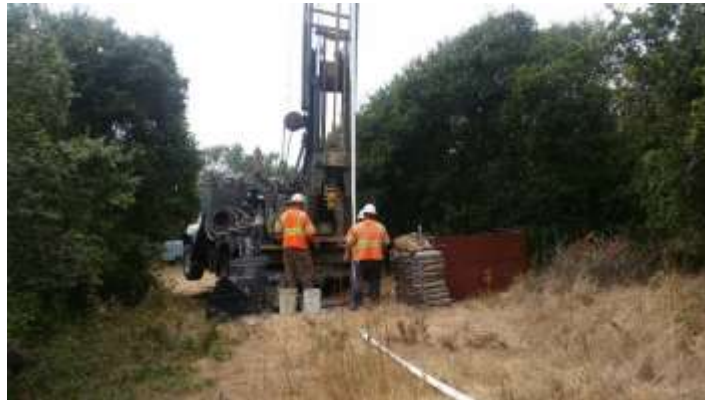
**Photograph 3 – Pulling injection pipe at IW-OU1-73-A. Equipment shown: CME 75 drill rig.**

Pumps, piping, power, and controls were removed from the extraction wells before grouting began. Likewise, piping and controls were removed from the two injection wells before they were sealed.

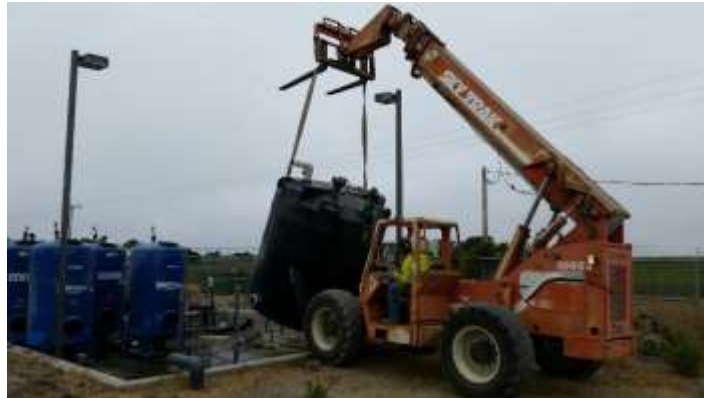
**Photograph 4 – Removing holding tank at NWTS. Equipment shown: SkyTrak 10054 telescopic forklift.**

The activated carbon contained in the carbon tanks was removed from the tanks and transported for recycling. Residual water in the carbon tanks, piping, and water tanks was drained and pumped into the infiltration trench at the NWTS. Residual water is water that remained in the NWTS components after the NWTS was shut down. All residual water is derived from the extraction wells. Sample results show that extraction well discharge did not contain contamination above site cleanup levels for at least 18 months and at least 6 consecutive samples before the well was shut down (HGL, 2016; Appendix B). Consequently, the residual water does not pose a threat to human or ecological health. The piping, pumps, valves, and gauges were disconnected using hand tools and placed in the rolloff bin for disposal. The carbon and water tanks were unbolted from the concrete pad and lifting straps were attached to hooks permanently affixed to the top of each tank. A telescopic forklift was used to lift each tank out of the containment basin and load all tanks for transport to the recycling facility.

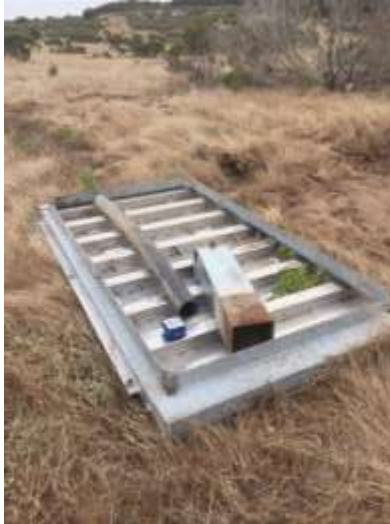
**Photograph 6 – FONG infiltration trench vault lid.**

The vault at the head of the FONR System Infiltration Trenches (Figure B2.2) was also excavated using a backhoe. The concrete was transported to a rolloff bin for disposal as construction debris and the vault lid was recycled.

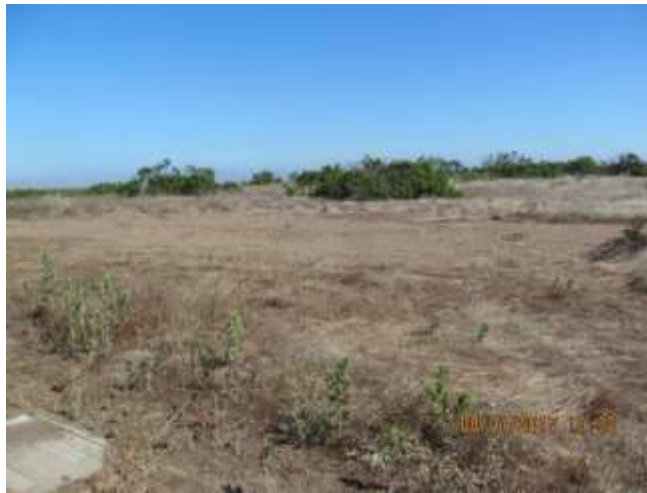
**Photograph 7 – Regraded area at former FONG System infiltration trench vault.**

Soil removed during the vault excavation and from the area around the vault was used as backfill. The grassland area surrounding the injection vault is primarily loose sand. The sand was easily regraded to fill in the relatively shallow void left from the injection vault. No imported backfill was used. Photograph 7 shows the regraded area after site demobilization.

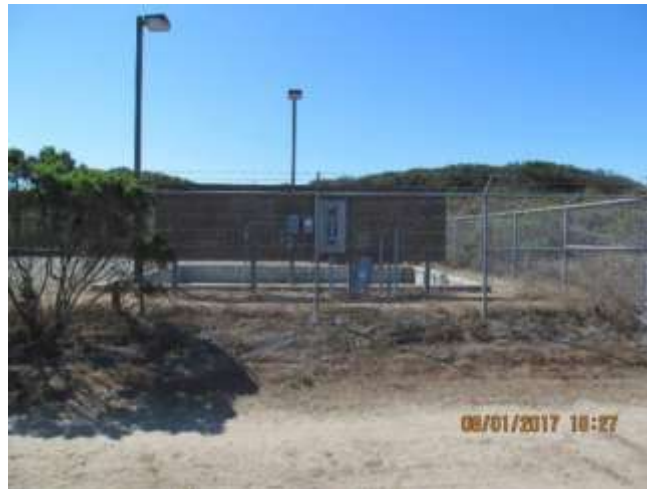
**Photograph 8 – NWTs after demobilization.**

UCSC accepted the final condition of the NWTs and the individual work areas as satisfactory. The NWTs is shown below after decommissioning was complete.

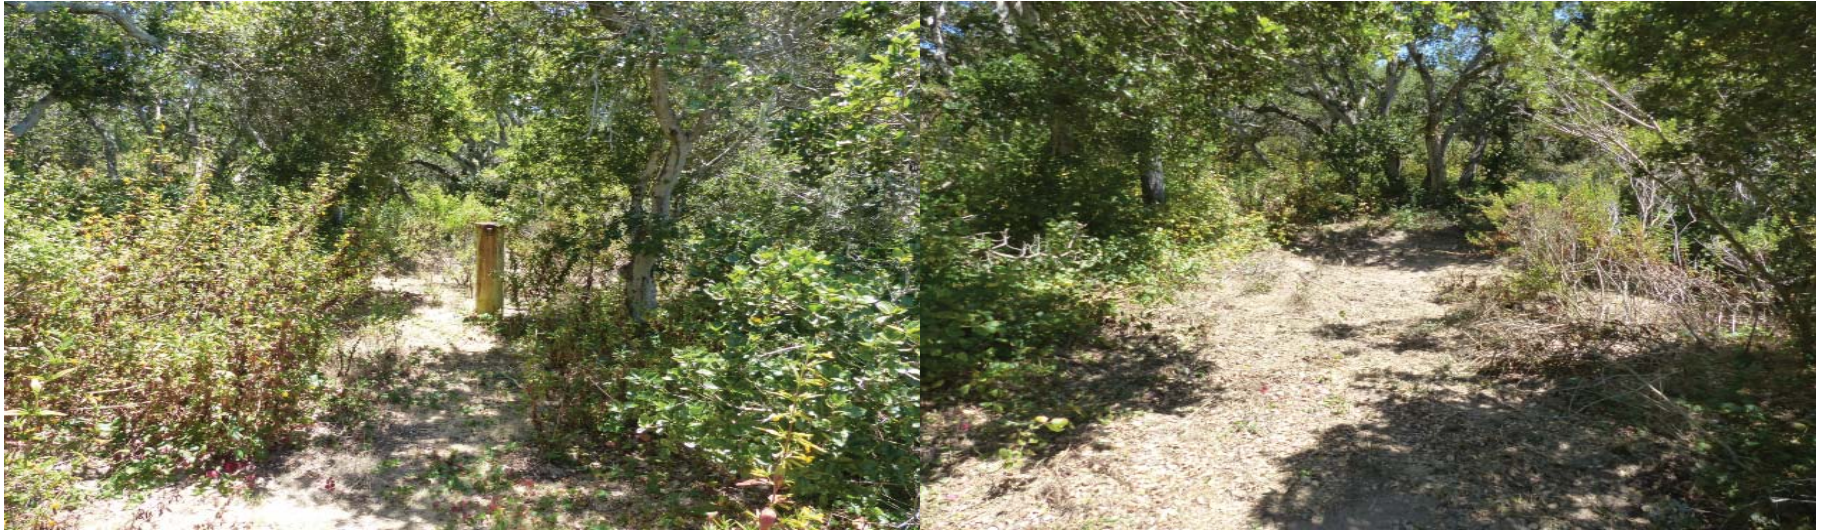
Photo 41. OU-1 FONR Well Sites IW-OU1-02-A and PZ-OU1-02-A1 Prior to Destruction. (July 11, 2017)

Photo 42. OU-1 FONR Well Sites IW-OU1-02-A and PZ-OU1-02-A1 After Destruction. (July 18, 2017)

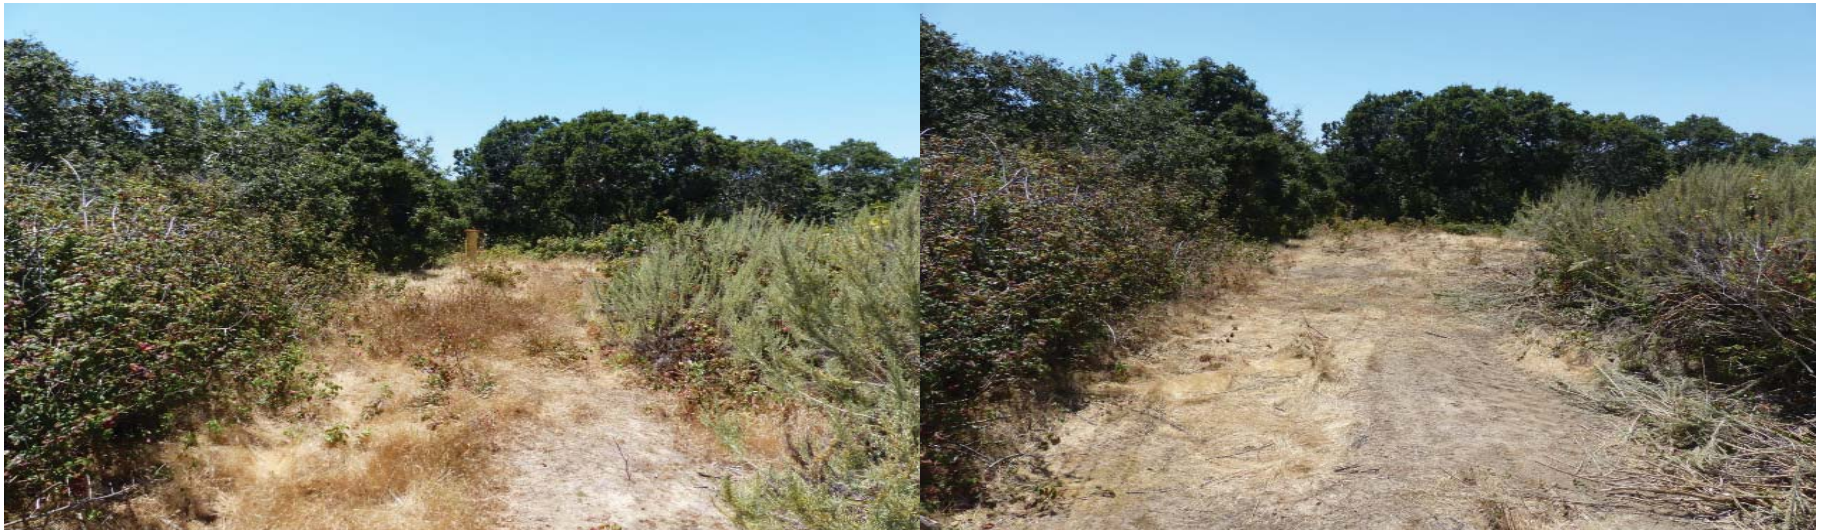
Photo 43. OU-1 FONR Well Site EW-OU1-52-A Prior to Destruction. (July 11, 2017)

Photo 44. OU-1 FONR Well Site EW-OU1-52-A After Destruction. (July 18, 2017)

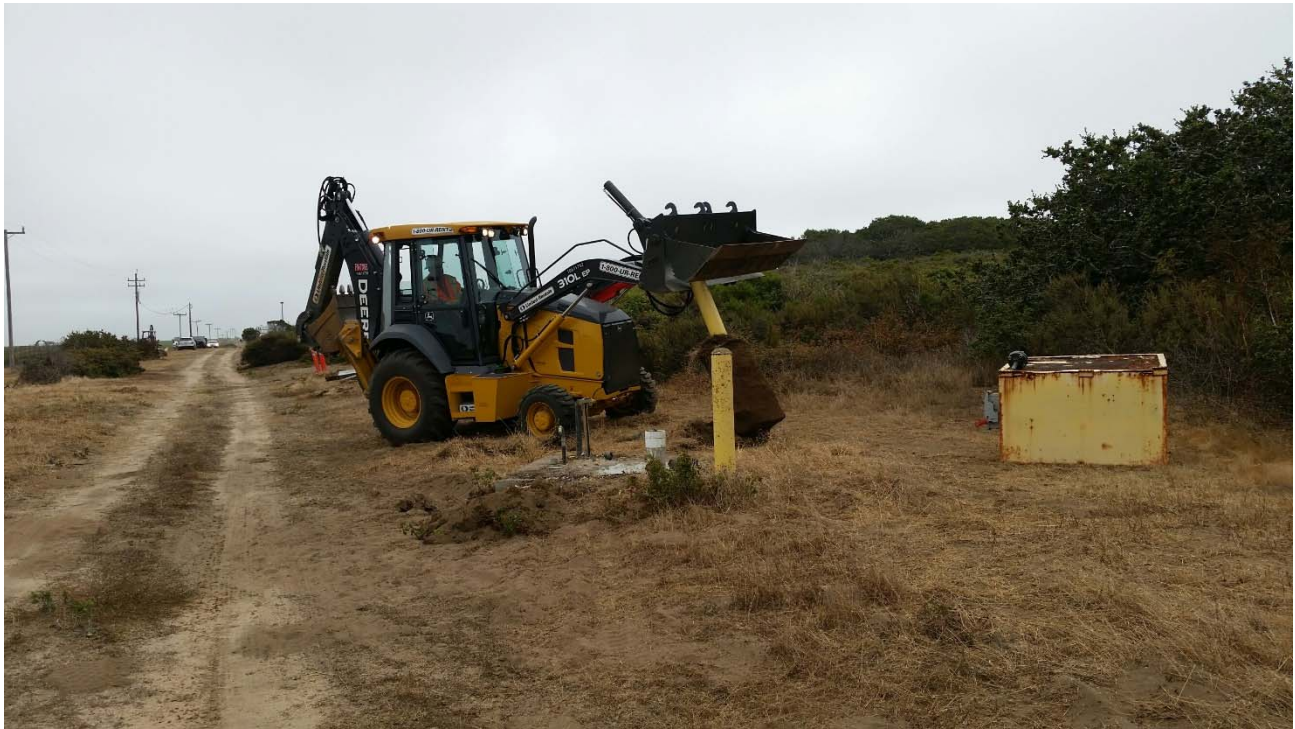
**Photo 01 – Removing bollards and surface completion.**

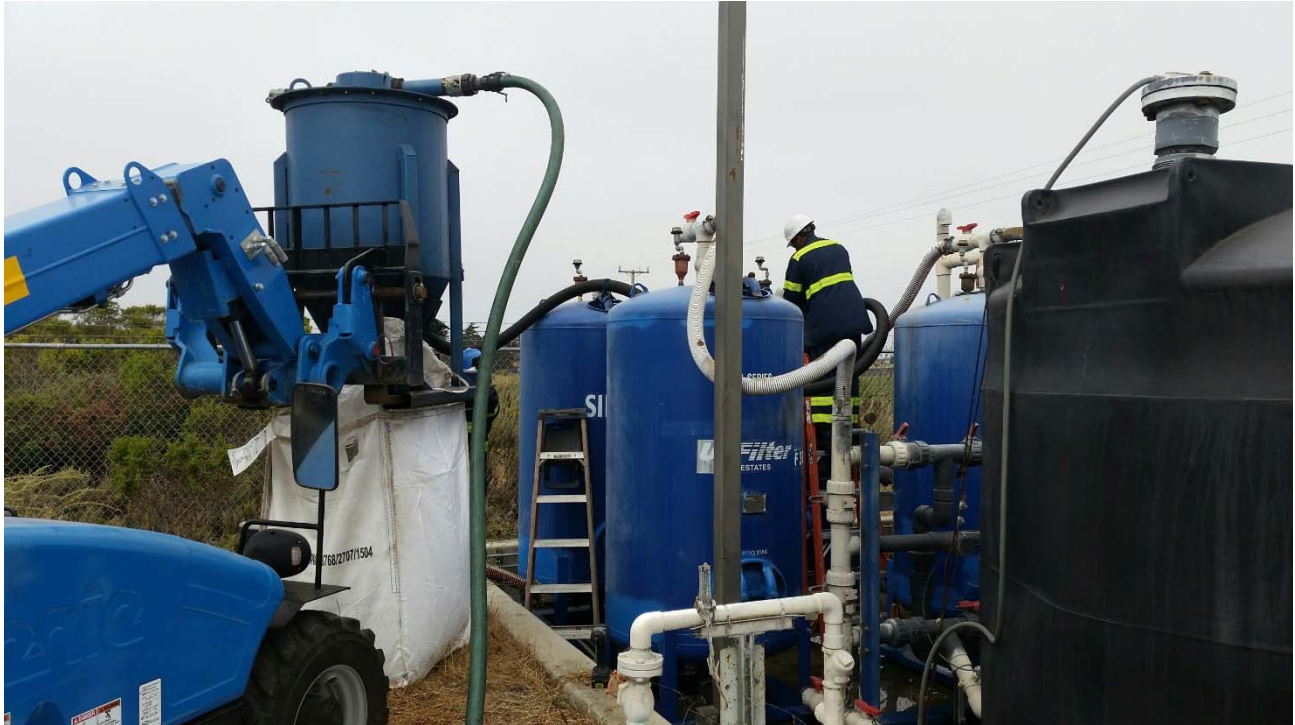
**Photo 02 – Removing GAC from vessels.**

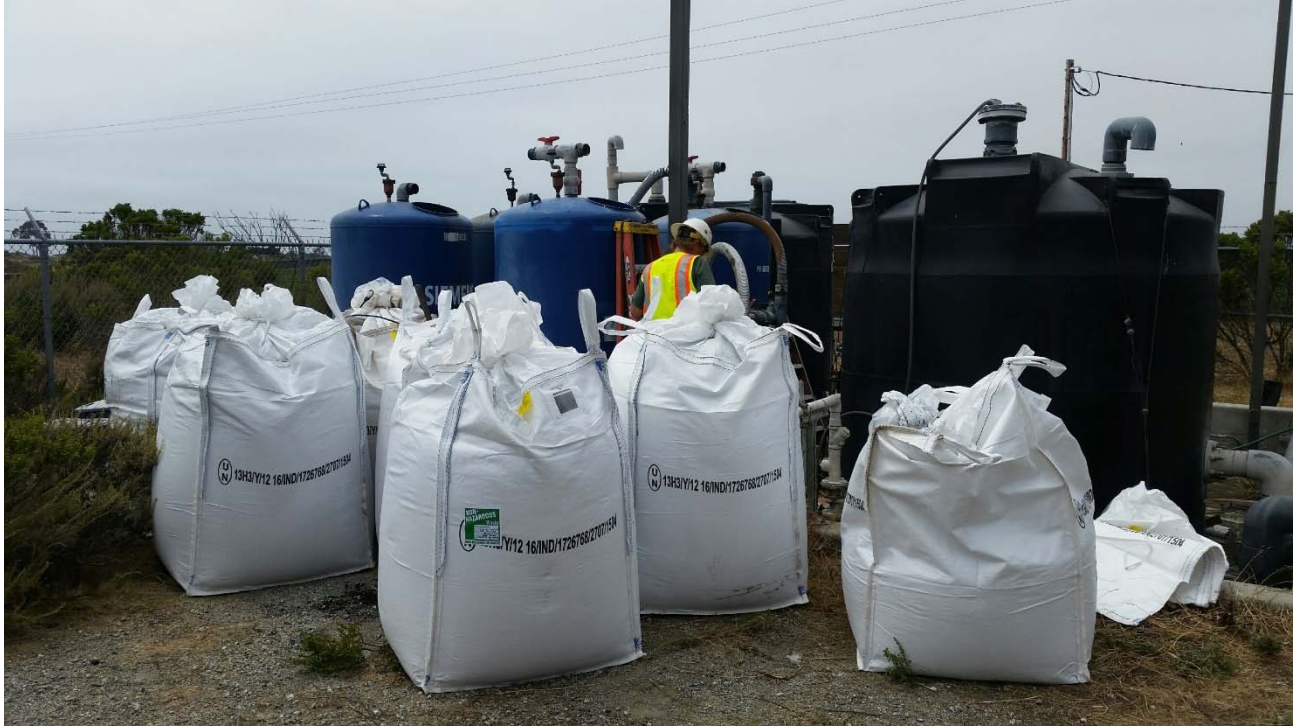
**Photo 03 – Seven super sacks of GAC removed from vessels.**

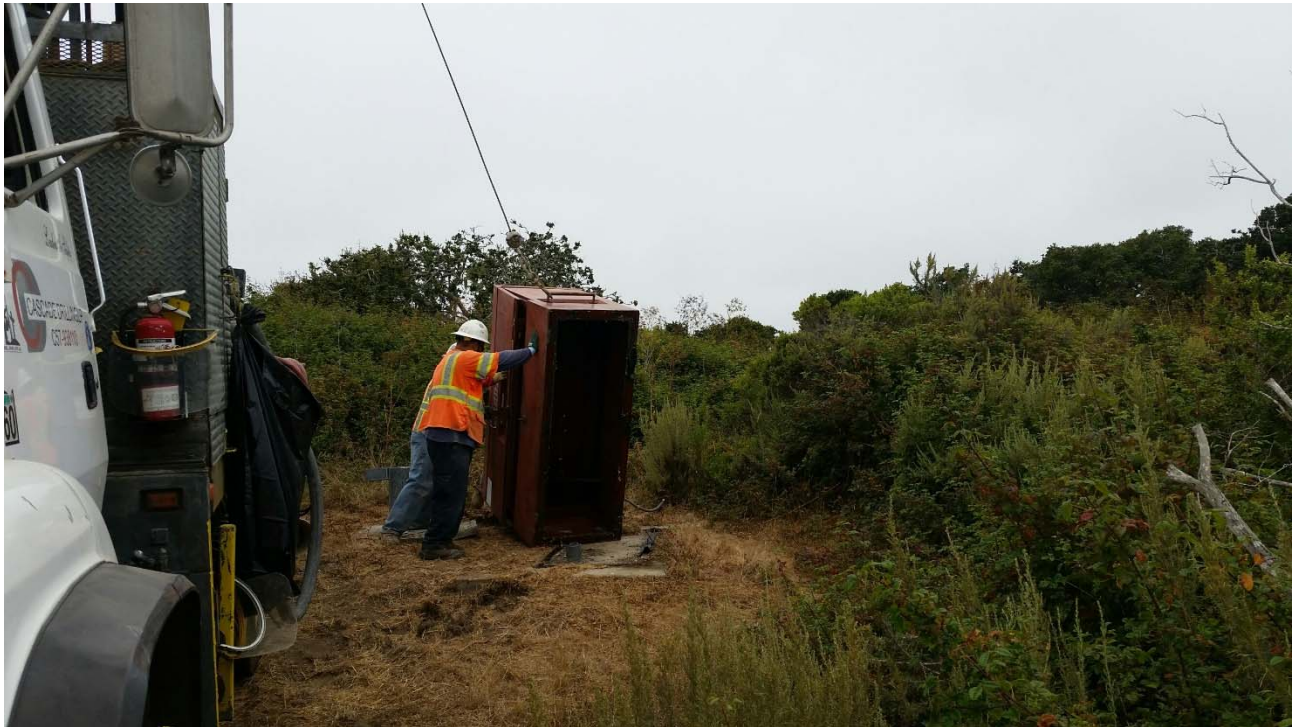
**Photo 01 – Removing protective housing at MW-OU1-46-AD.**

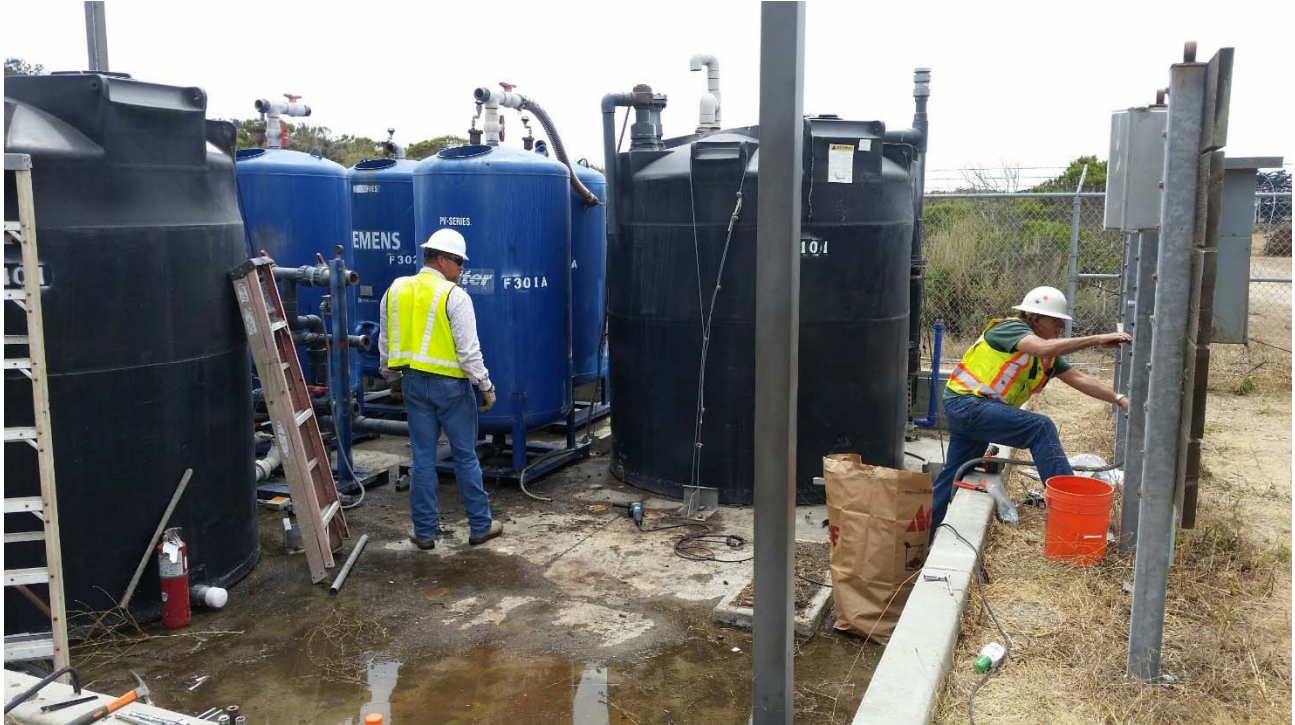
**Photo 02 – Disassembling NWTS.**

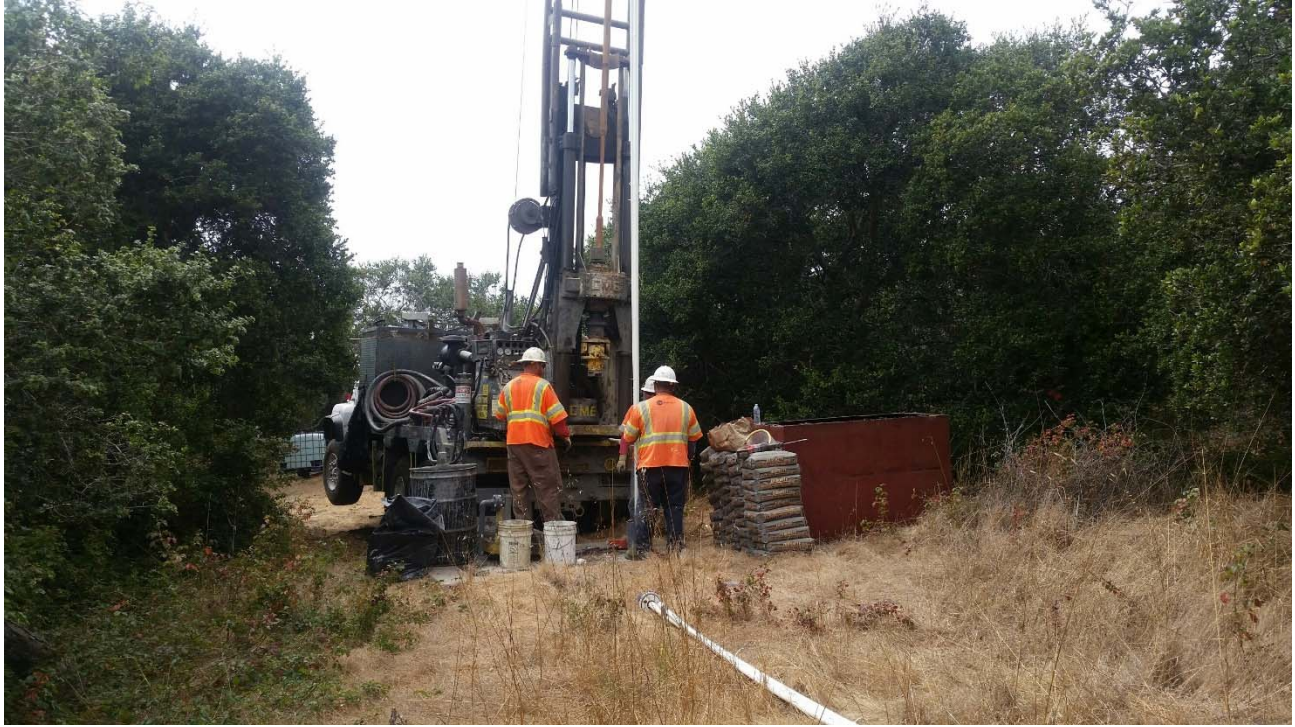
**Photo 03 – Pulling injection pipe at IW-OU1-73-A.**

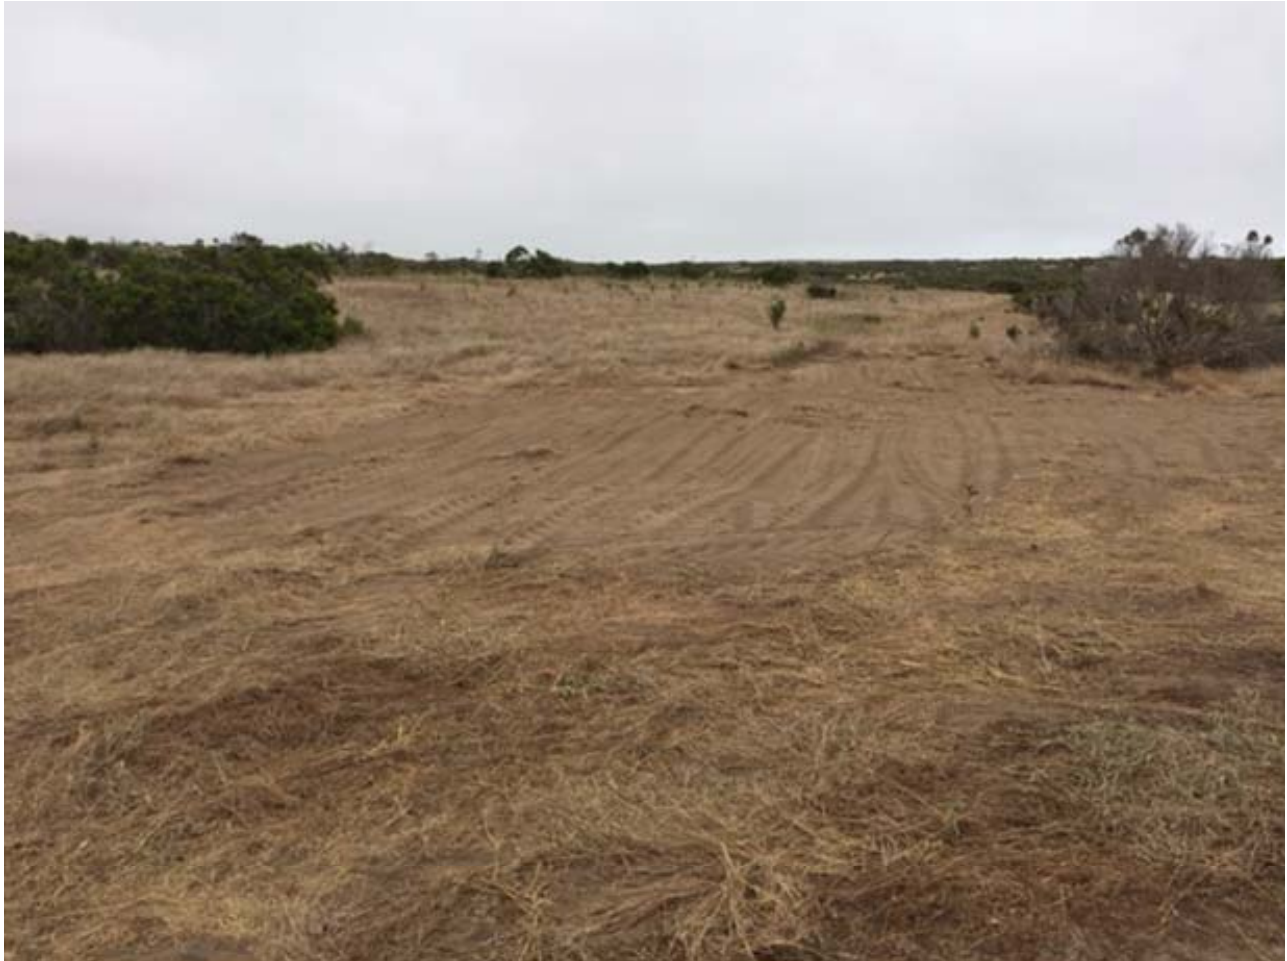
**Photo 04 – Grassland Surface After Treated Water Infiltration Vault Removed**

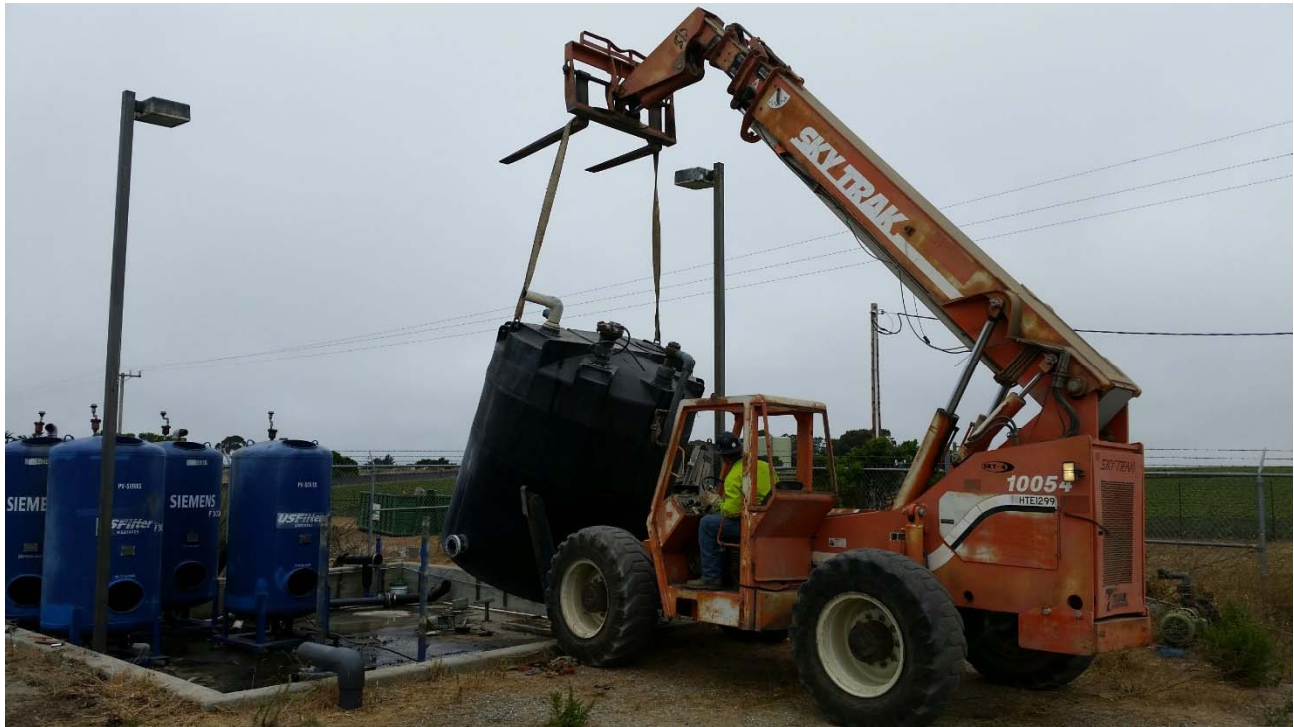
**Photo 01 – Removing holding tank at NWTS.**

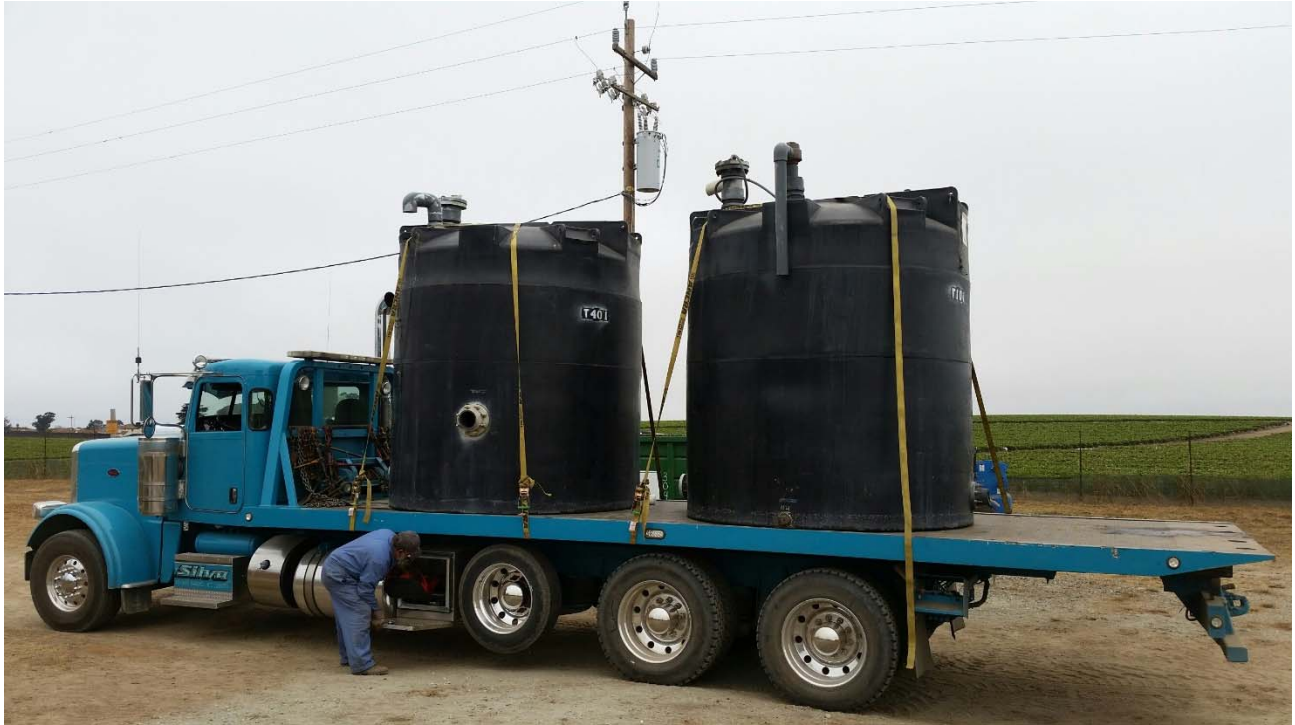
**Photo 02 – Tanks loaded on truck for disposal.**

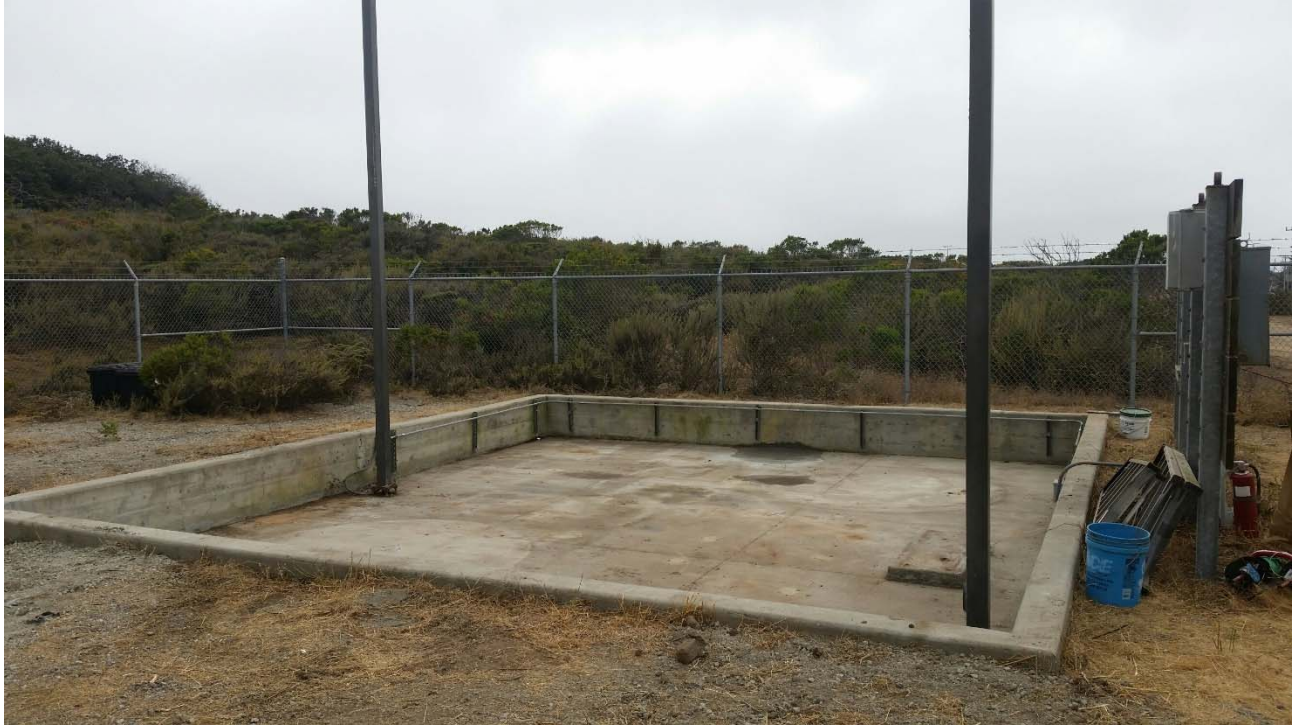
**Photo 03 – NWTs decommissioning complete.**

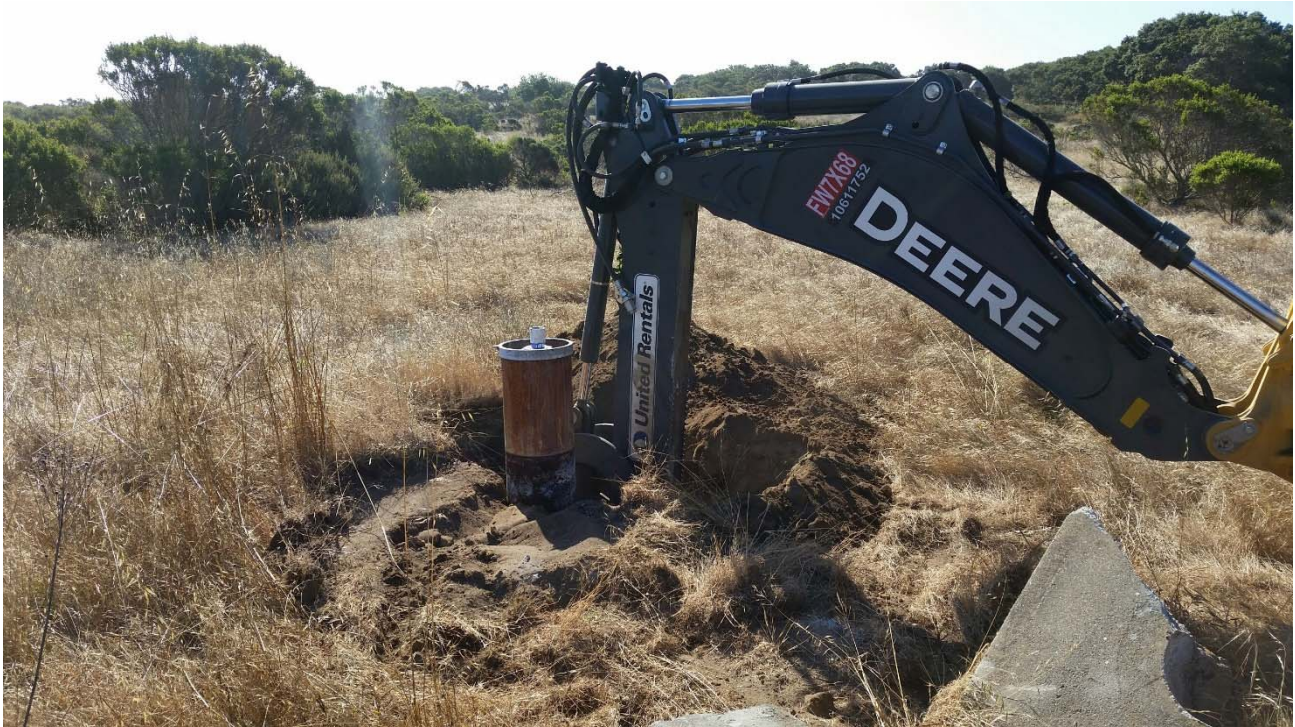
**Photo 01 – Excavating to 5 ft bgs to remove casing at MW-OU1-27-A.**

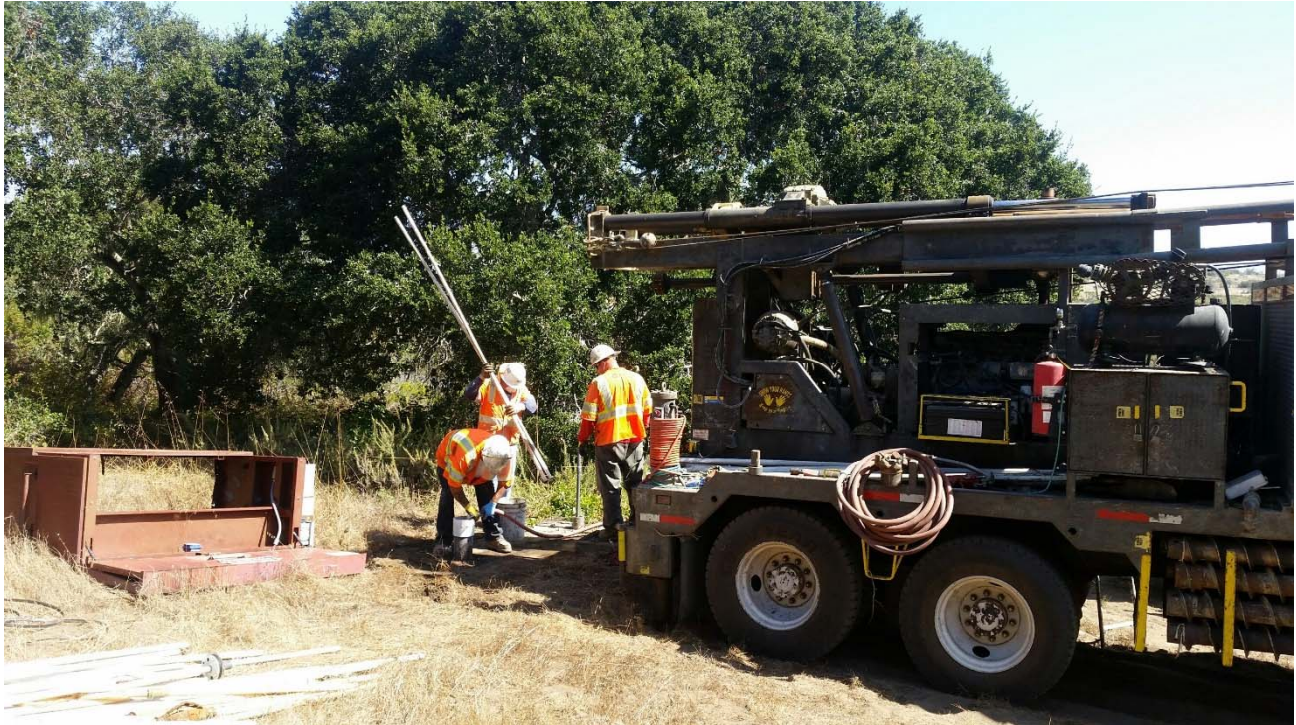
**Photo 02 – Pressure grouting.**

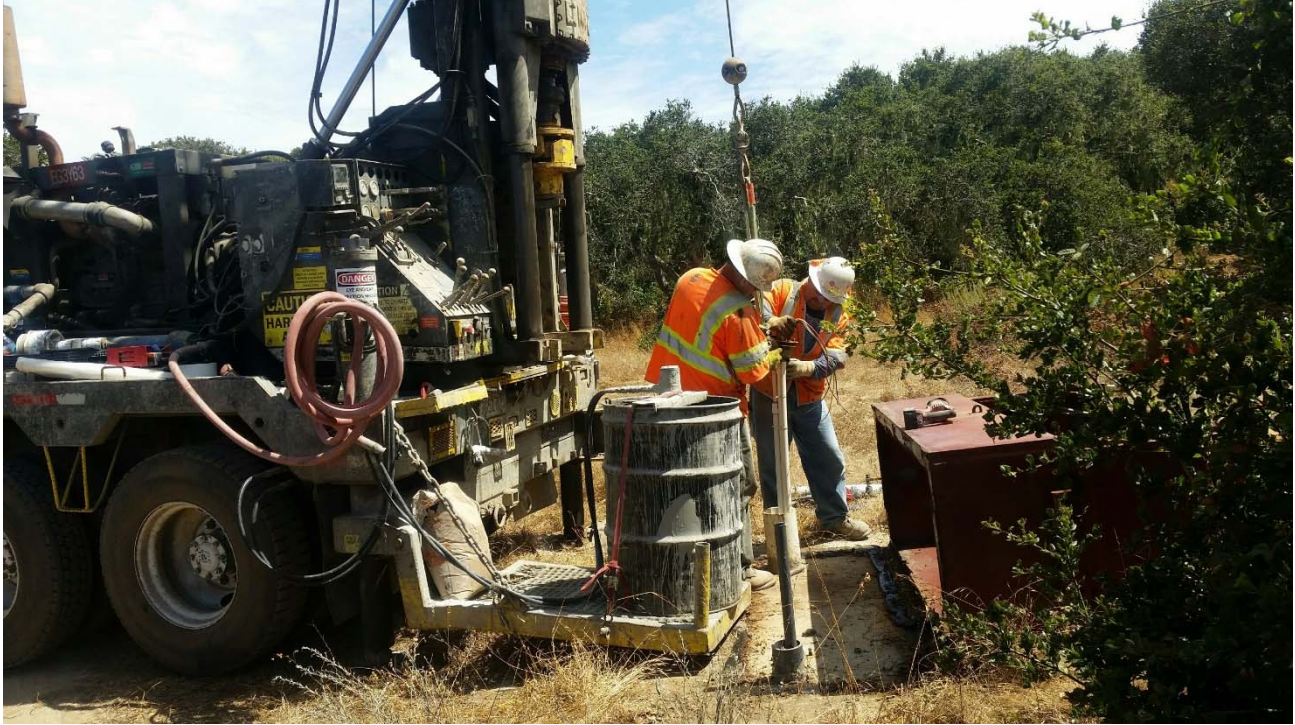
**Photo 03 – Removing extraction pump.**

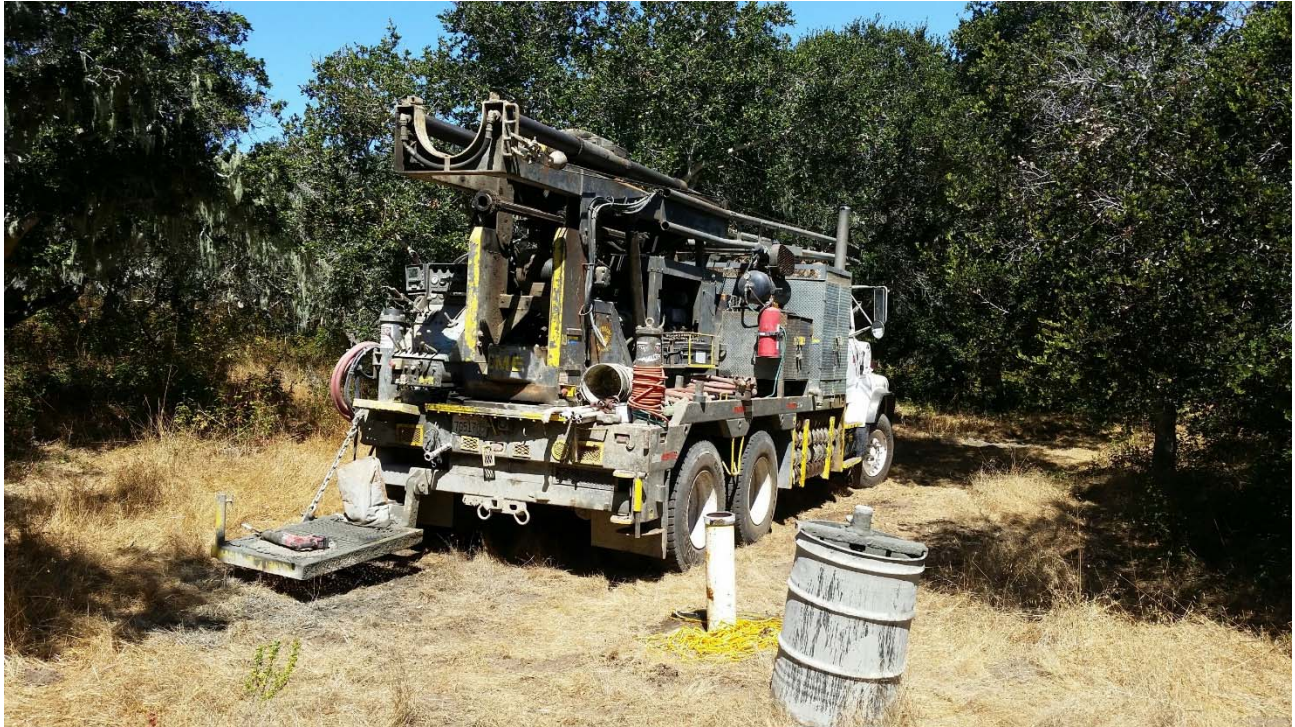
**Photo 01 – Setting up to pressure grout.**

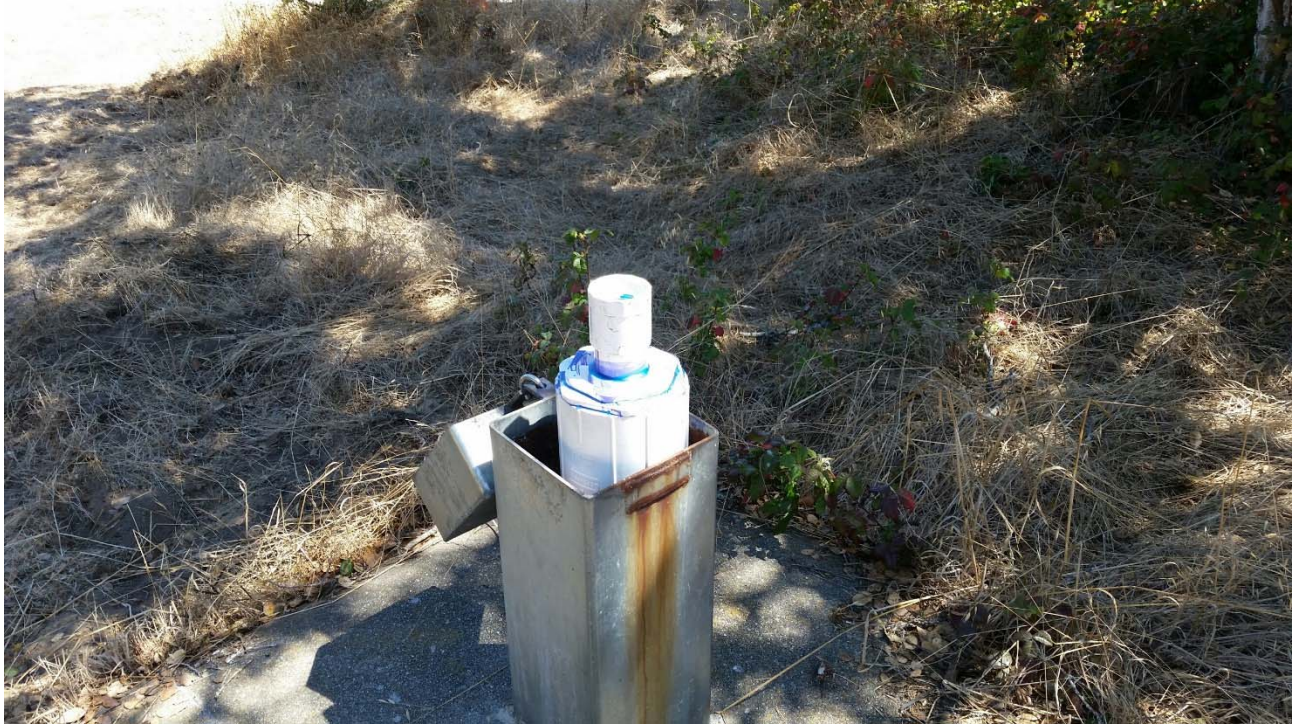
**Photo 02 – Wellhead fitting used to connect to air compressor after a well has been filled with grout.**
