**DRAFT  
CLOSEOUT REPORT  
OPERABLE UNIT 1 GROUNDWATER REMEDIATION  
FRITZSCHE ARMY AIRFIELD FIRE DRILL AREA  
FORMER FORT ORD, CALIFORNIA**

**U.S. Army Corps of Engineers  
Sacramento District  
1325 J Street  
Sacramento, CA 95814-2922**

**HydroGeoLogic, Inc.  
14142 Denver West Parkway  
Suite 225  
Lakewood, CO 80401-3189**

**September 2017**

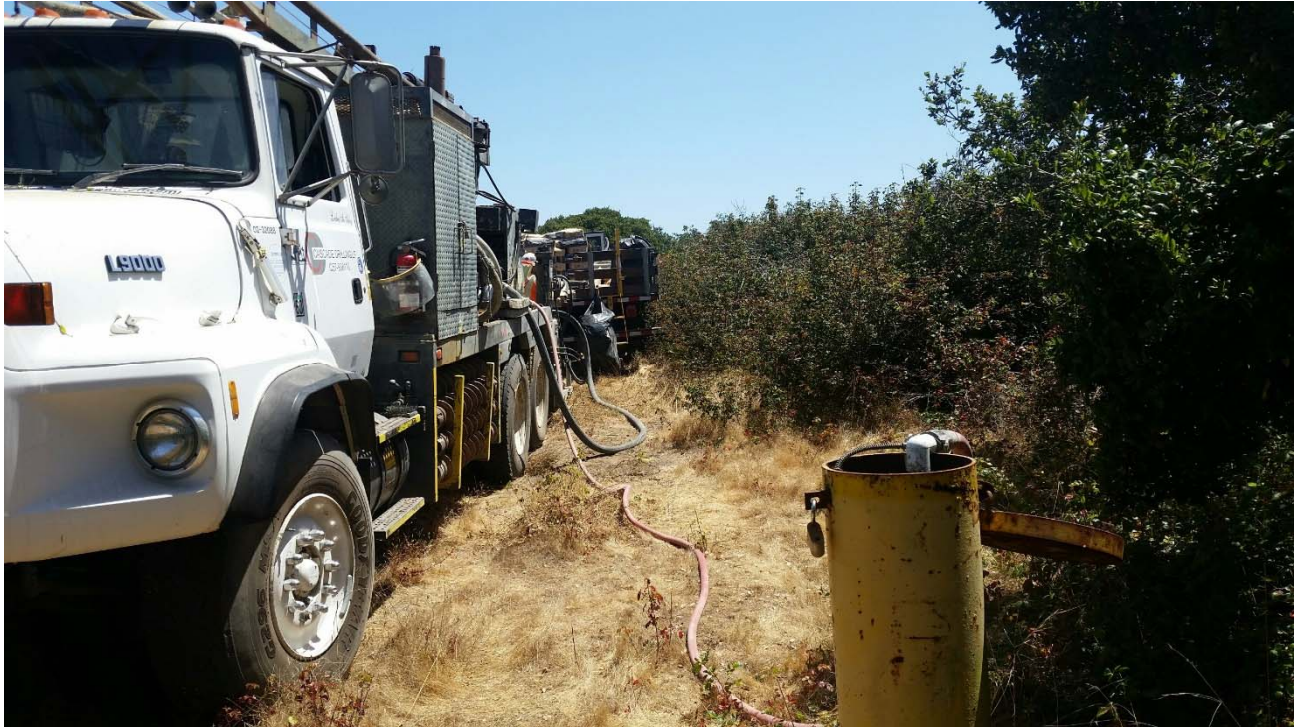
**Photo 01 –Pressure grouting EW-OU1-52-A.**

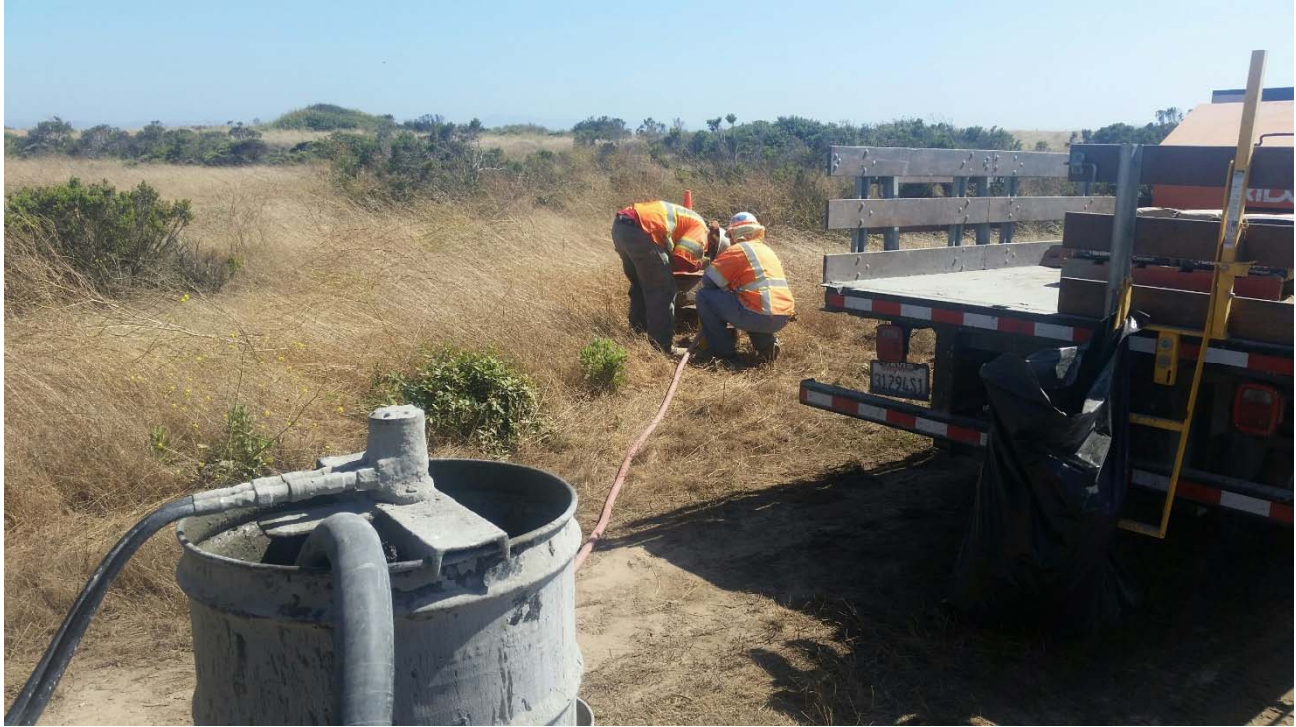
**Photo 03 – Grouting MW-B-02-A.**

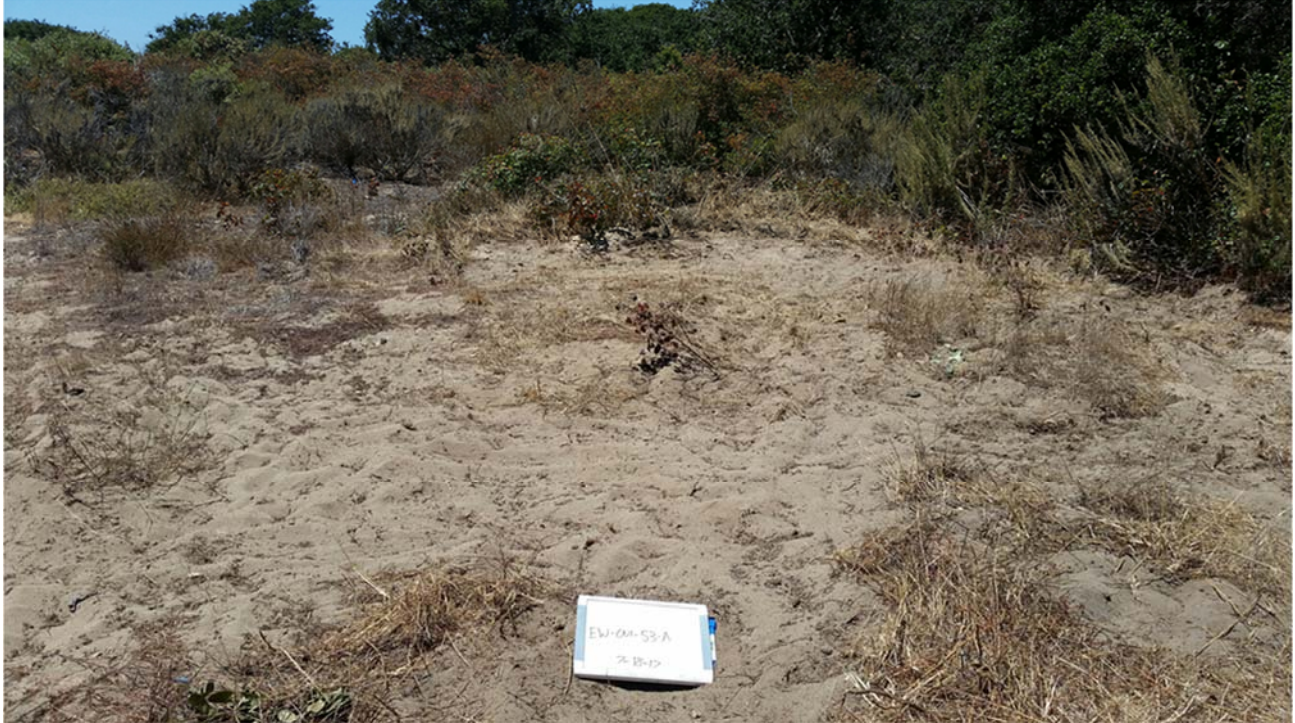
**Photo 02 – Well destruction and restoration complete at EW-OU1-53-A.**

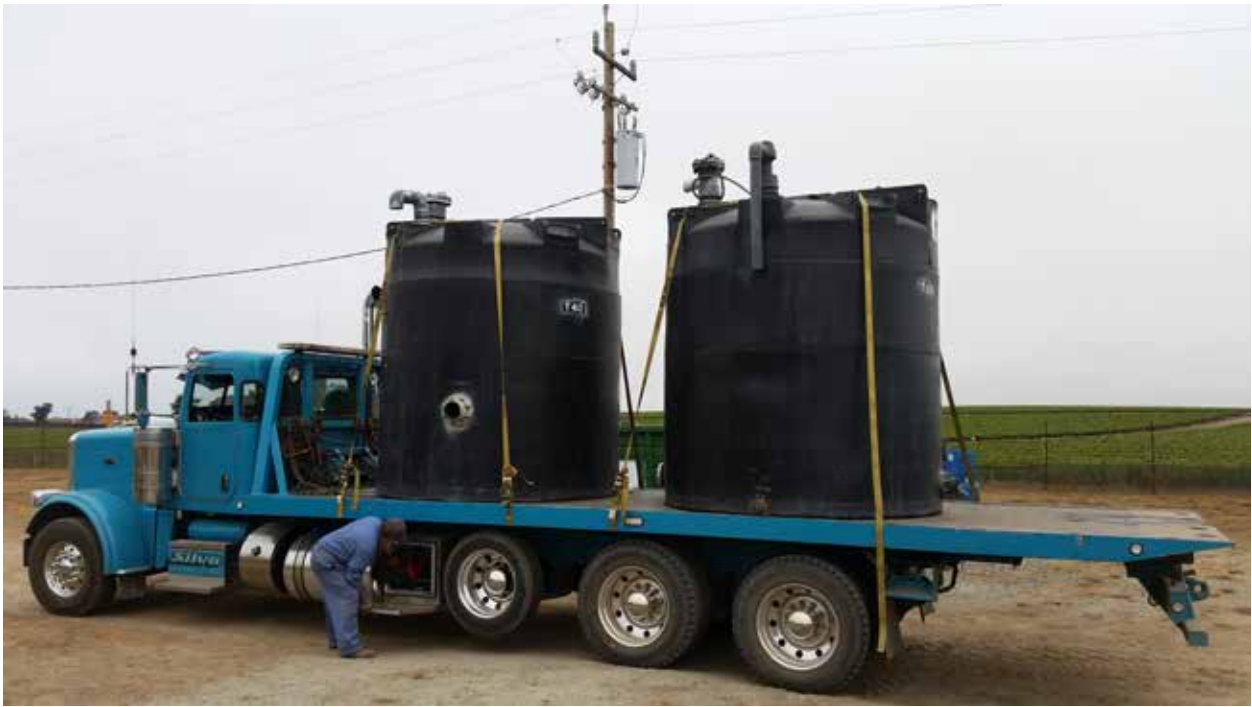
Influent and treated water holding tanks being loaded for transport

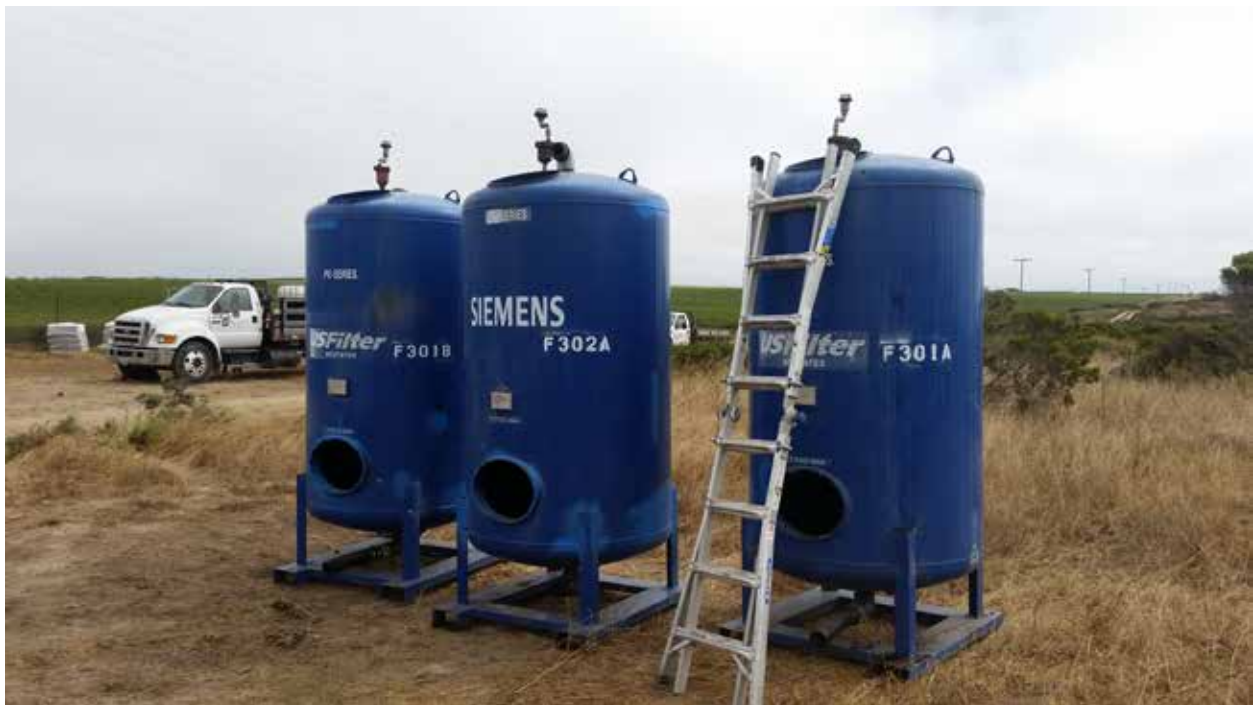
Remaining carbon vessels removed and staged for transport

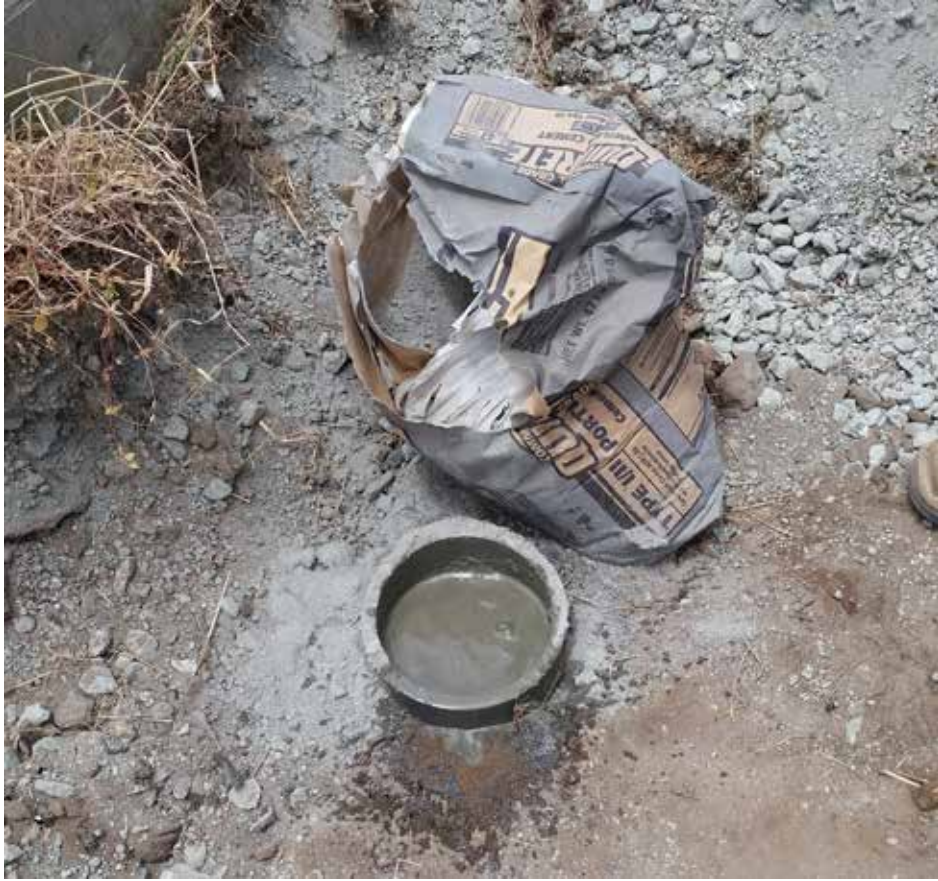
Infiltration trench pipe sealed with concrete

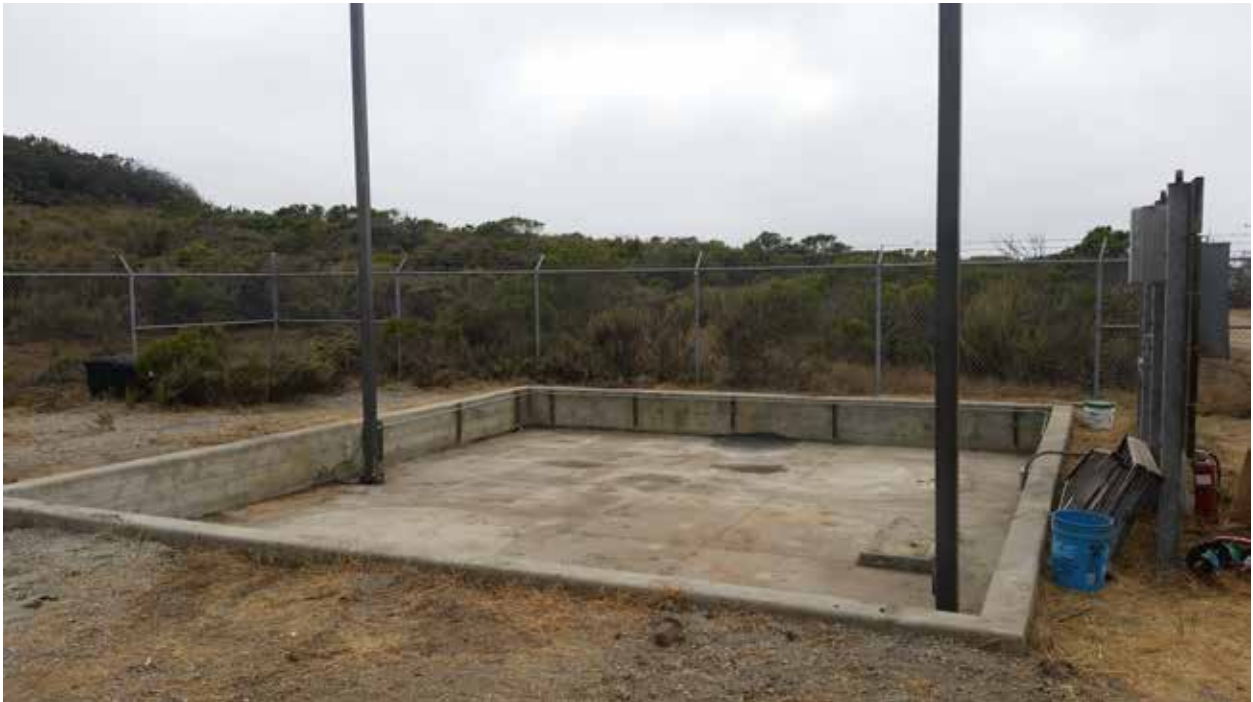
NWTS containment basin after decommissioning

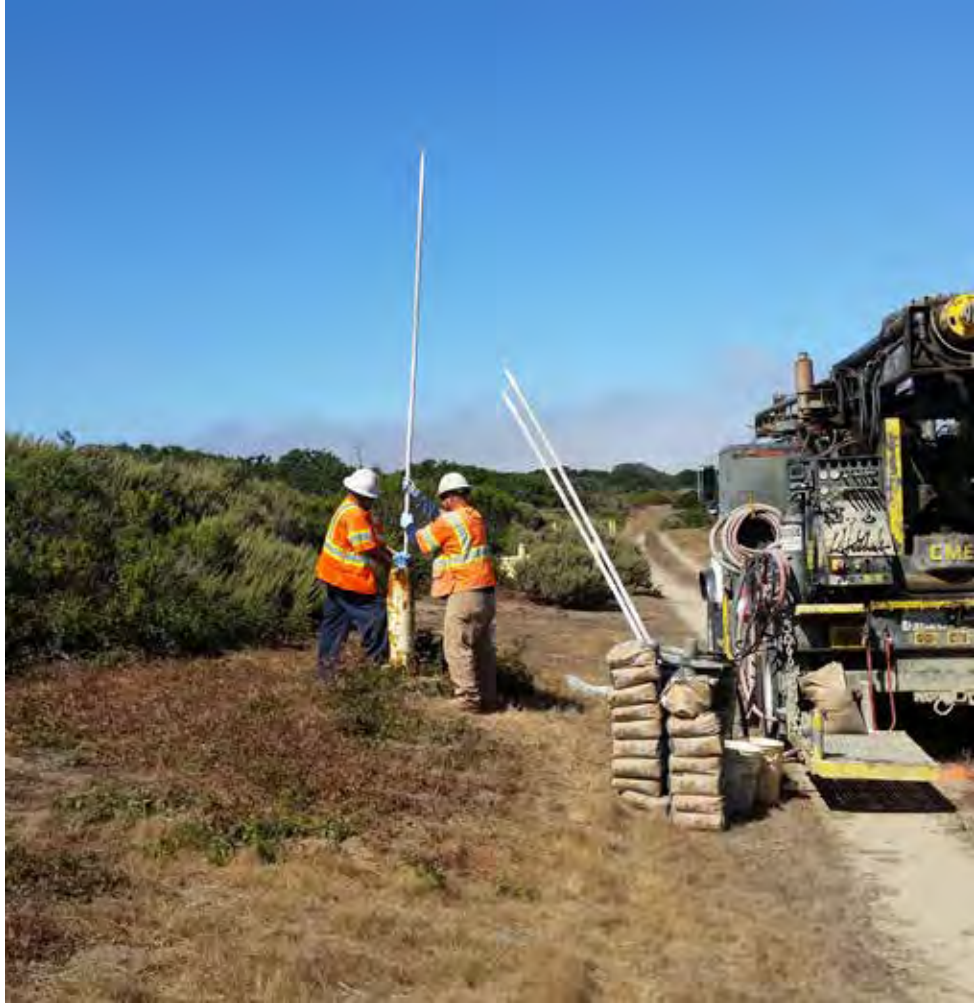
Setting tremie pipe before grouting

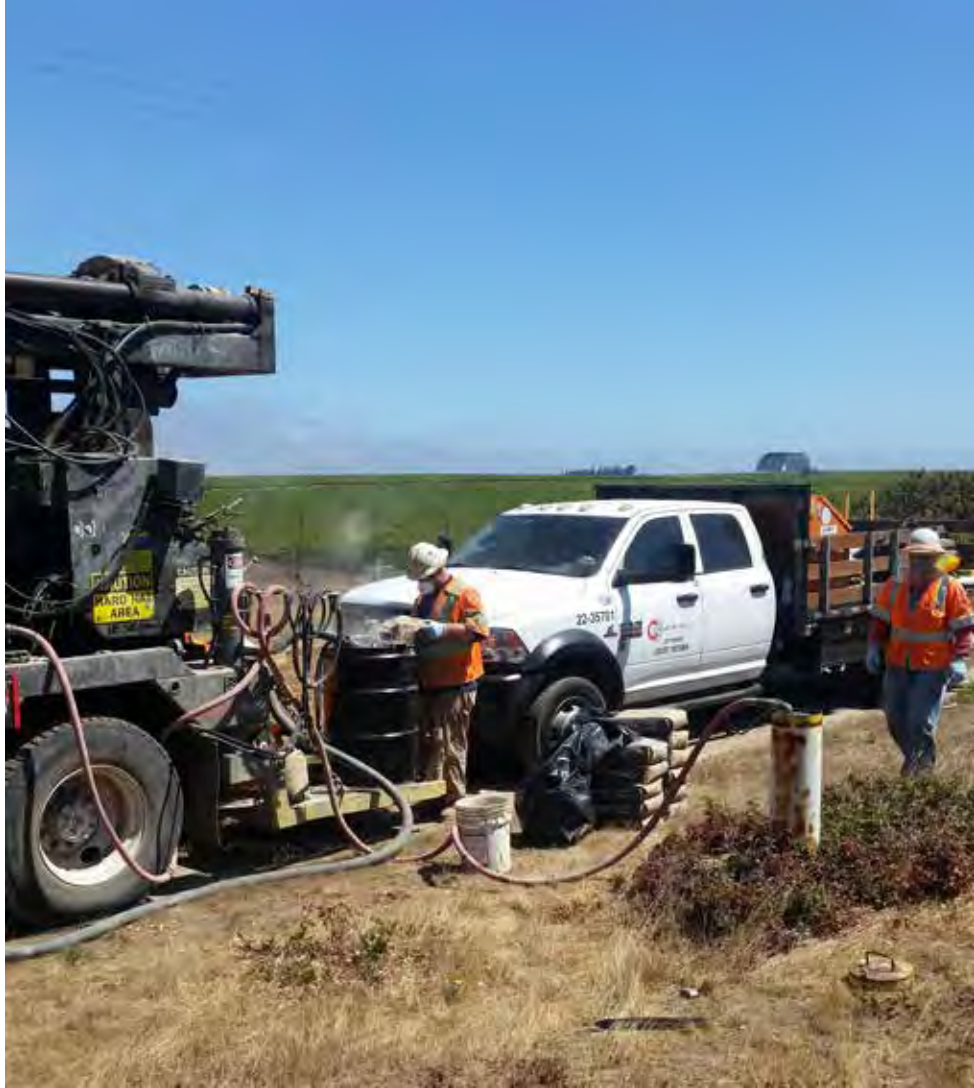
Well sealing in progress

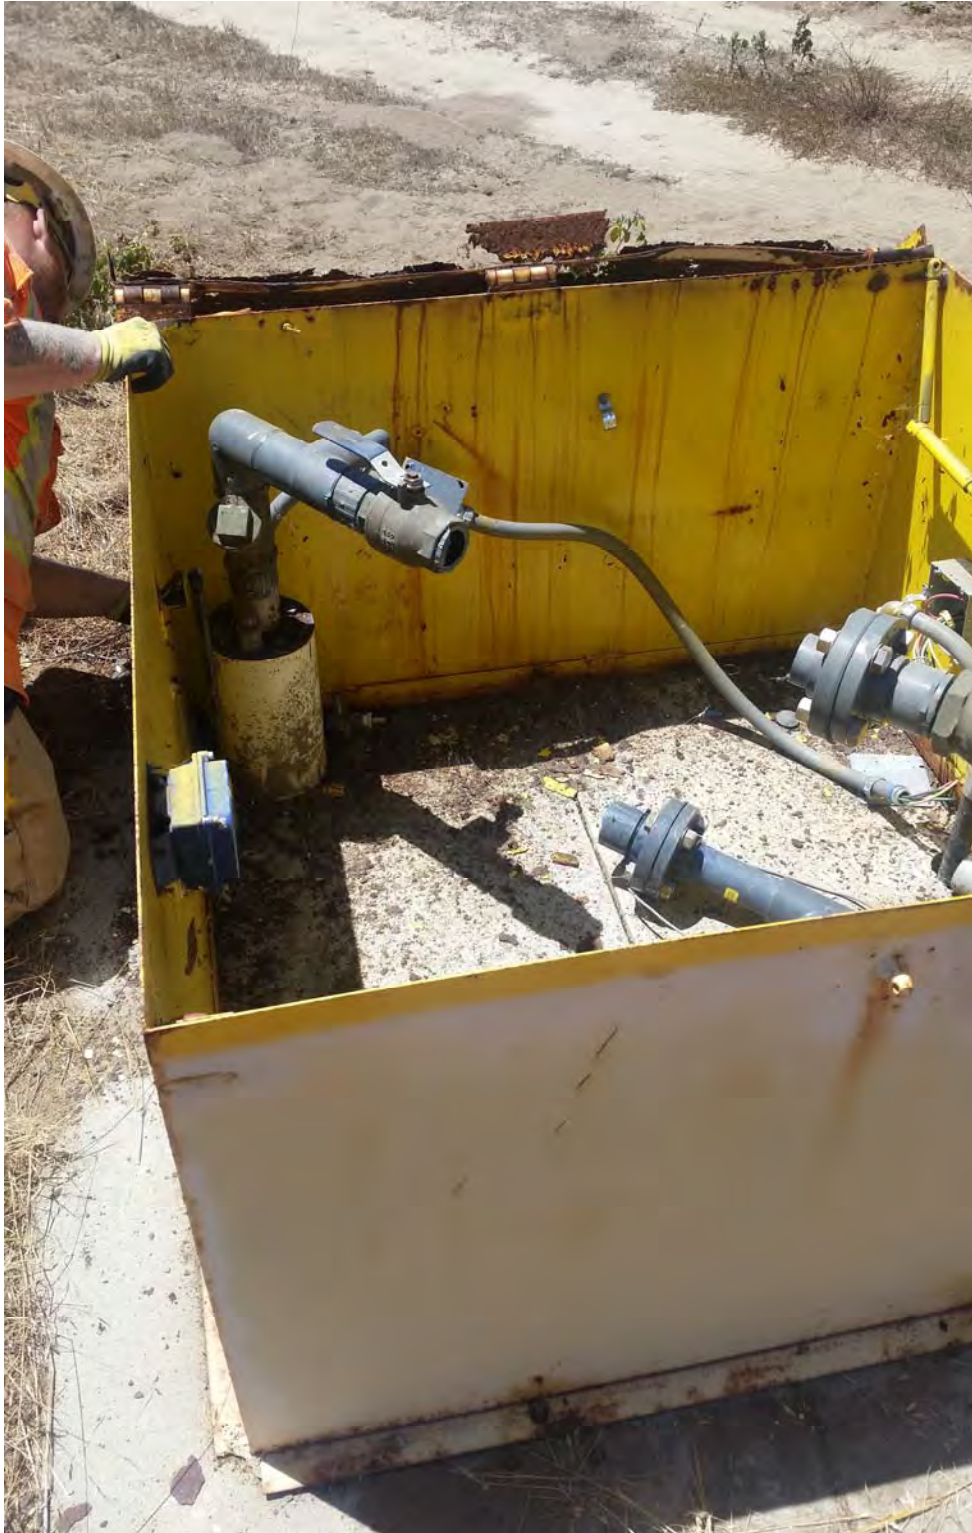
Removing well housing and pipe on boundary well

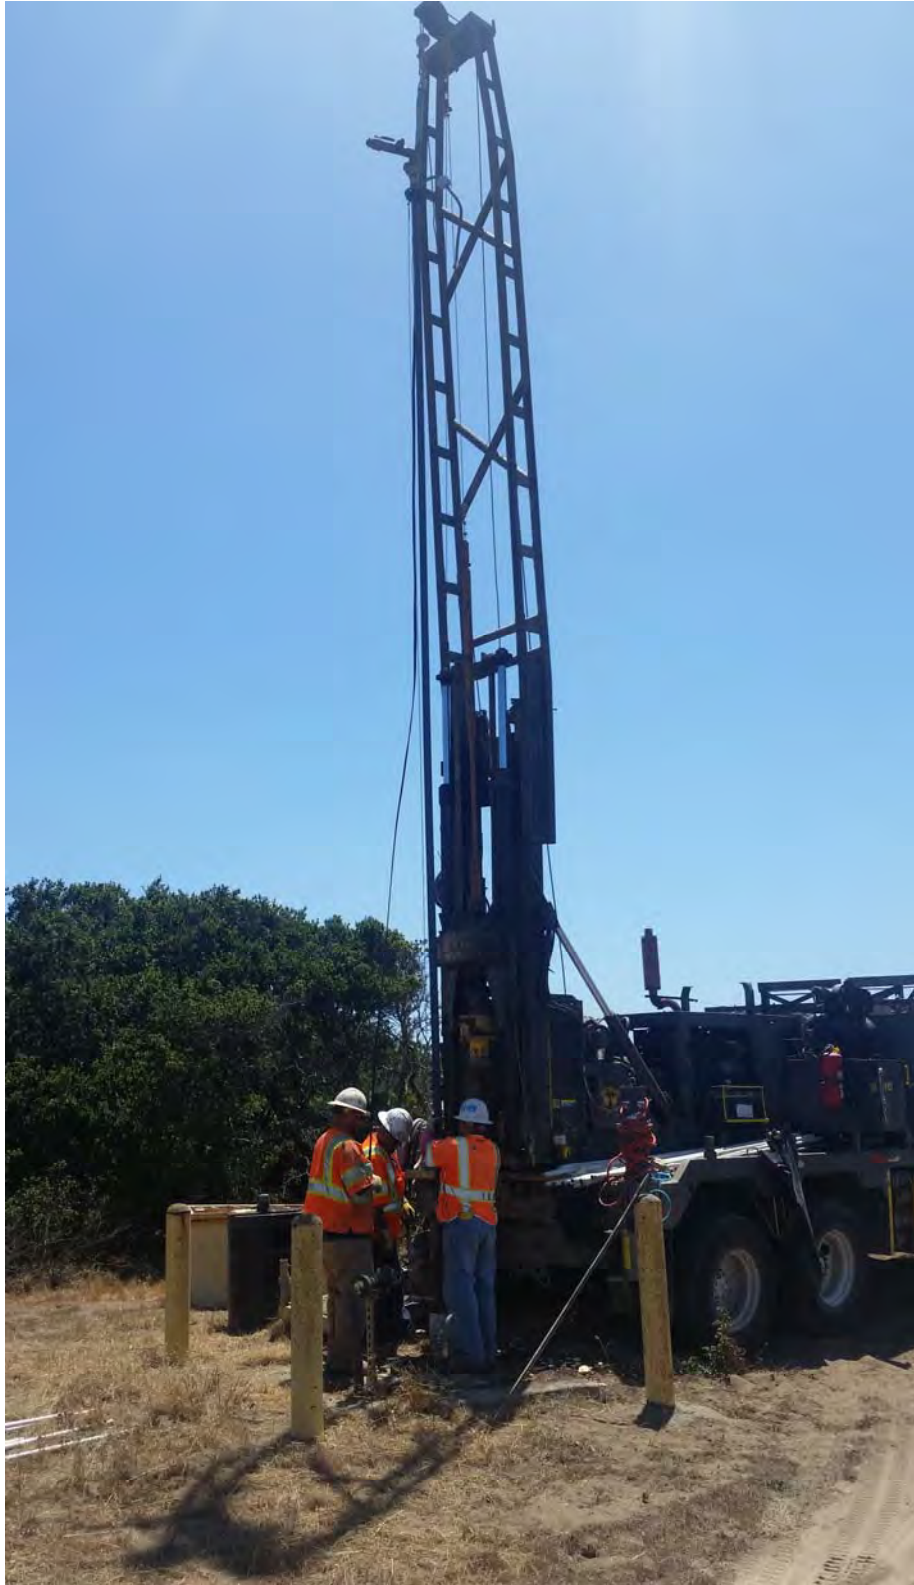
Removing pump from extraction well

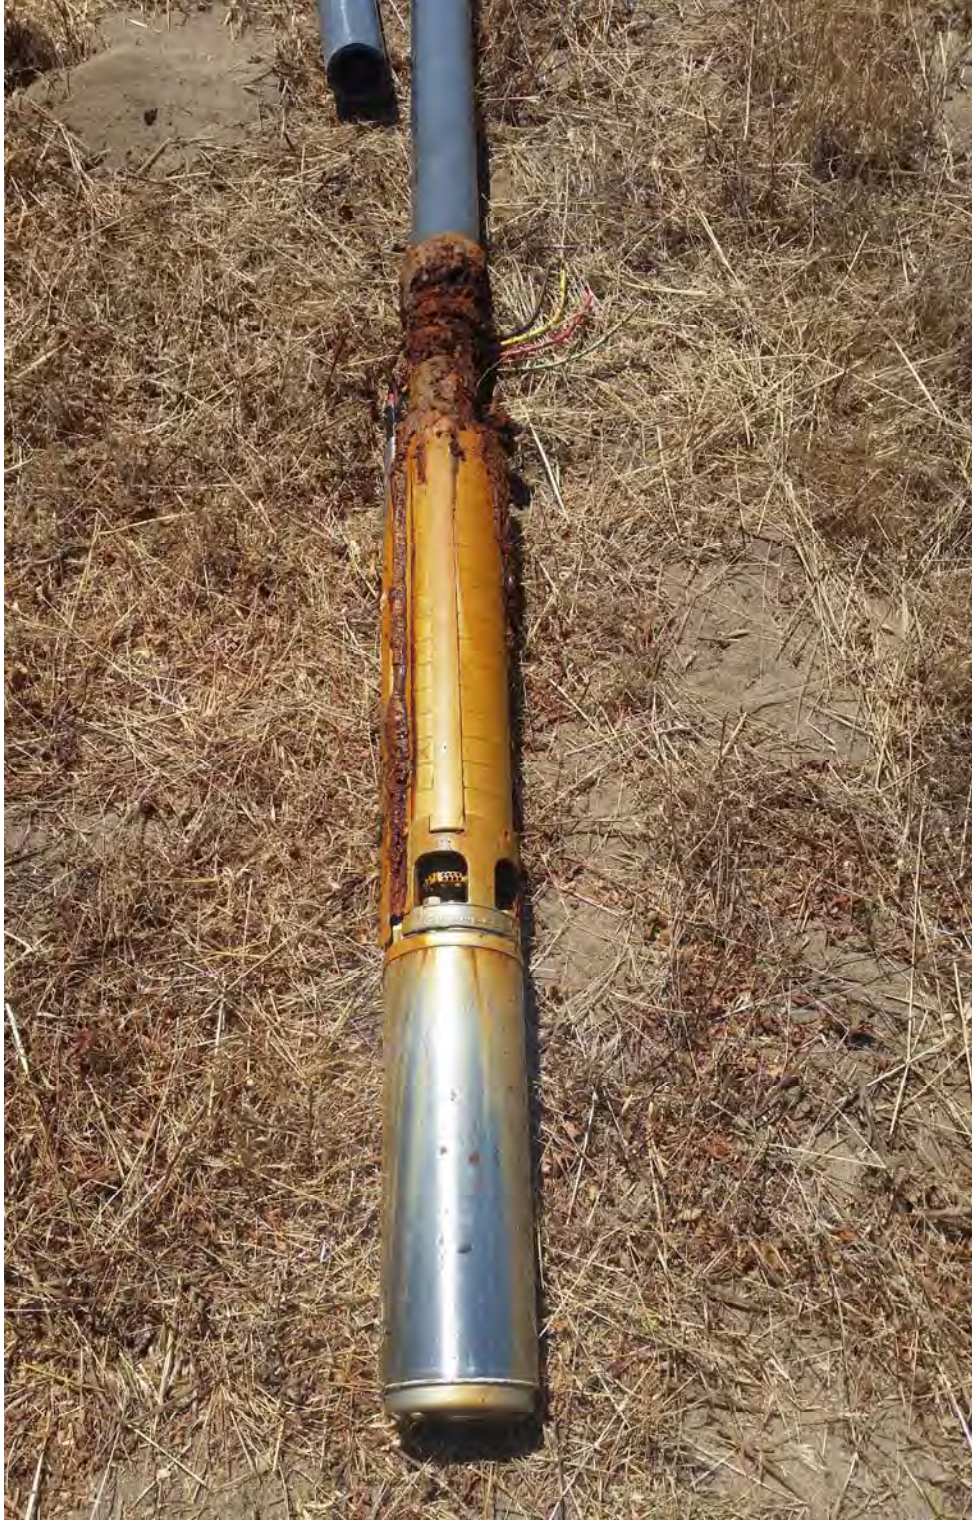
Pump removed from extraction well

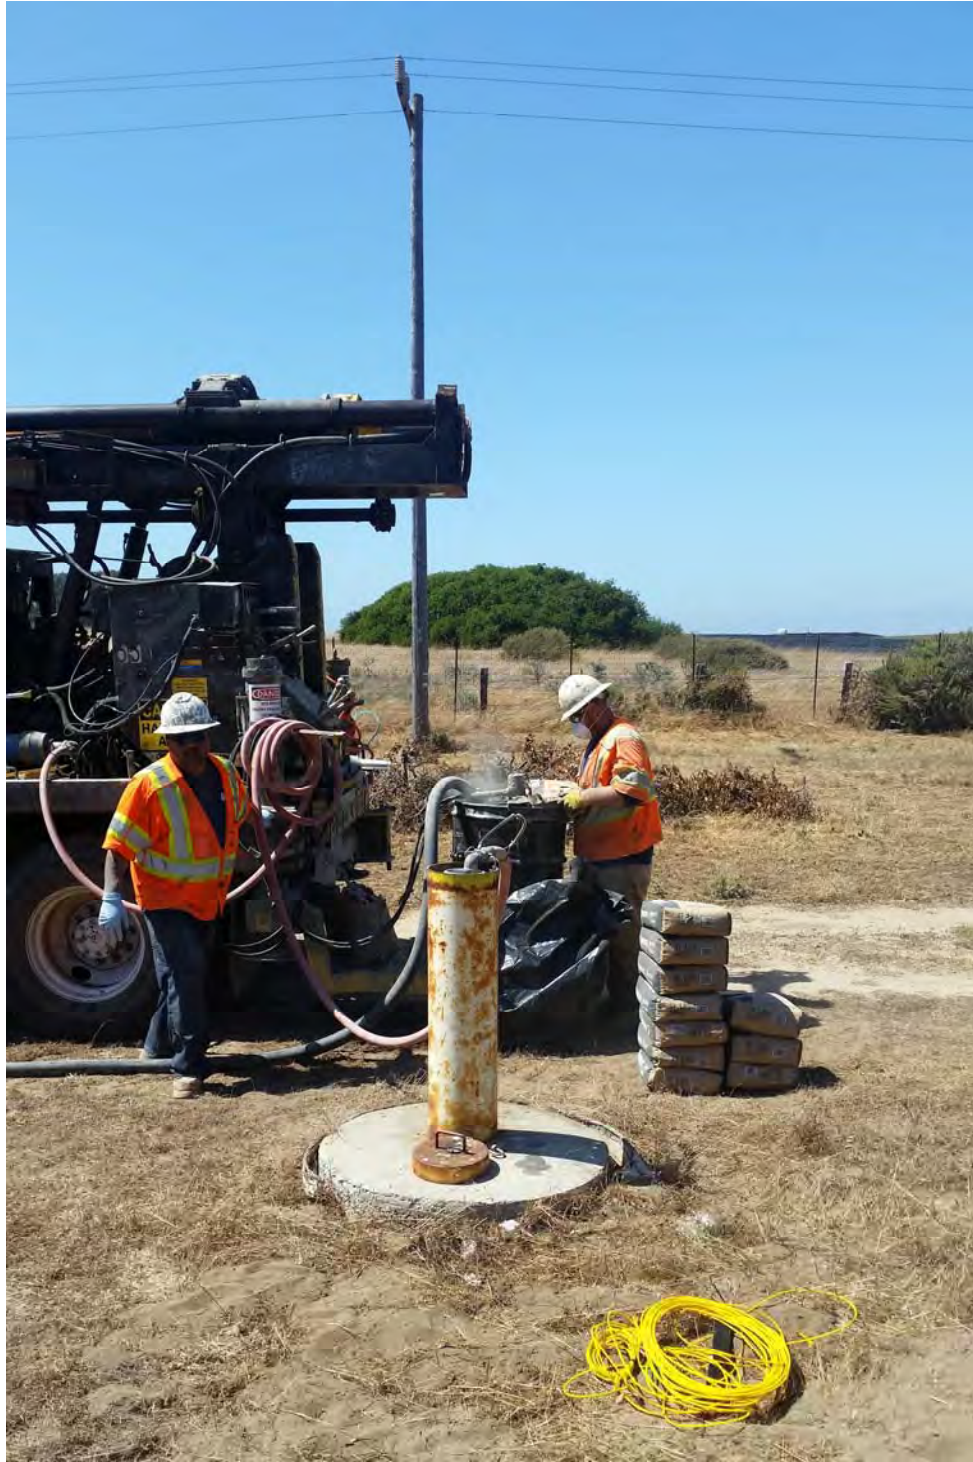
Mixing and pumping grout to seal well on northwest boundary 20170711\_152623

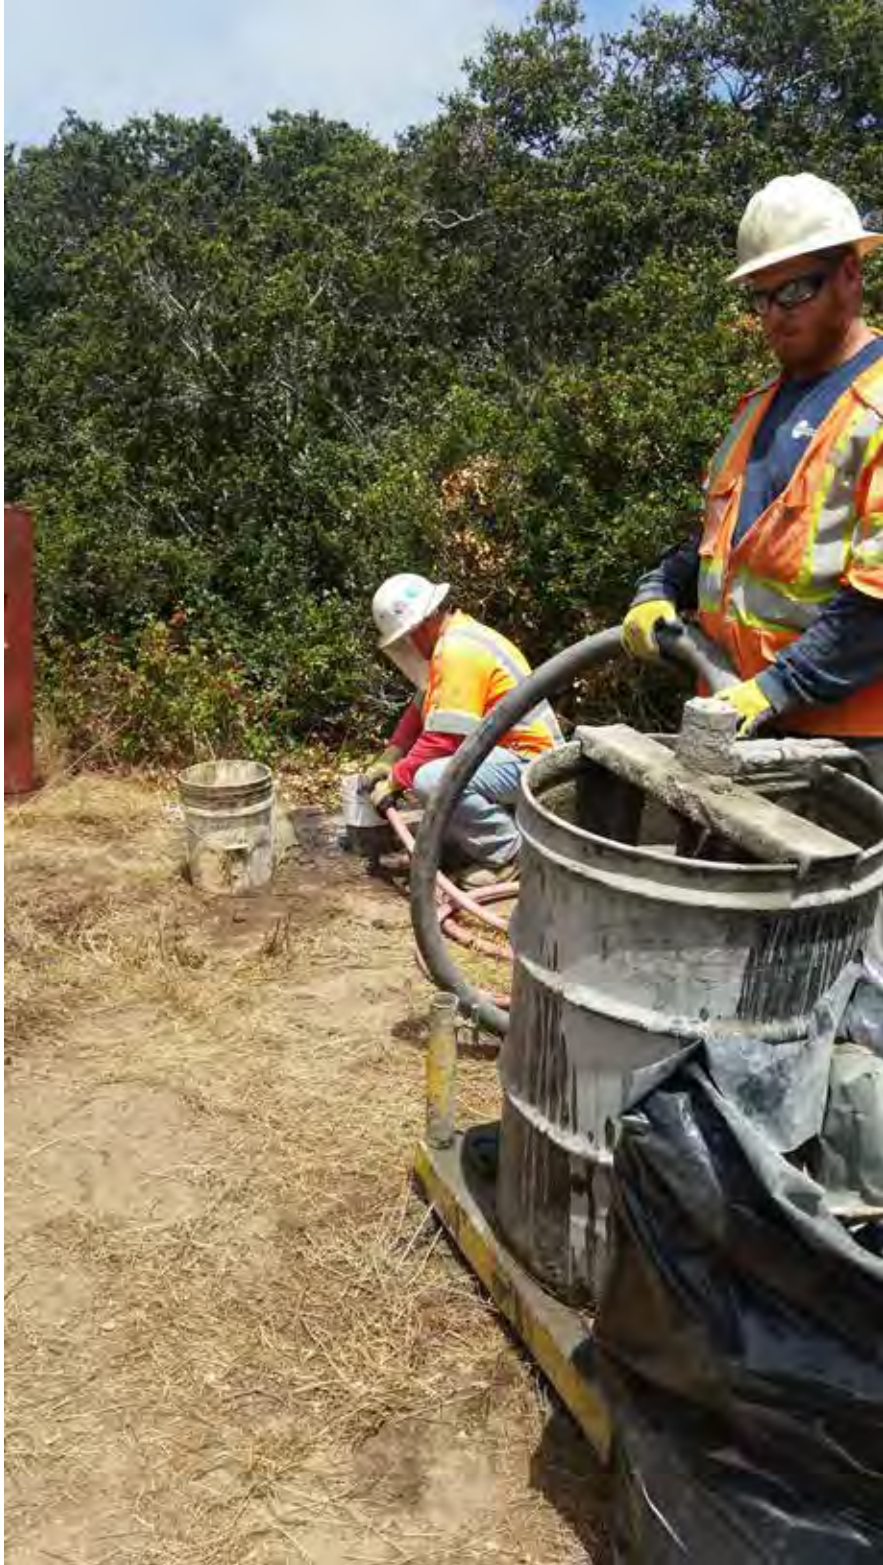
Mixing and pumping grout to seal well in habitat area 20170714\_132221

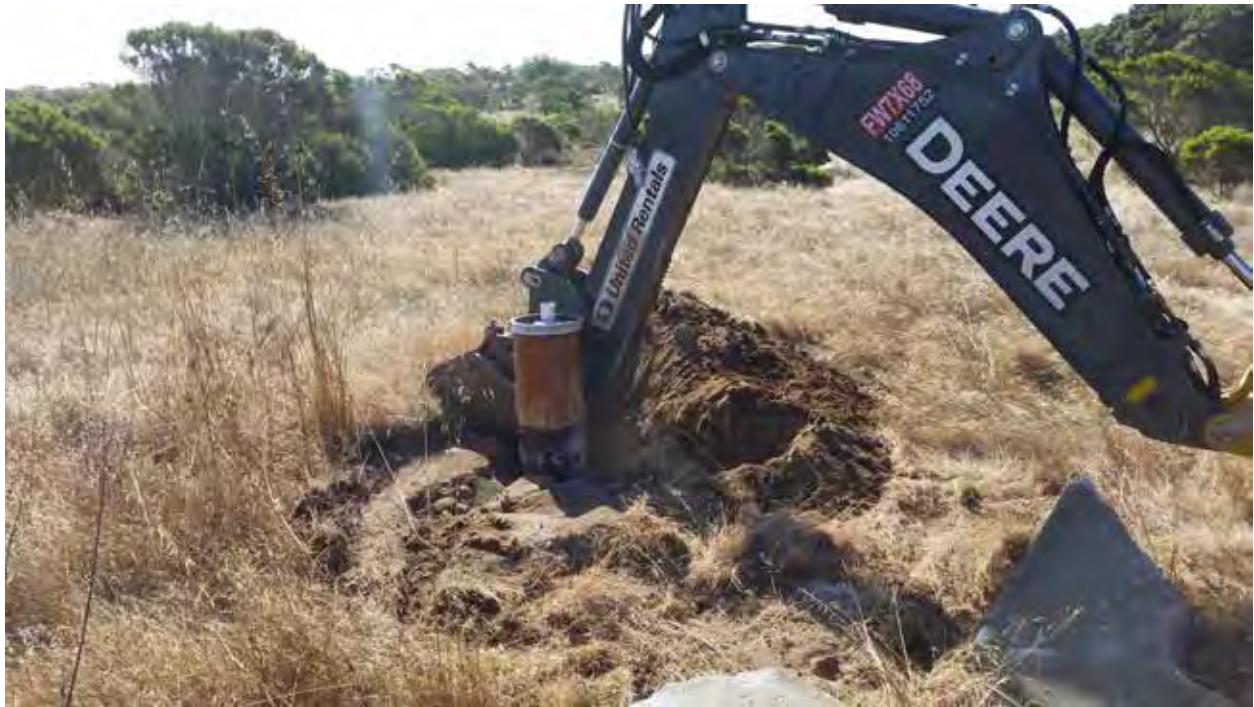
Removing well casing to 5 feet below ground

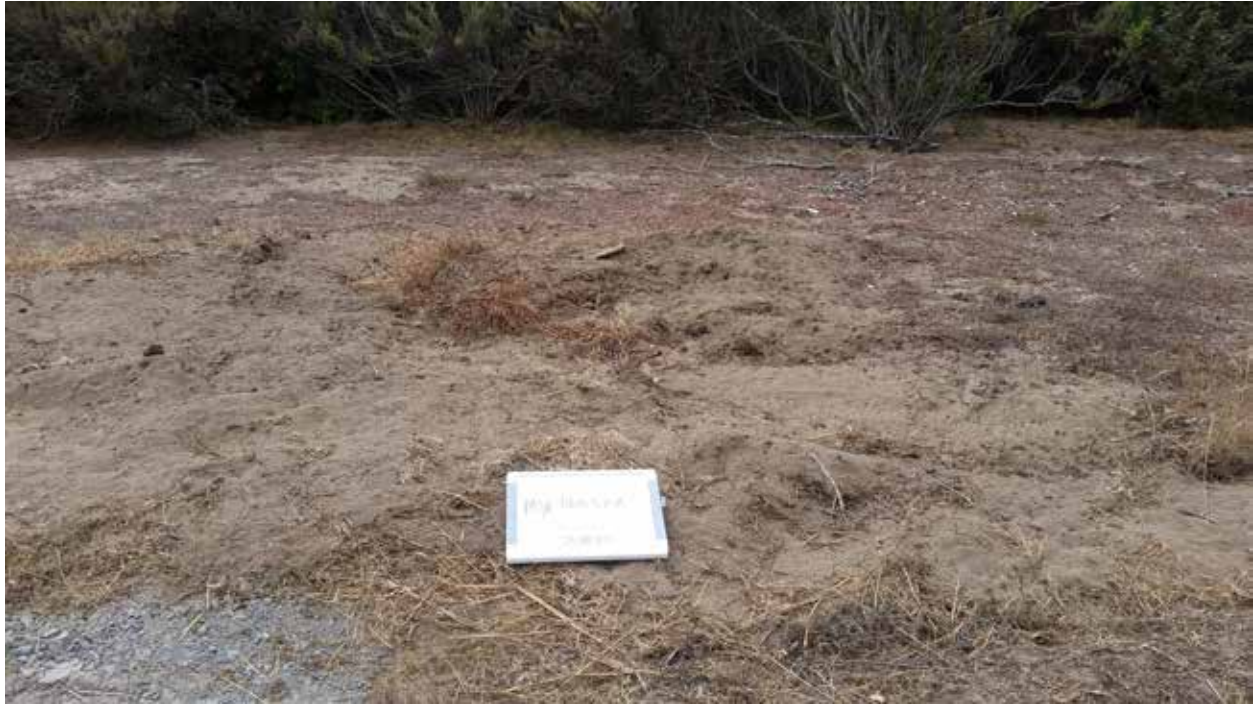
Site condition after completing destruction and demobilization at well MW-OU1-57-A 20170718\_110656

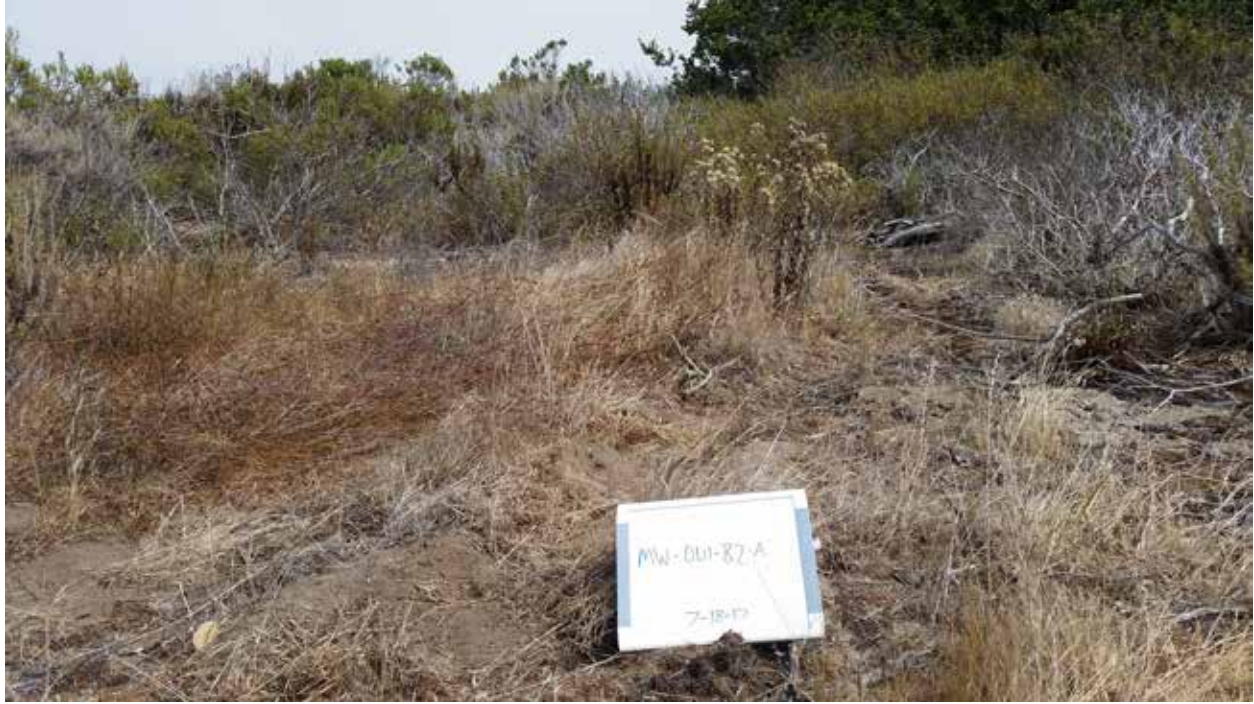
Site condition after completing destruction and demobilization at well MW-OU1-82-A 20170718\_111533

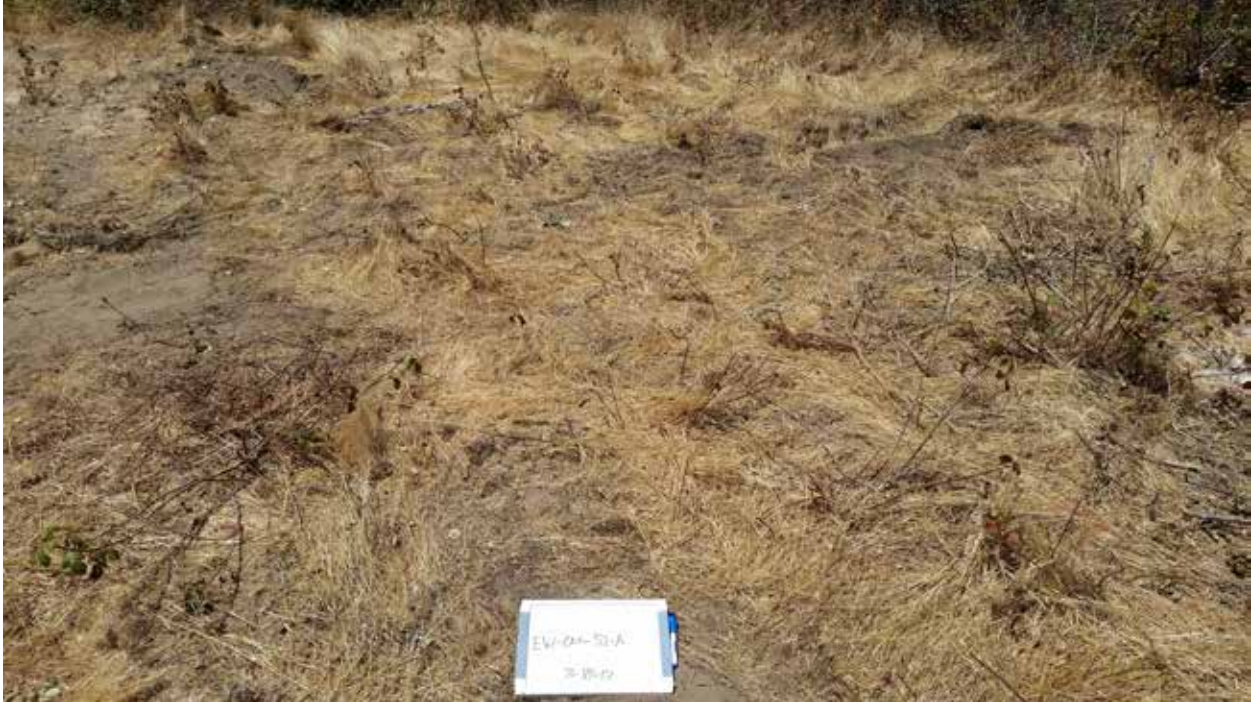
Site condition after completing destruction and demobilization at well EW-OU1-52-A
