Technical Report Iso-Settlement Survey Operable Unit 2 Landfills Former Fort Ord, California

U.S. Army Corps of Engineers Sacramento District 1325 J Street Sacramento, CA 95814-2922

Ahtna Environmental, Inc. 296 12th Street Marina, CA 93933-6001

January 2019

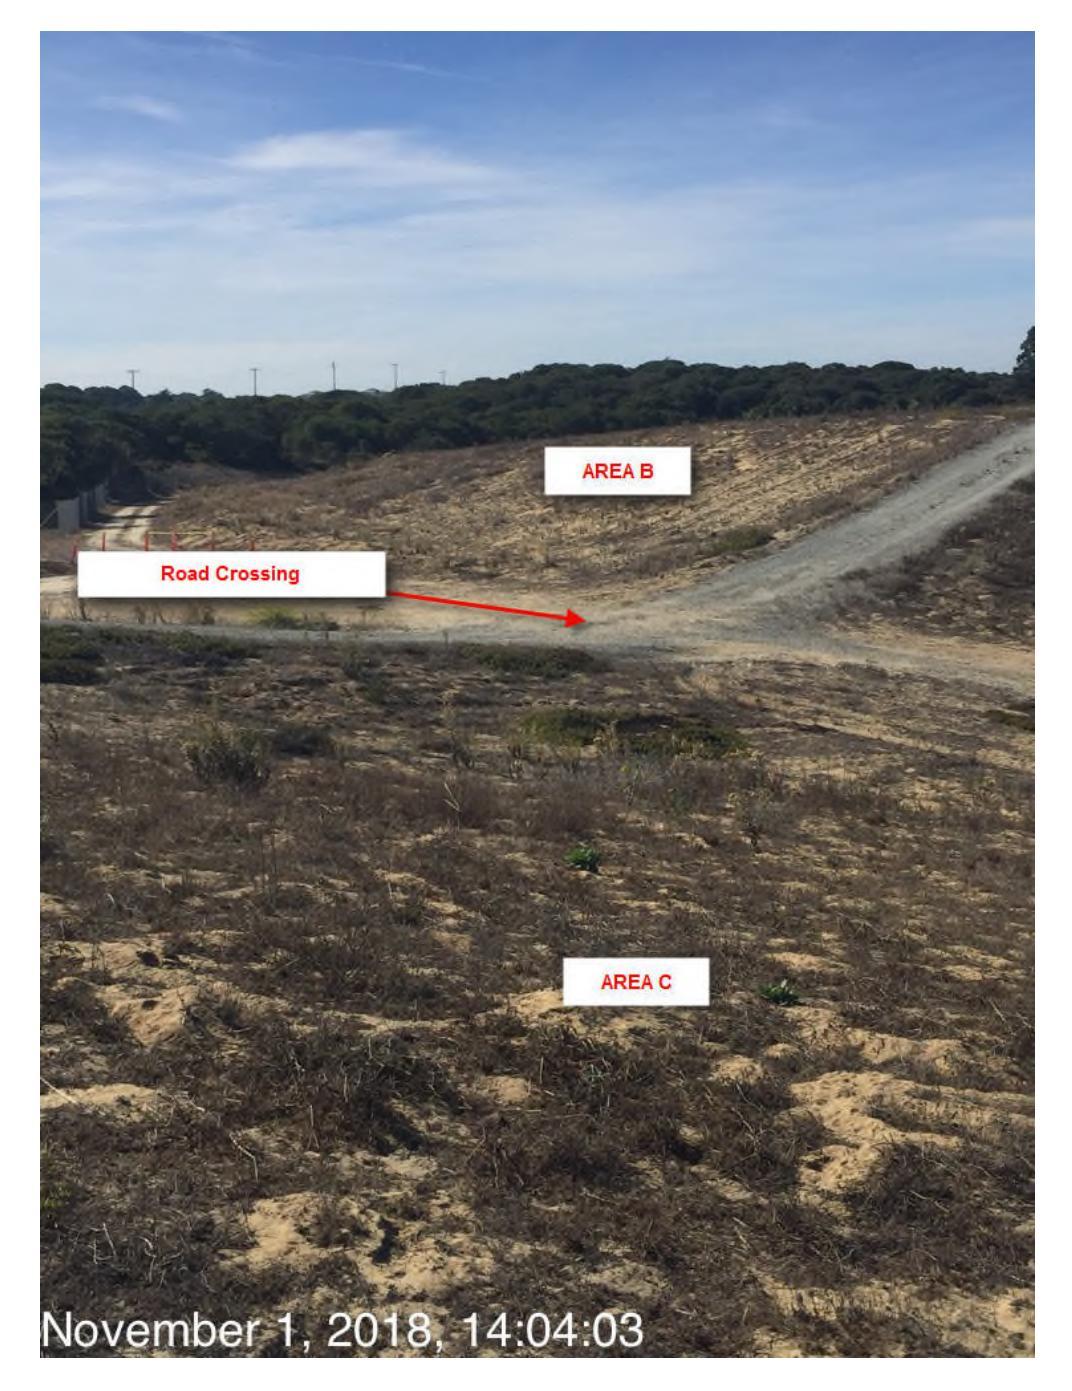
Photograph 1. Areas B/C Road Crossing

Area B accepted waste from 1966 to 1975 (Dames & Moore, 1993). Minor sloughing of the vegetative cover has occurred in isolated locations around the perimeter of Area B resulting in decreases in elevation of 1 foot to 2 feet relative to the 1998 base topography. The location with the most significant change in elevation is on the southeastern side of Area B where perimeter road improvements created a depression between Areas B and C as shown in Sheet C80 (Attachment C); however, this has not had an adverse effect on the engineered cover system as shown in Photograph 1.

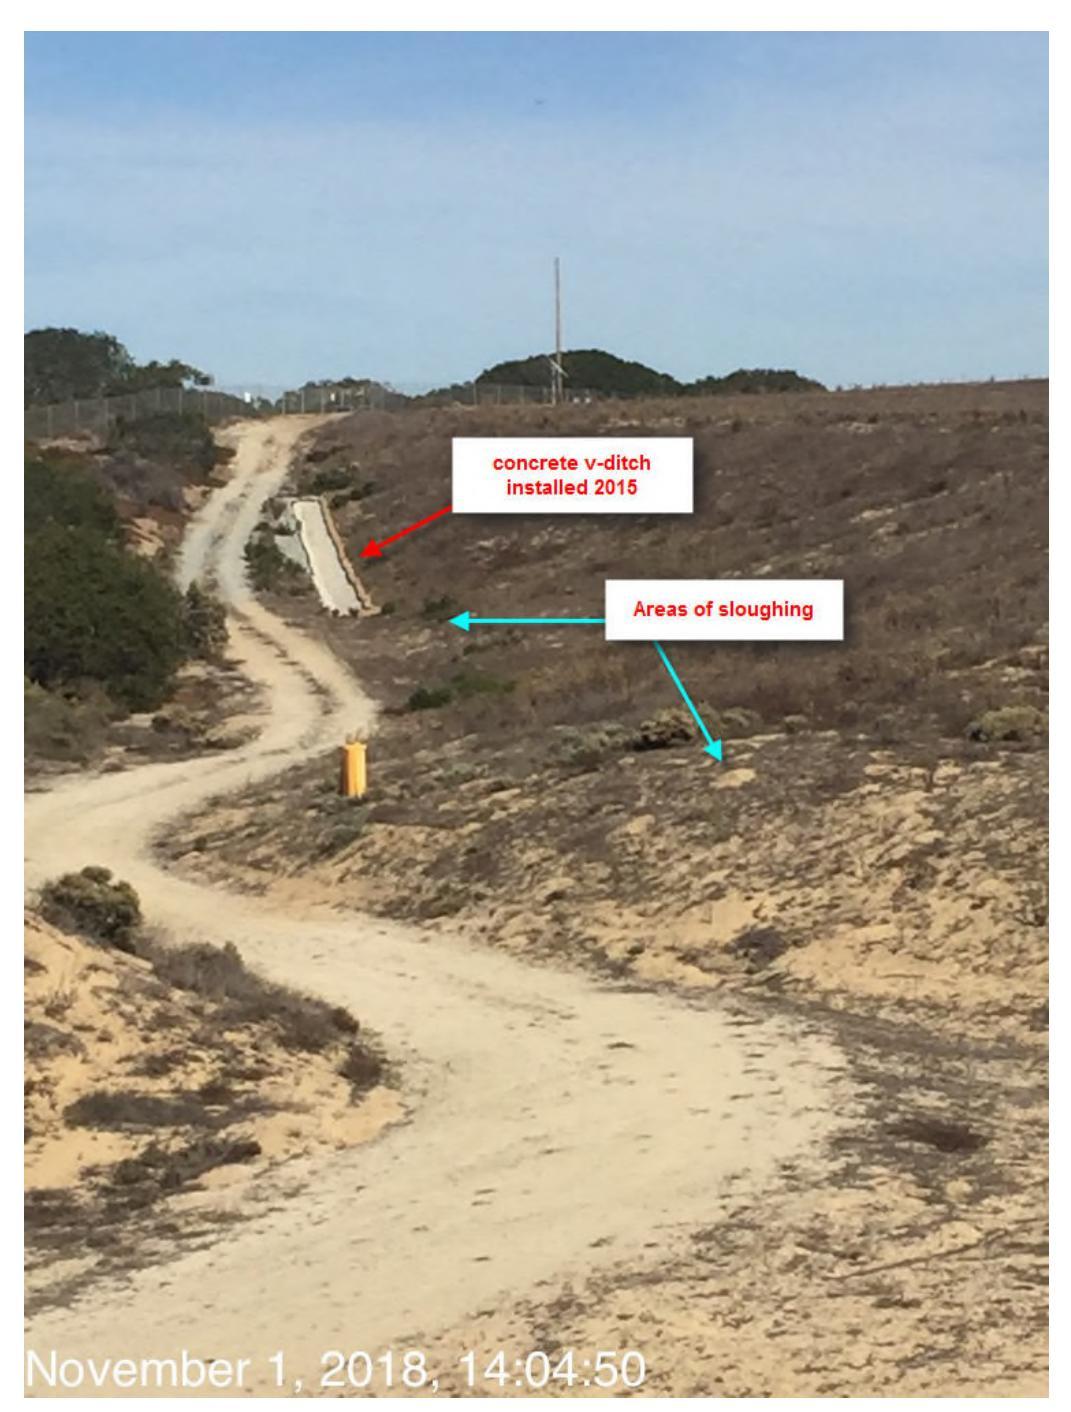
Photograph 2. Western Area D Concrete V-Ditch

Area D accepted waste from 1966 to 1975 (Dames & Moore, 1993). Minor to moderate sloughing of the vegetative cover has occurred on the northwestern and southeastern slopes of Area D resulting in decreases in elevation of 1 foot to 3 feet relative to the 1998 base topography. Repair of the vegetative cover on the northwestern slope included the placement of a concrete-lined drainage ditch to mitigate erosion (Photograph 2).

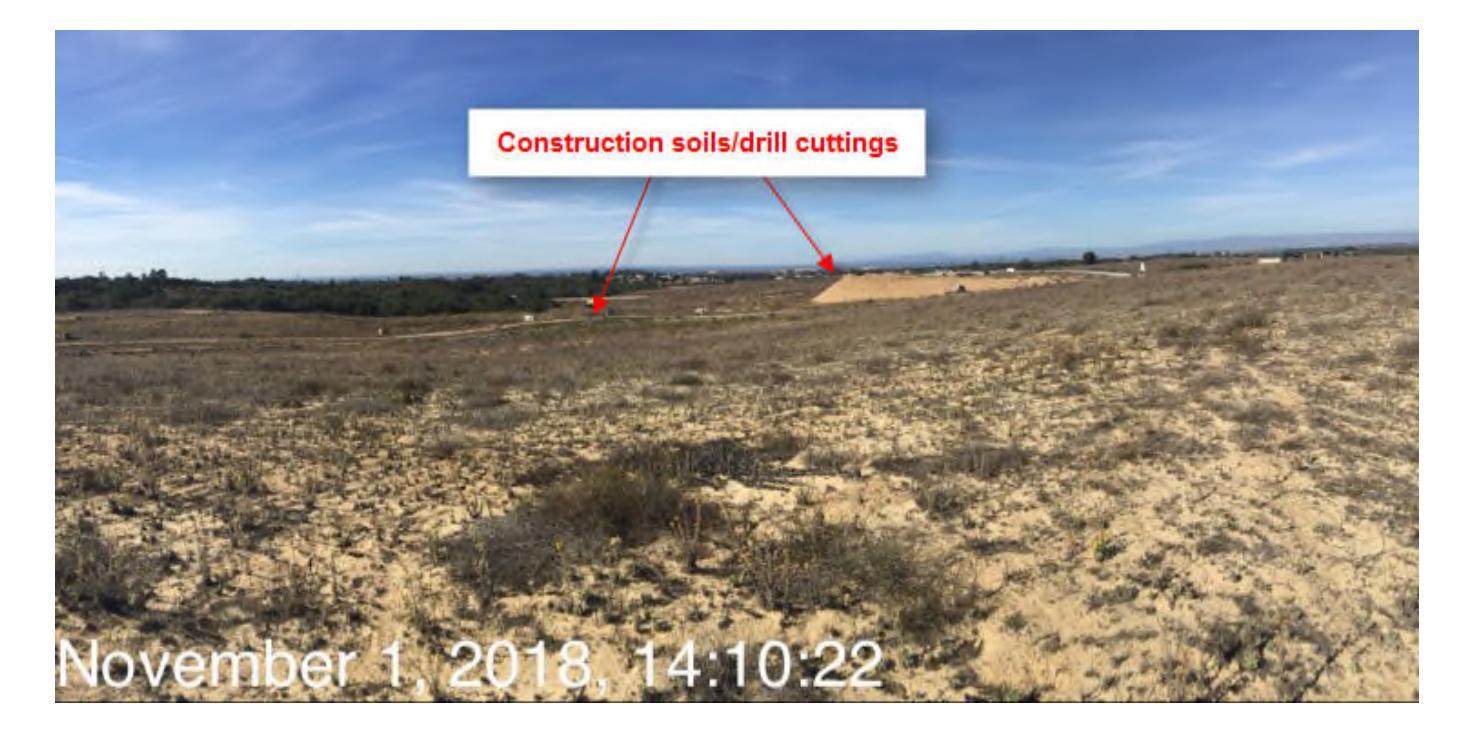
Photograph 3. Area E Construction Soils/Drill Cuttings

The larger blue shaded area on the Area E iso-settlement map represents the increase in elevation associated with the Phase 1 vertical expansion completed in 2013, as depicted on Sheet C-11 in Attachment C. The smaller blue shaded areas west of the Phase 1 area represent recent placement of clean soils from construction and well installation projects at the former Fort Ord (Photograph 3). These

clean soils will be used as cover material when additional remediation waste is placed in the Phase 2 area at a future date.²

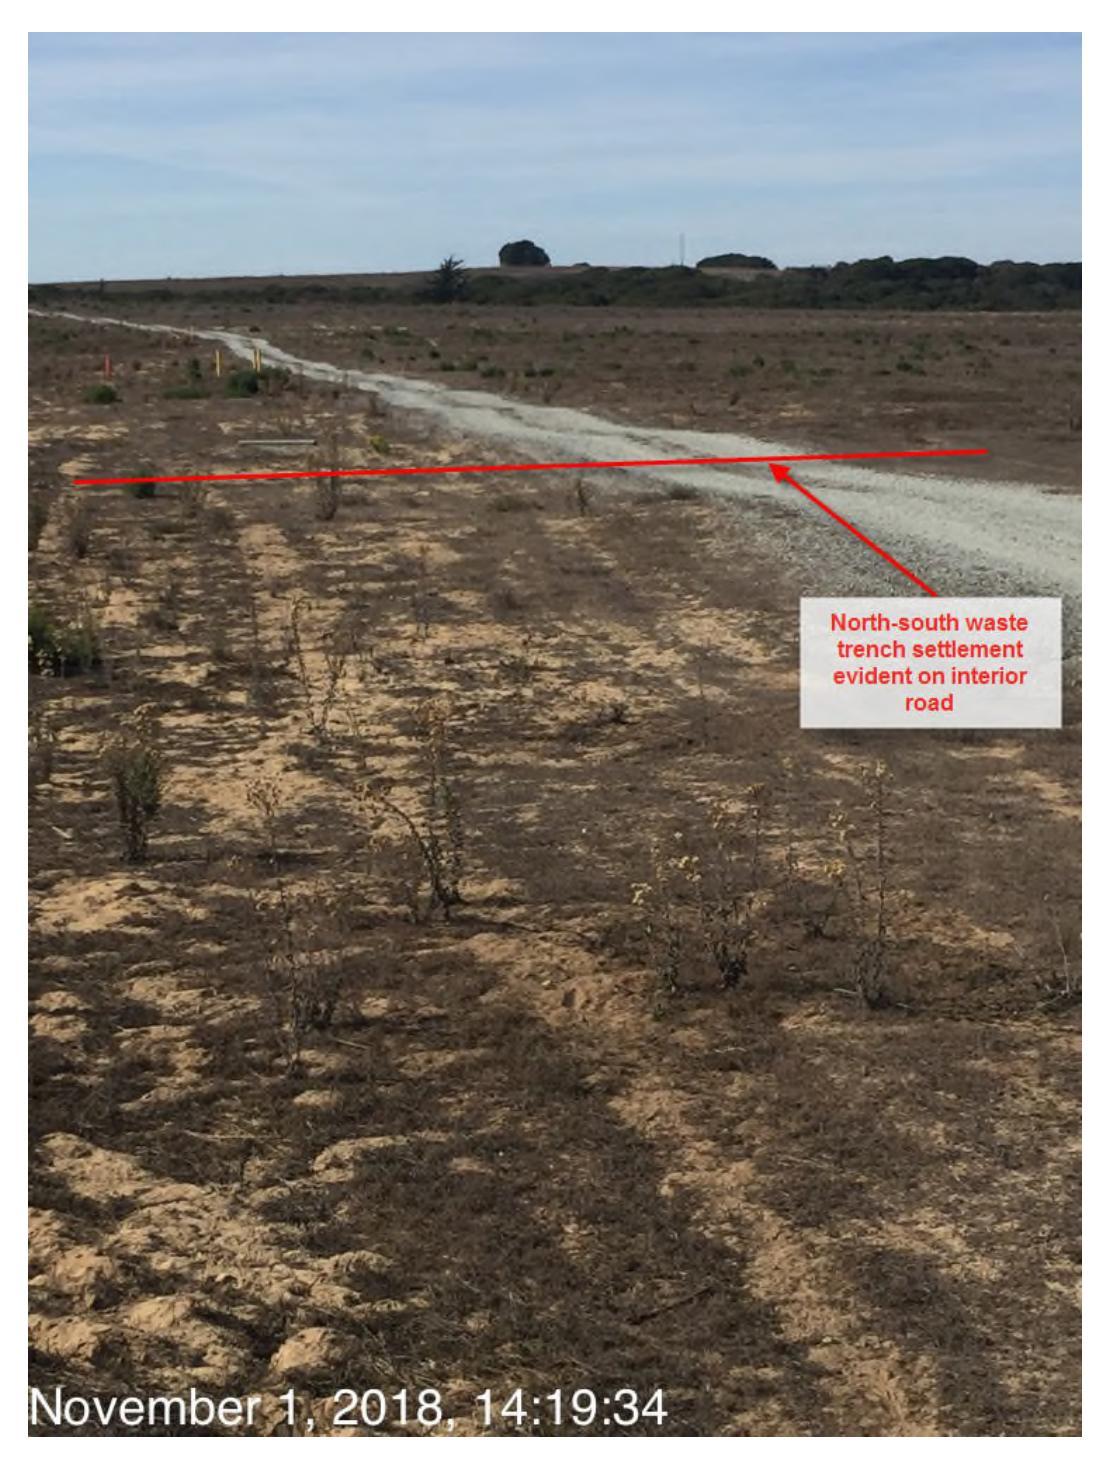
Photograph 4. Area F Waste Trench Settlement

Minor to significant sloughing of the vegetative cover has occurred on the northern slope of Area F resulting in decreases in elevation of 1 foot to 2 feet relative to the 1998 base topography. Repair of the vegetative cover on the northern slope included the placement of a subdrain system in 2017 to mitigate erosion (Ahtna, 2018). As shown on the iso-settlement map for Area F in Attachment B, elevation differentials between 1998 and 2018 over most of Area F have been less than 1 foot, with isolated settlement areas of -1 to -2 feet in the waste disposal trenches. A maximum differential of 3 to 4 feet is observed at the western extent of Area F in an area of access road improvements.

Based on site history and the results of the iso-settlement mapping and settlement monument survey, differential settlement in Area F appears to be the result of slope stability issues, particularly on the northern slope, and decomposition of the underlying waste in the parallel disposal trenches.

Because Area F continued to receive decomposable waste until interim closure of the OU2 Landfills in 1987, this area showed evidence of settlement related to waste decomposition in areas that correspond to the locations of waste disposal trenches. However, no significant changes were observed in Area F when the 2018 surface elevations were compared to 1998 surface elevations.

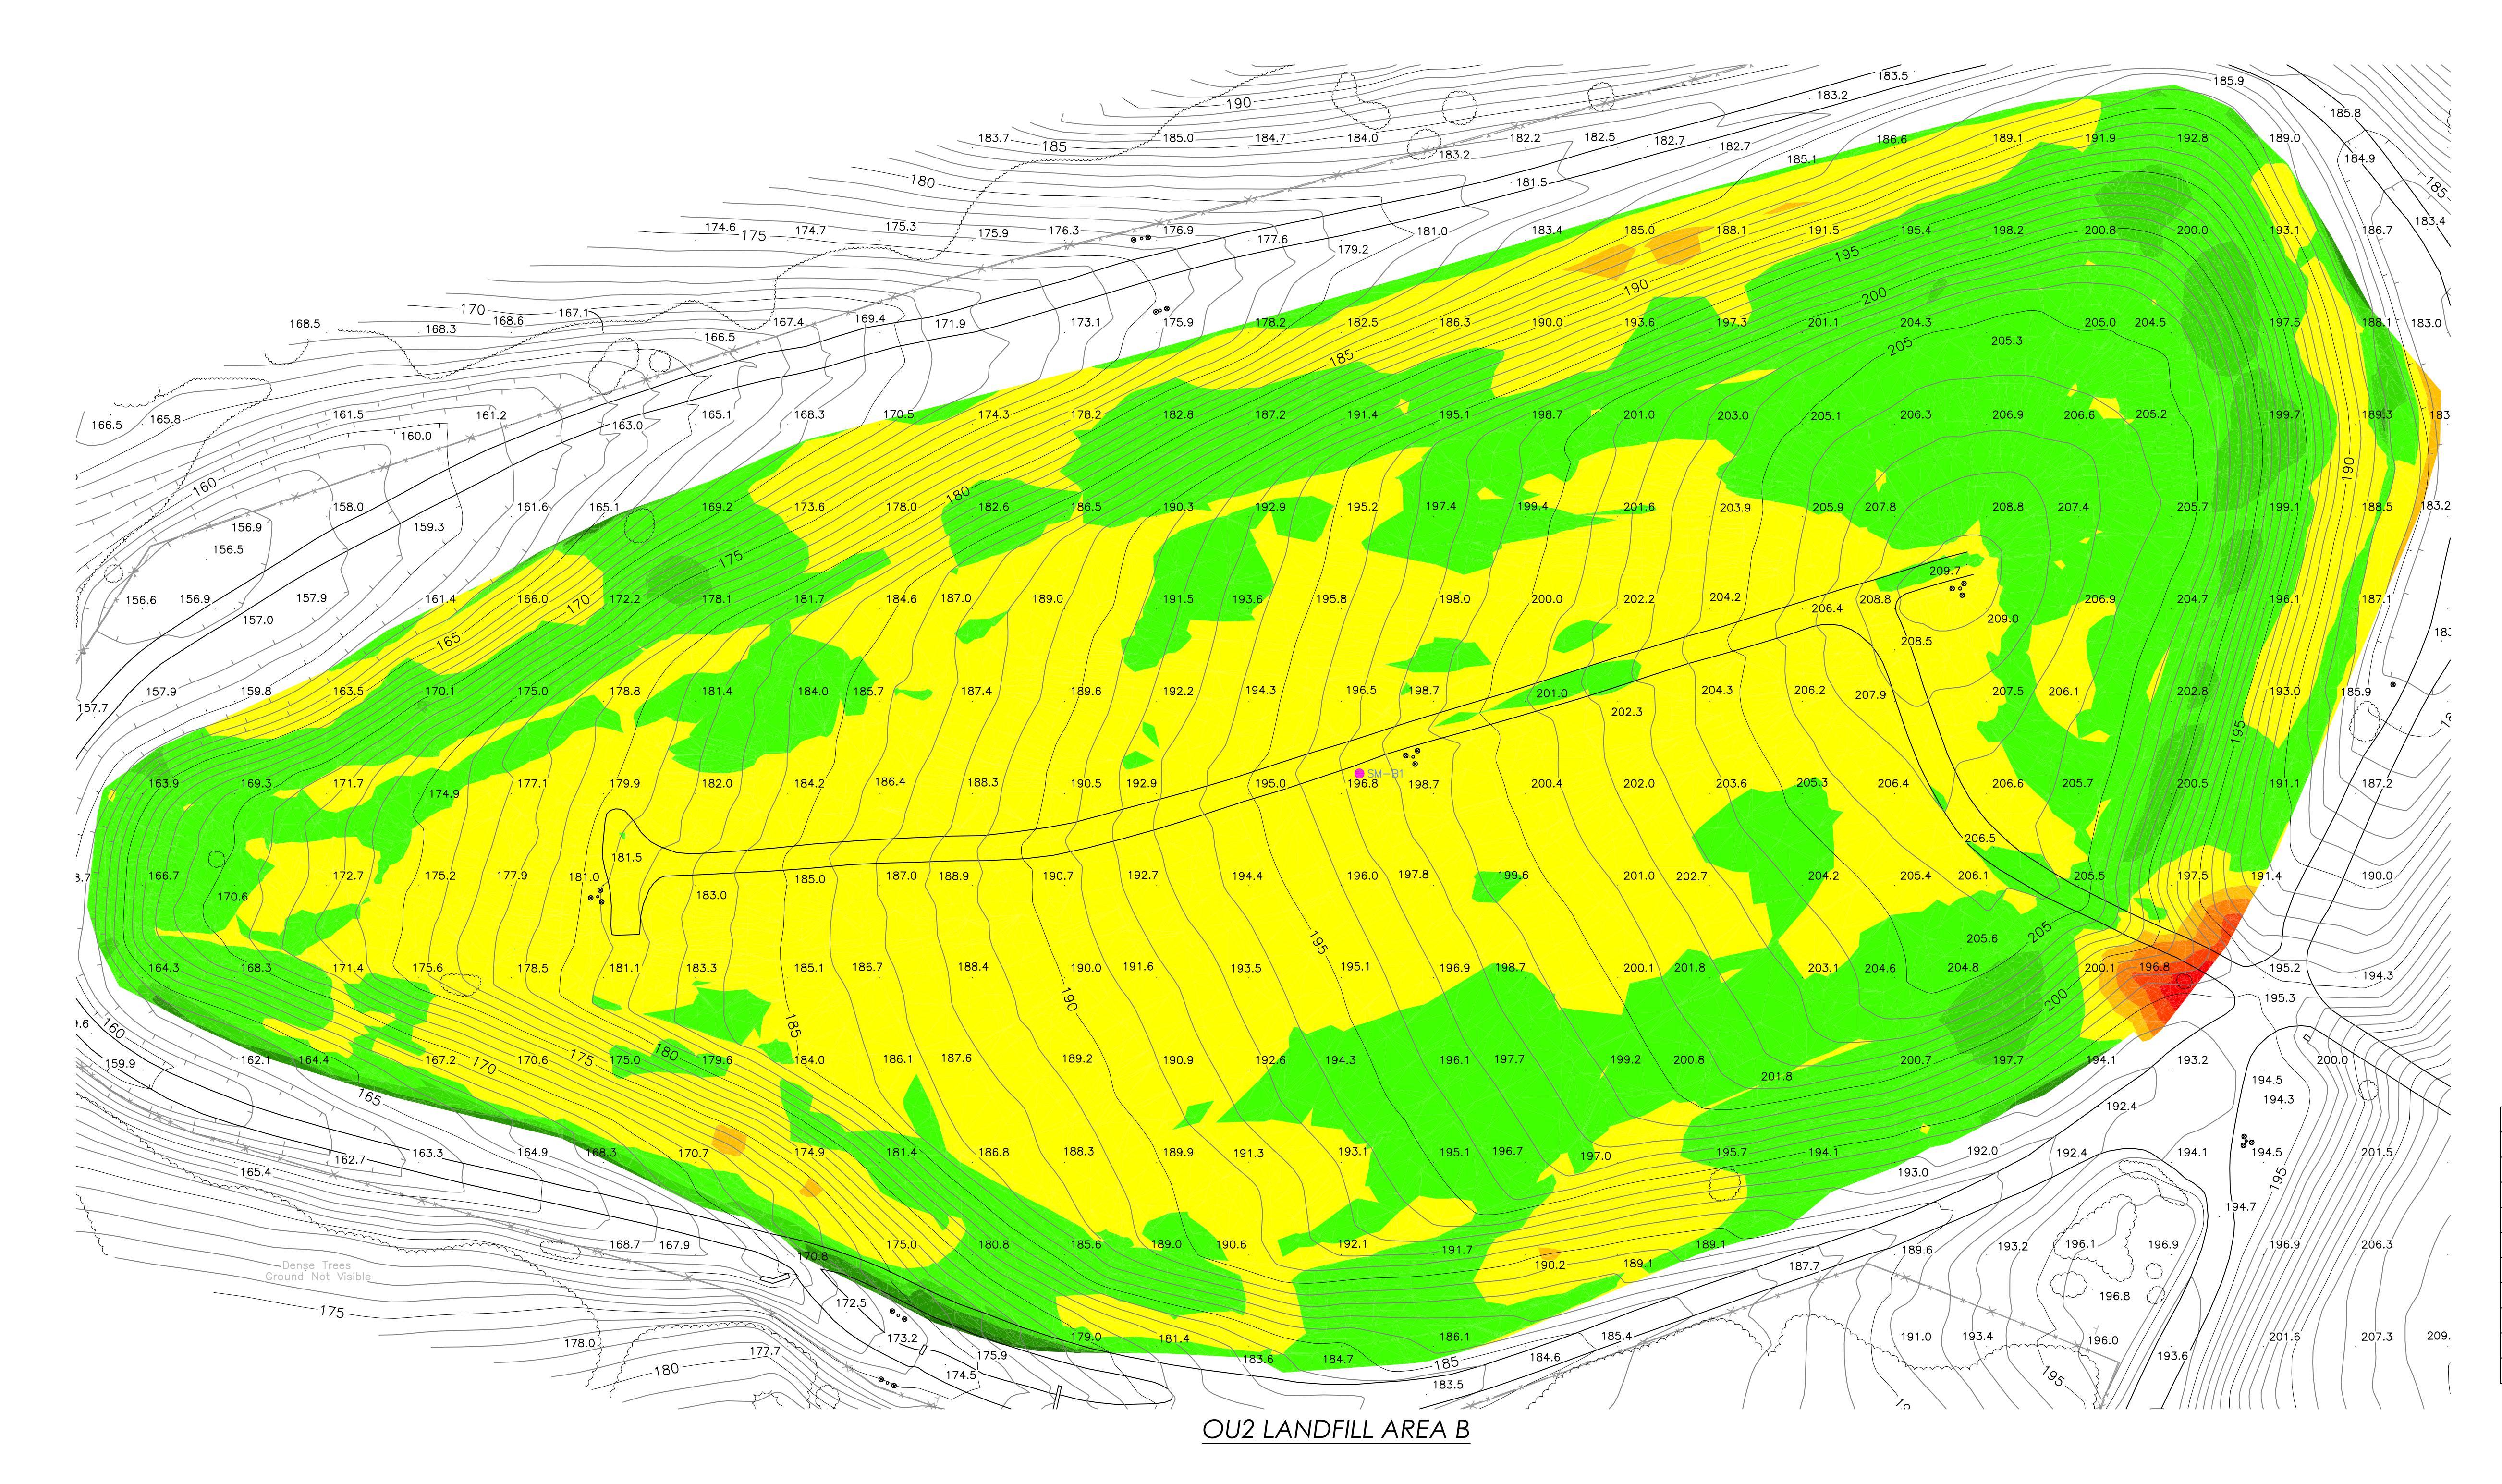
Volume Surface showing the change in elevation from 1998 to 2018 at Area B

Settlement monument SM-B1 is in the middle of Area B (Attachment C, Sheet C80). In the 20-year period following placement of waste and the engineered cover system in Area B, the elevation of SM-B1 has declined 0.20 of a foot (2.4 inches) (Table 2). As shown on the iso-settlement map for Area B in Attachment B, elevation differentials between 1998 and 2018 over most of Area B have been less than 1 foot, with a maximum differential of -4 to -5 feet in the area of the perimeter road improvements noted above.

Based on site history and the results of the iso-settlement mapping and settlement monument survey, elevation changes in Area B appear to be the result of historical slope stability issues and construction activities, and are not related to decomposition of the underlying waste.

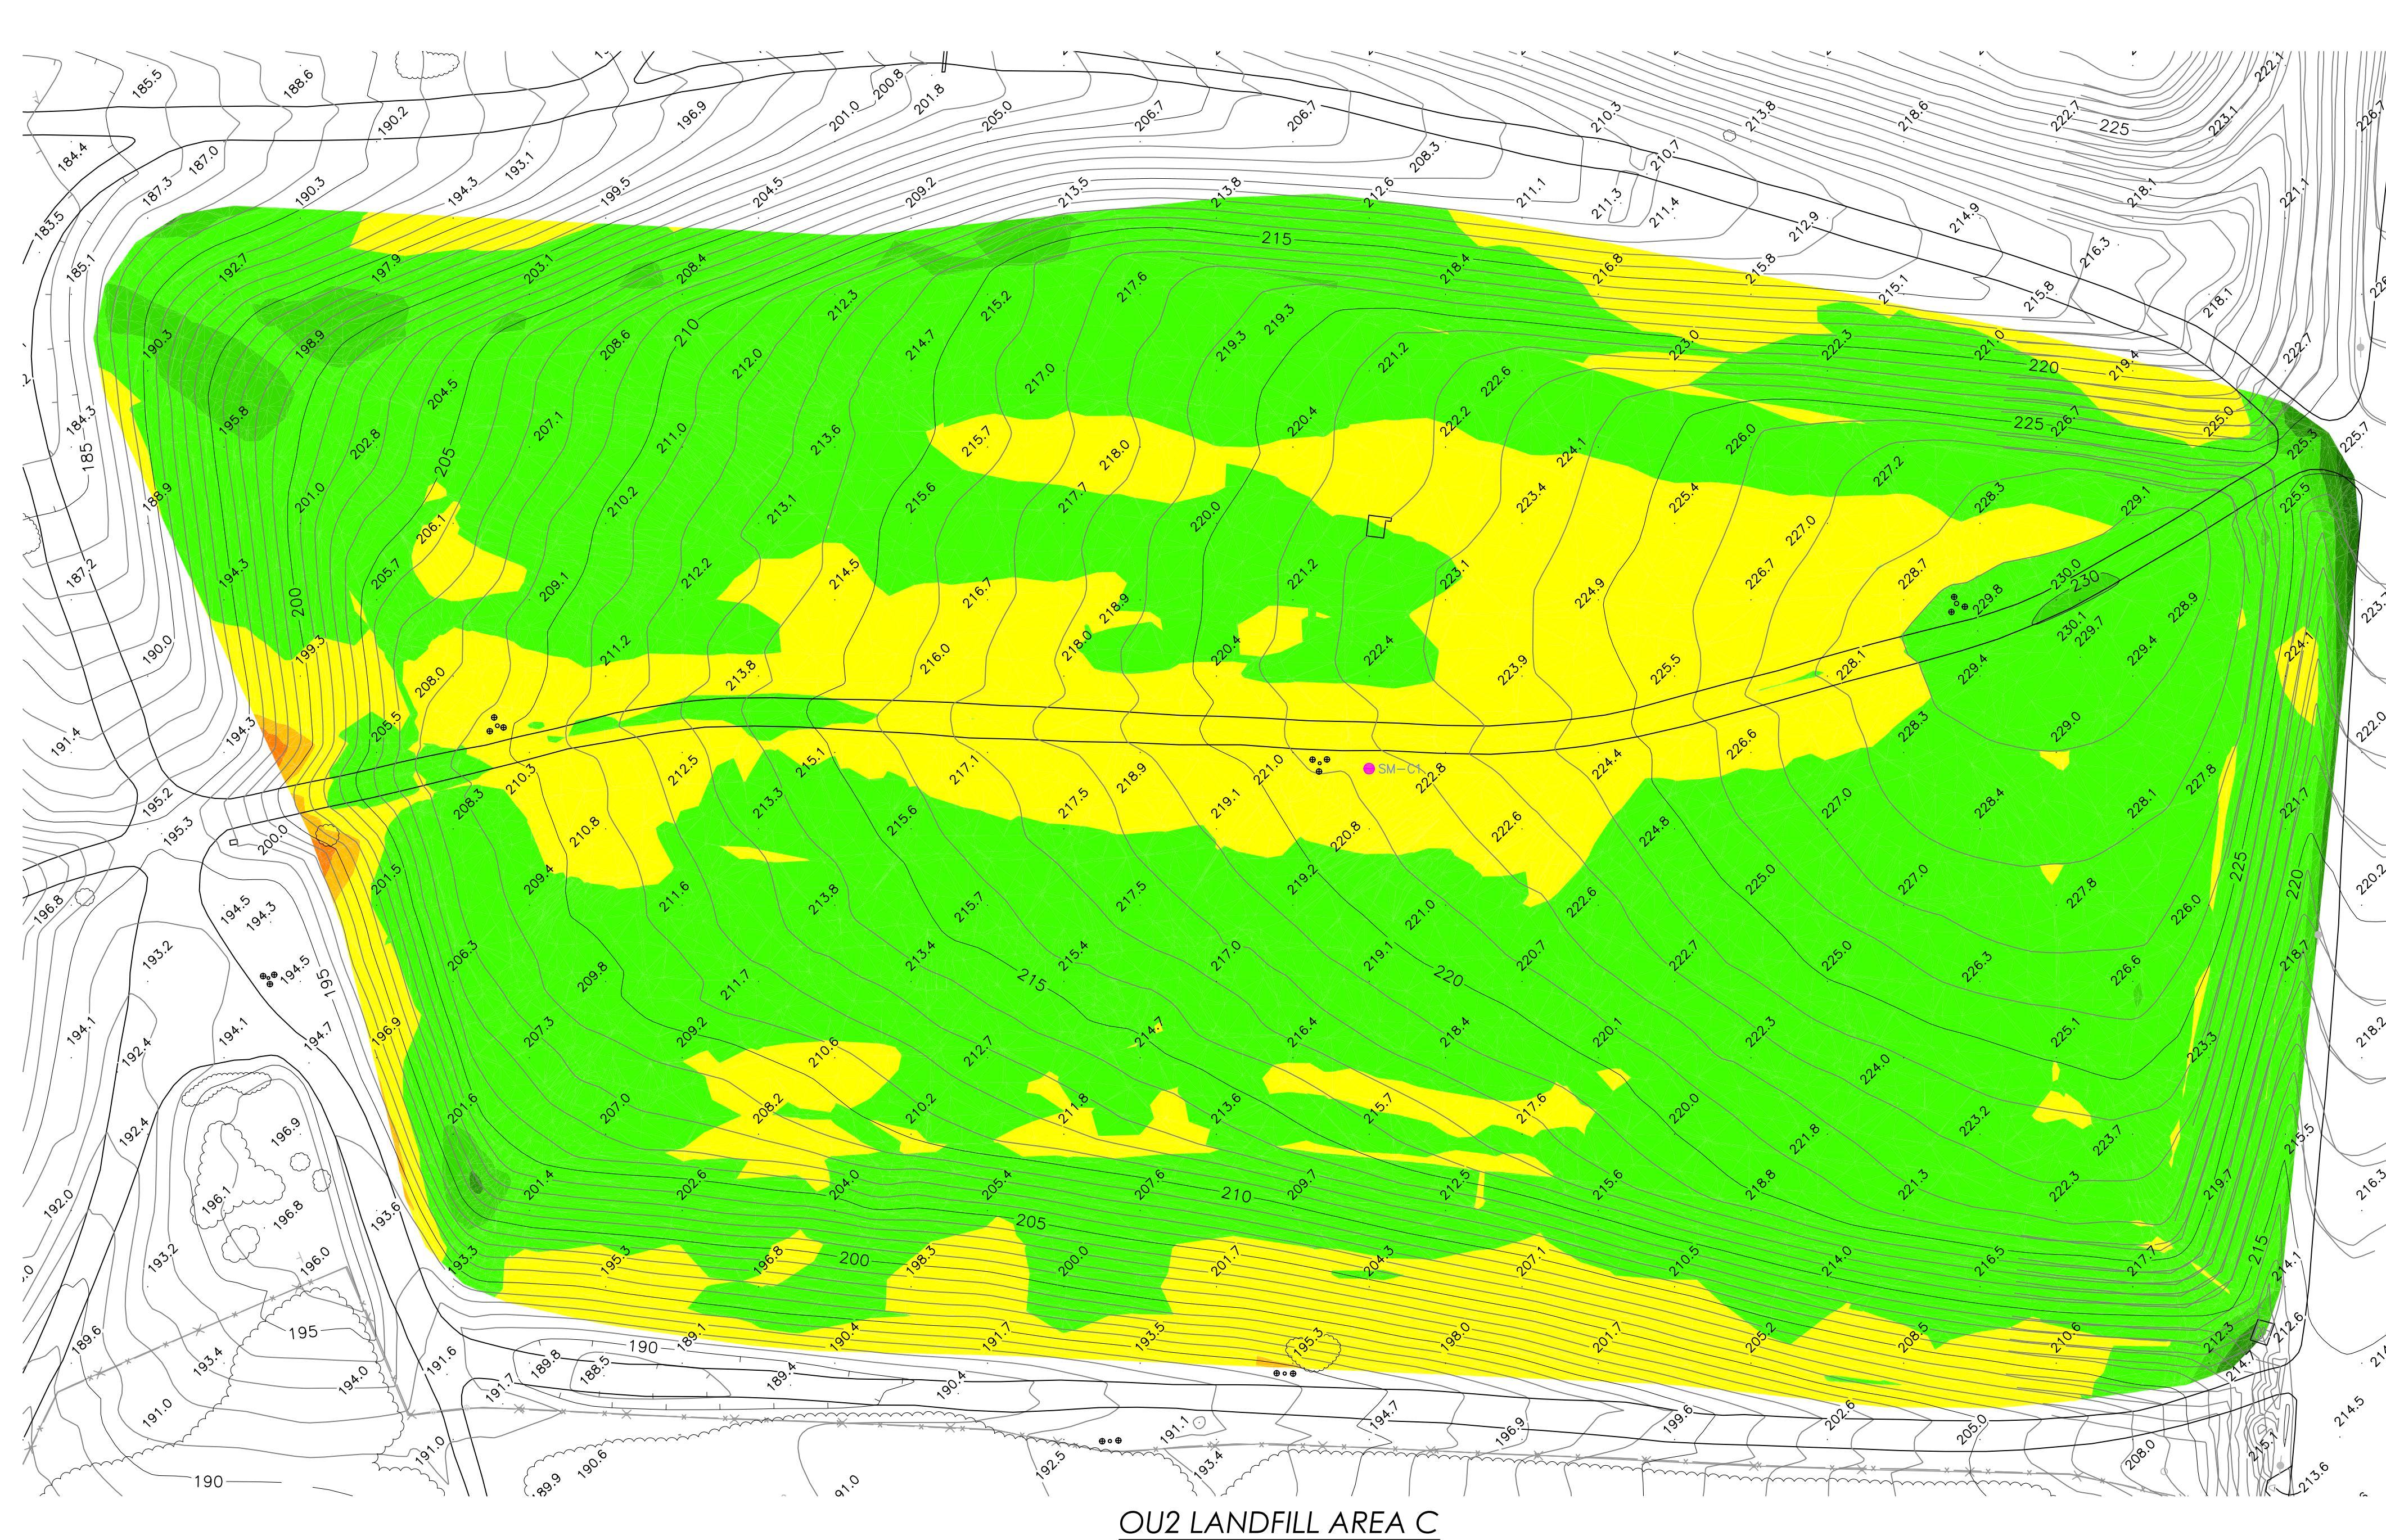
SCALE: 1" = 40' VIEW: AREA C DATE: October 26, 2018 FILE NAME: 2018 Compilation.dwg JOB #18186 Sheet 3 of 6

Area C accepted waste from 1966 to 1975 (Dames & Moore, 1993). The location with the most significant decrease in elevation is on the western side of Area C where perimeter road improvements created a depression between Areas B and C as shown in Sheet C80 (Attachment C); however, this has not had an adverse effect on the engineered cover system as shown in Photograph 1. In addition, the northeastern corner of Area C exhibits increases in surface elevation of up to 4 feet when compared to the 1998 base topography that were likely the result of road construction and maintenance.

Settlement monument SM-C1 is in the middle of Area C (Attachment C, Sheet C80). In the 20-year period following placement of waste and the engineered cover system in Area C, the elevation of SM-C1 has declined 0.17 of a foot (2.0 inches) (Table 2). As shown on the iso-settlement map for Area C in Attachment B, elevation differentials between 1998 and 2018 over most of Area C have been less than 1 foot, with a maximum differential of 3 to 4 feet in the area of the road maintenance noted above.

Based on site history and the results of the iso-settlement mapping and settlement monument survey, elevation changes in parts of Area C appear to be the result of construction activities, and there is no indication of settlement related to decomposition of the underlying waste.

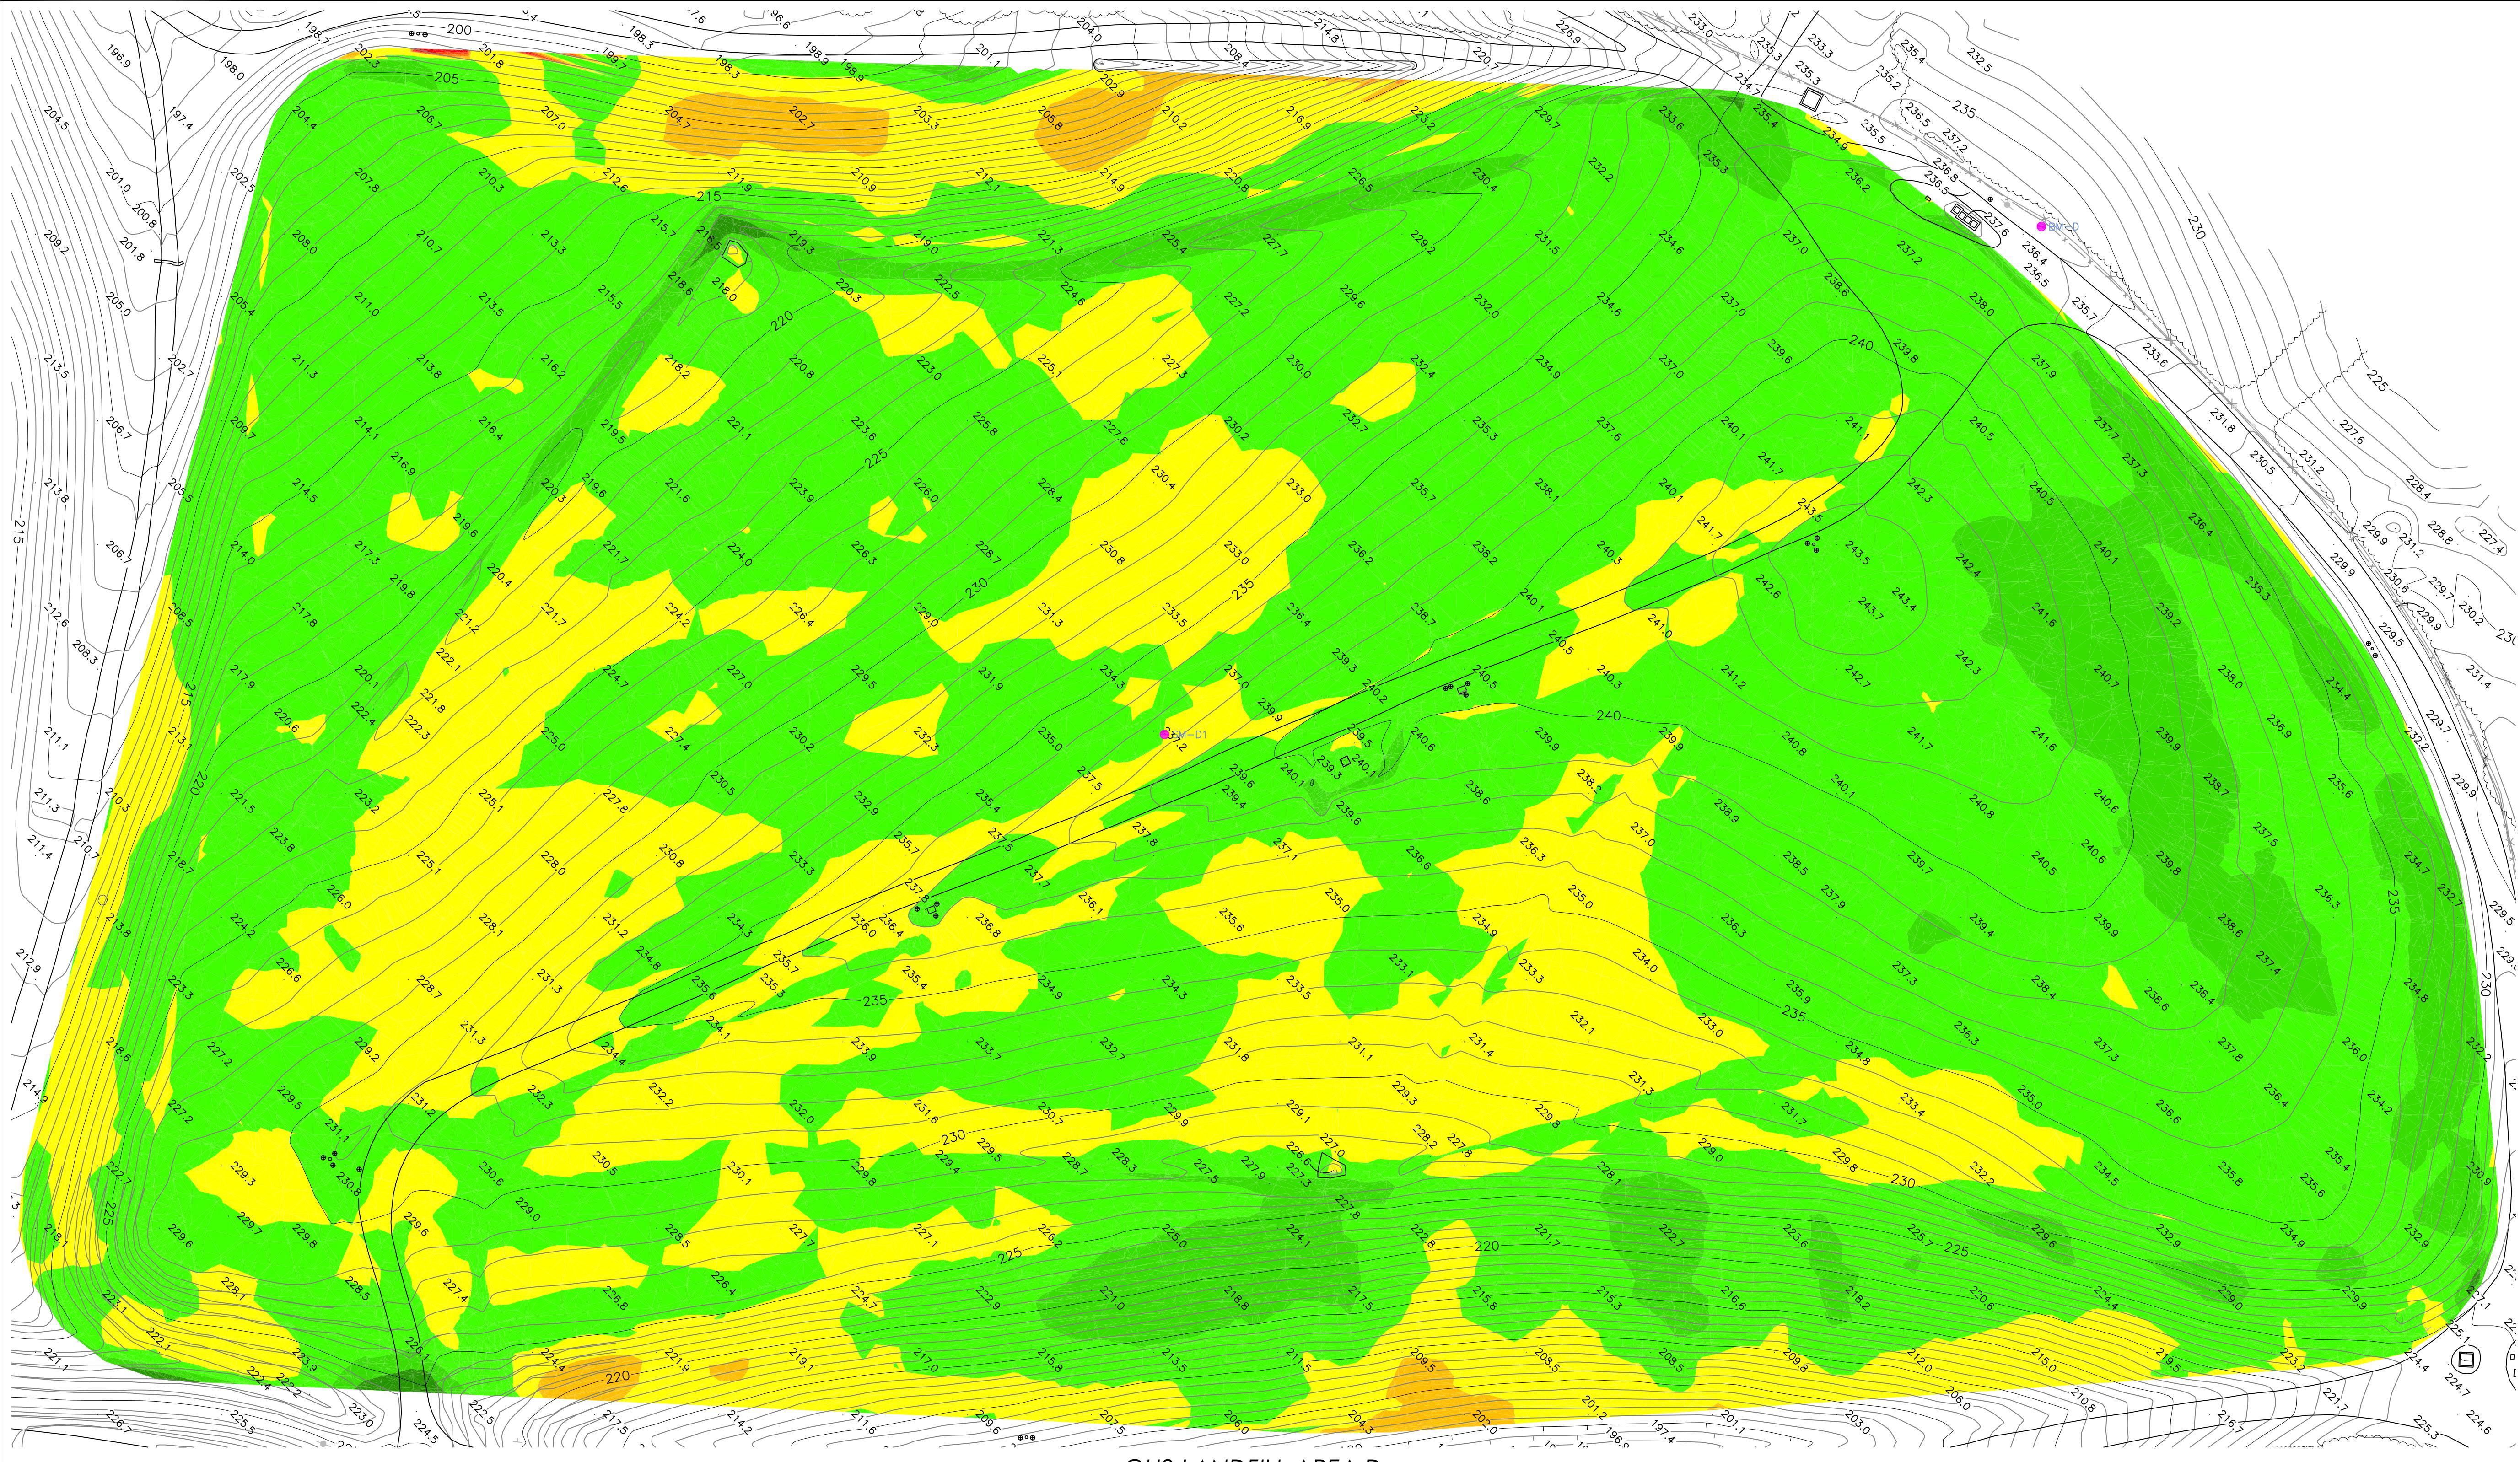
Volume Surface showing the change in elevation from 1998 to 2018 at Area D

Settlement monument SM-D1 is in the middle of Area D (Attachment C, Sheet C80). In the 20-year period following placement of waste and the engineered cover system in Area D, the elevation of SM-D1 has declined 0.25 of a foot (3.0 inches) (Table 2). As shown on the iso-settlement map for Area D in Attachment B, elevation differentials between 1998 and 2018 over most of Area D have been less than 1 foot, with a maximum differential of -5 to -6 feet in an isolated area of the northwestern slope. The iso-settlement map also shows increasing elevation differential of 1 to 4 feet that represents the top deck berm on the north side of Area D constructed after 1998 to manage storm water runoff and mitigate erosion of the northern slope.

Based on site history and the results of the iso-settlement mapping and settlement monument survey, differential settlement in parts of Area D appears to be the result of slope stability issues and is not related to decomposition of the underlying waste.

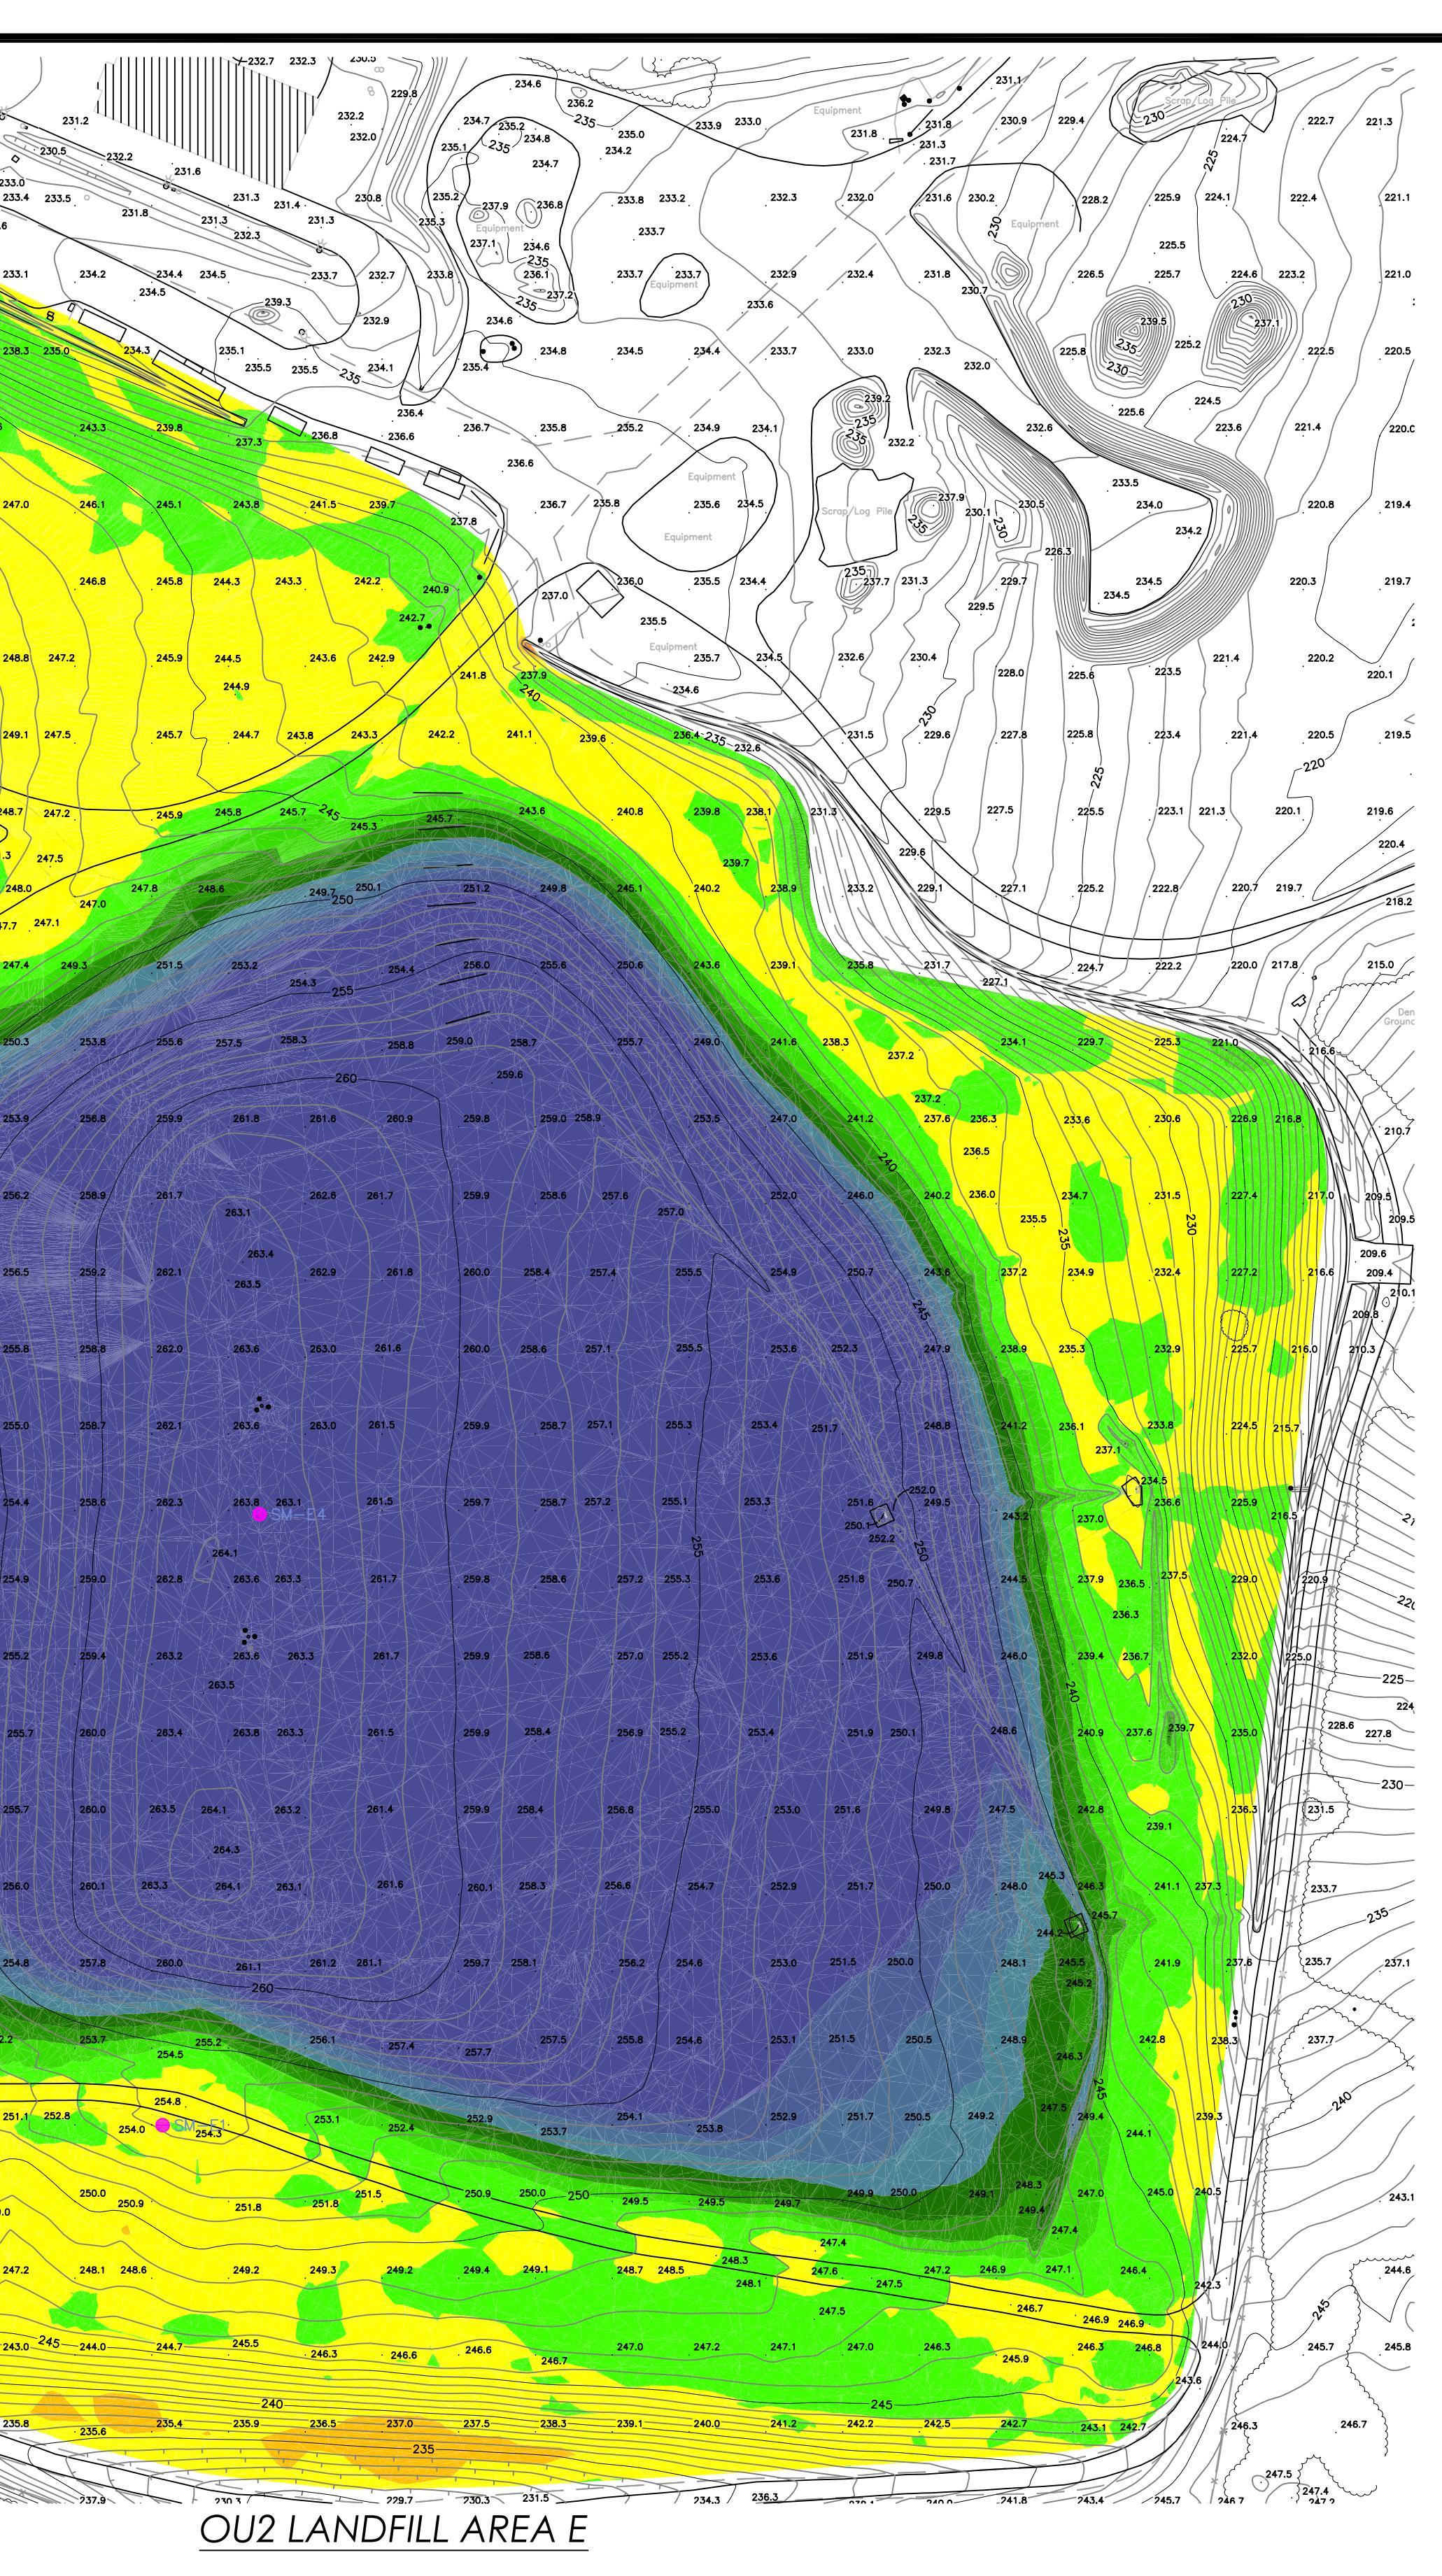
Volume Surface showing the to 2018 at Area E

Comparison of 2003 base topography with 2018 photogrammetric survey data for Area E indicated significant changes in surface elevations related to the Phase 1 vertical expansion and clean soil stockpiling in the Phase 2 area as shown on the iso-settlement map for Area E (Attachment B).

At the western extent of the Phase 2 area, a trench was left in place so a new LLDPE geomembrane may be secured to the existing LLDPE geomembrane to cover additional remediation waste from the Site 39 Inland Ranges to be brought to Area E sometime in the future. This "tie-in" trench is indicated by the narrow "open bracket" shape with surface elevations that are 1 foot to 3 feet lower than the 2003 base topography.

Based on site history and the results of the iso-settlement mapping and settlement monument survey, elevation changes in Area E appear to be the result of slope stability issues and construction activities, and are not related to decomposition of the underlying waste.

Differential settlement related to waste decomposition could not be assessed for all of Area E because of the amount of construction changes that have occurred there since 1998; however, the change in elevation of less than one foot at settlement monument SM-E1 indicates minimal settlement since 1998. Differential settlement at Area E may continue to be a challenge to assess because more remediation waste from the Site 39 Inland Ranges will be placed in the Phase 2 vertical expansion area within the next few years.
