Technical Report Iso-Settlement Survey Operable Unit 2 Landfills Former Fort Ord, California

U.S. Army Corps of Engineers Sacramento District 1325 J Street Sacramento, CA 95814-2922

Ahtna Environmental, Inc. 296 12th Street Marina, CA 93933-6001

January 2019

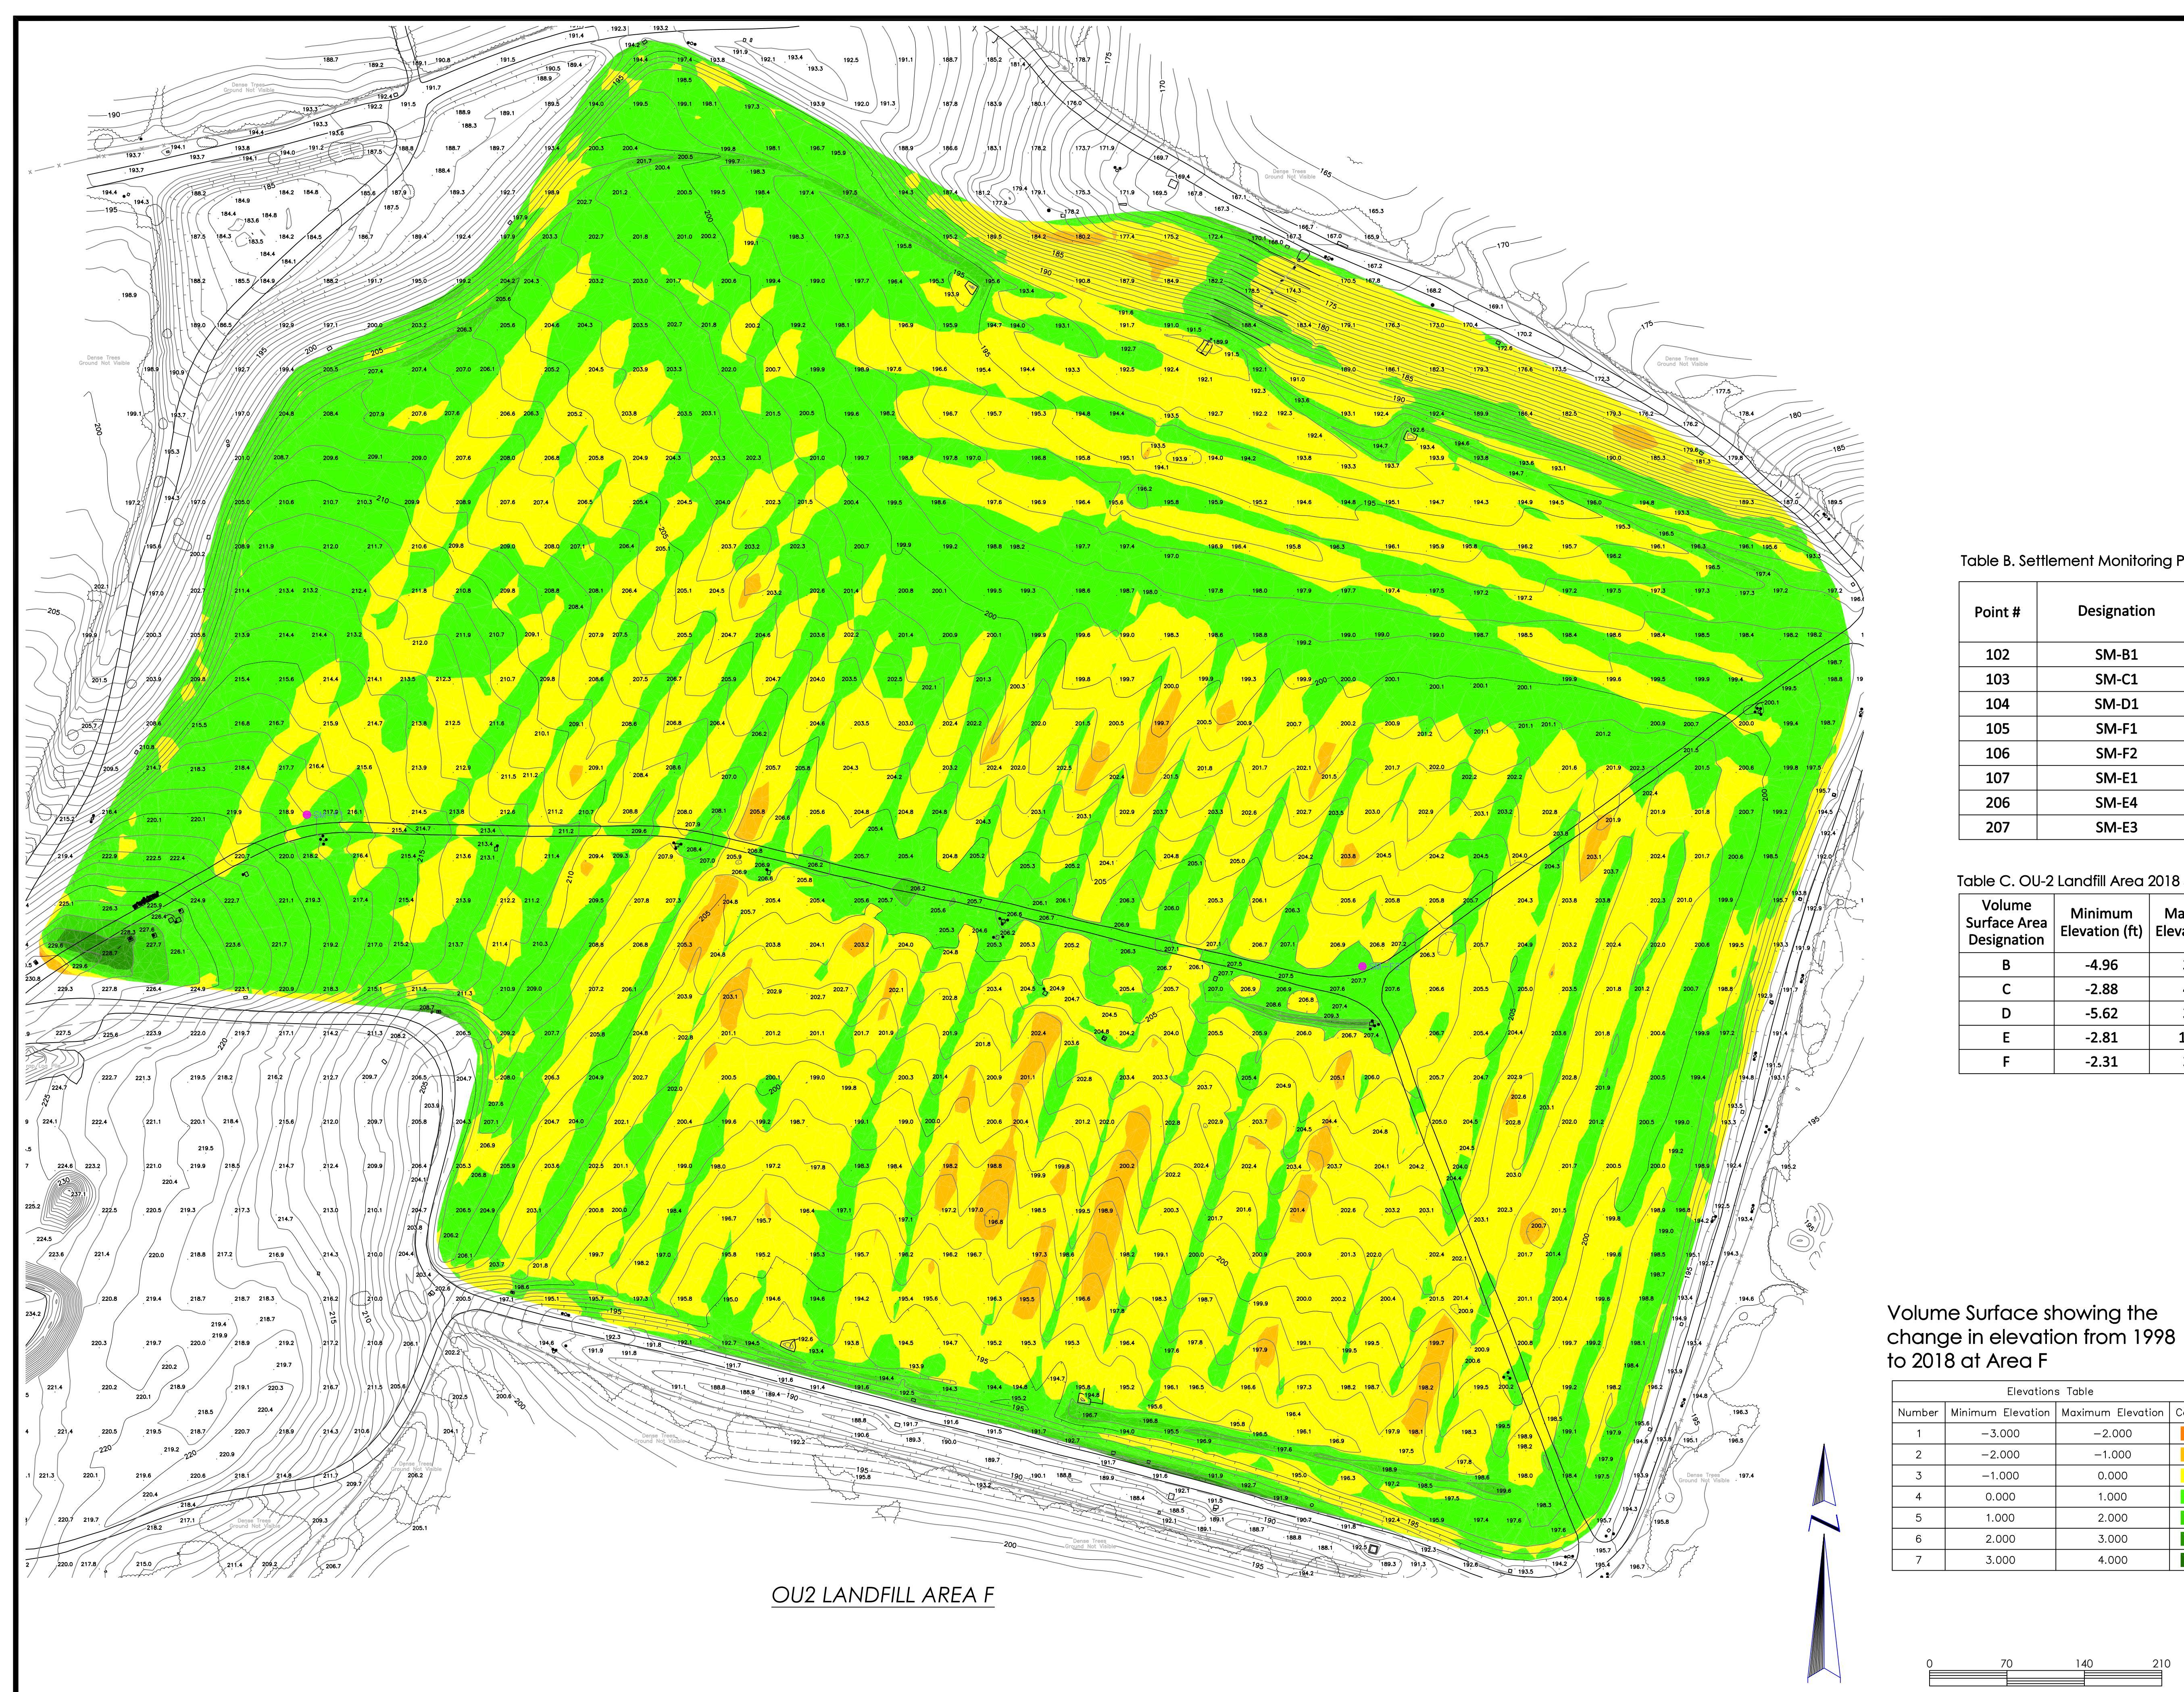
ISO-SETTLEMENT MAP

Comparison of 1998 base topography with 2018 photogrammetric survey data indicated no significant changes in surface elevations at Areas B, C, D, and F as shown on the iso-settlement maps for each area (Attachment B). Comparison of historical elevation data for settlement monuments on all the OU2 Landfills areas also demonstrates no significant changes in surface elevations (Table 2). This is likely due to the age of the waste in these areas, with waste last received at the OU2 Landfills in the western half of Area F in 1987 (Dames & Moore, 1993). Typically 20 percent of waste settlement occurs in the first 5 years after disposal as decomposition reduces the waste volume; therefore, most of the long-term settlement in the waste trenches in Areas B, C, D, and F had already occurred prior to construction of the engineered cover system in 1997 and 1998 (Ahtna, 2018).

Comparison of 2003 base topography with 2018 photogrammetric survey data for Area E indicated significant changes in surface elevations related to the Phase 1 vertical expansion and clean soil stockpiling in the Phase 2 area as shown on the iso-settlement map for Area E (Attachment B).

It is recommended iso-settlement mapping be completed again in 2023 in accordance with 27CCR Section 21090(e)(2).
